MINISTRY OF TRANSPORT AND CIVIL AVIATION

# CIVIL AIRCRAFT ACCIDENT

Report of the Court of Inquiry  
into the Accidents to  
Comet G—ALYP on 10th January, 1954  
and Comet G—ALYY on  
8th April, 1954

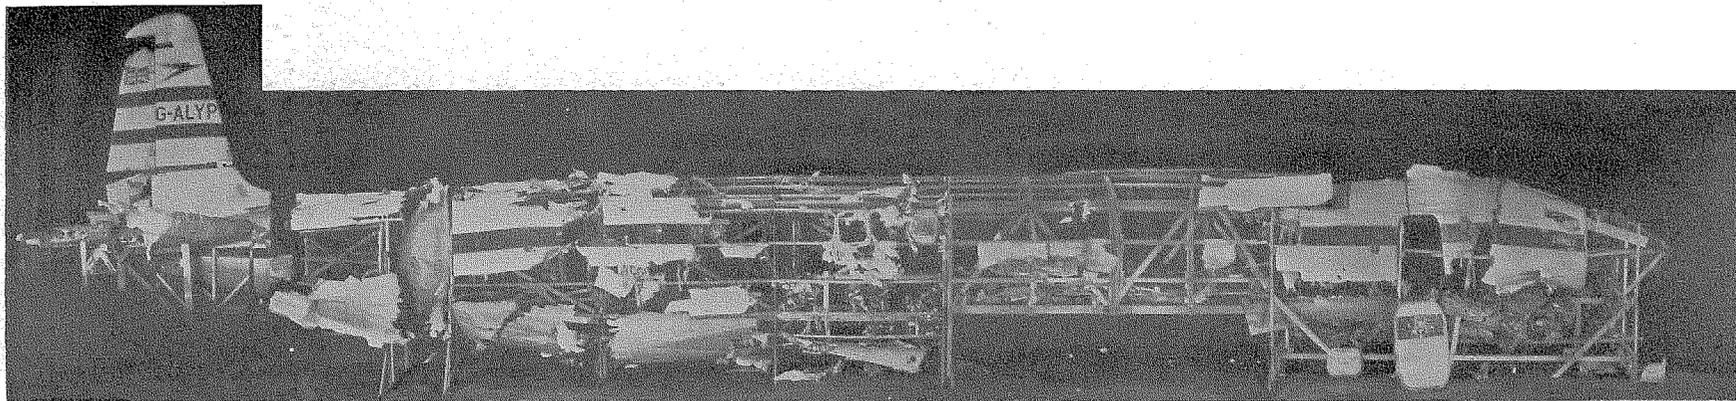
FIG. 4. RECONSTRUCTION OF FUSELAGE AND TAIL UNIT WRECKAGE—G-ALYP.

THIS PANEL  
(INCLUDING CREW  
ENTRY DOOR)  
RECOVERED  
SEPARATELY AND  
SHOWS WATER IMPACT  
DAMAGE ON OUTER  
FACE.

FORWARD EQUIPMENT  
BAY REAR BULKHEAD  
TORN FROM FRONT  
FUSELAGE AND  
REMAINED ATTACHED  
TO WING.

NOSE DOWN BENDING  
FAILURE OF PICK UP  
POINTS ON WING WITH  
FINALLY SOME BENDING  
TO STARBOARD.

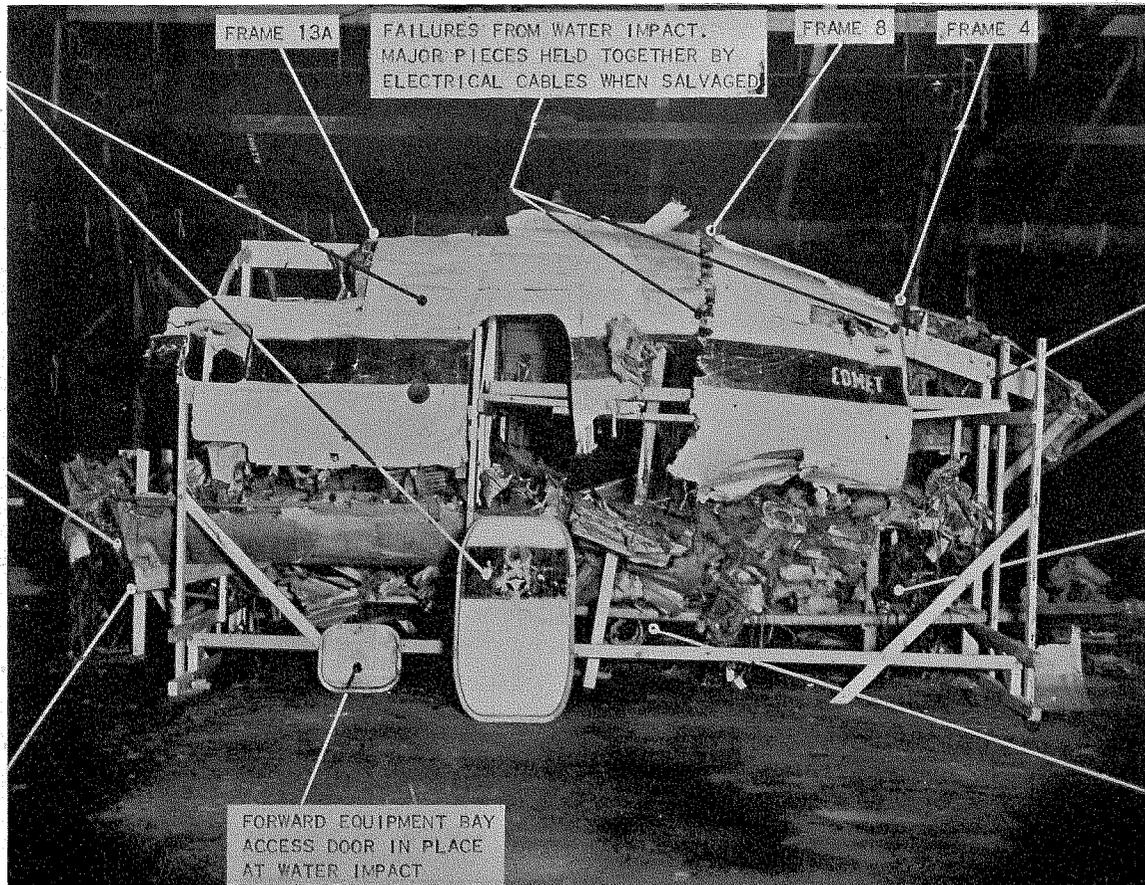
FIG. 5. FRONT FUSELAGE—VIEW ON STARBOARD SIDE—G-ALYP.

STARBOARD  
WINDSCREEN MISSING.

EXTENSIVE CRUSHING  
OF WHOLE UNDERSIDE  
OF FRONT FUSELAGE  
BY WATER.

FORWARD EQUIPMENT BAY  
ACCESS DOOR IN PLACE  
AT WATER IMPACT

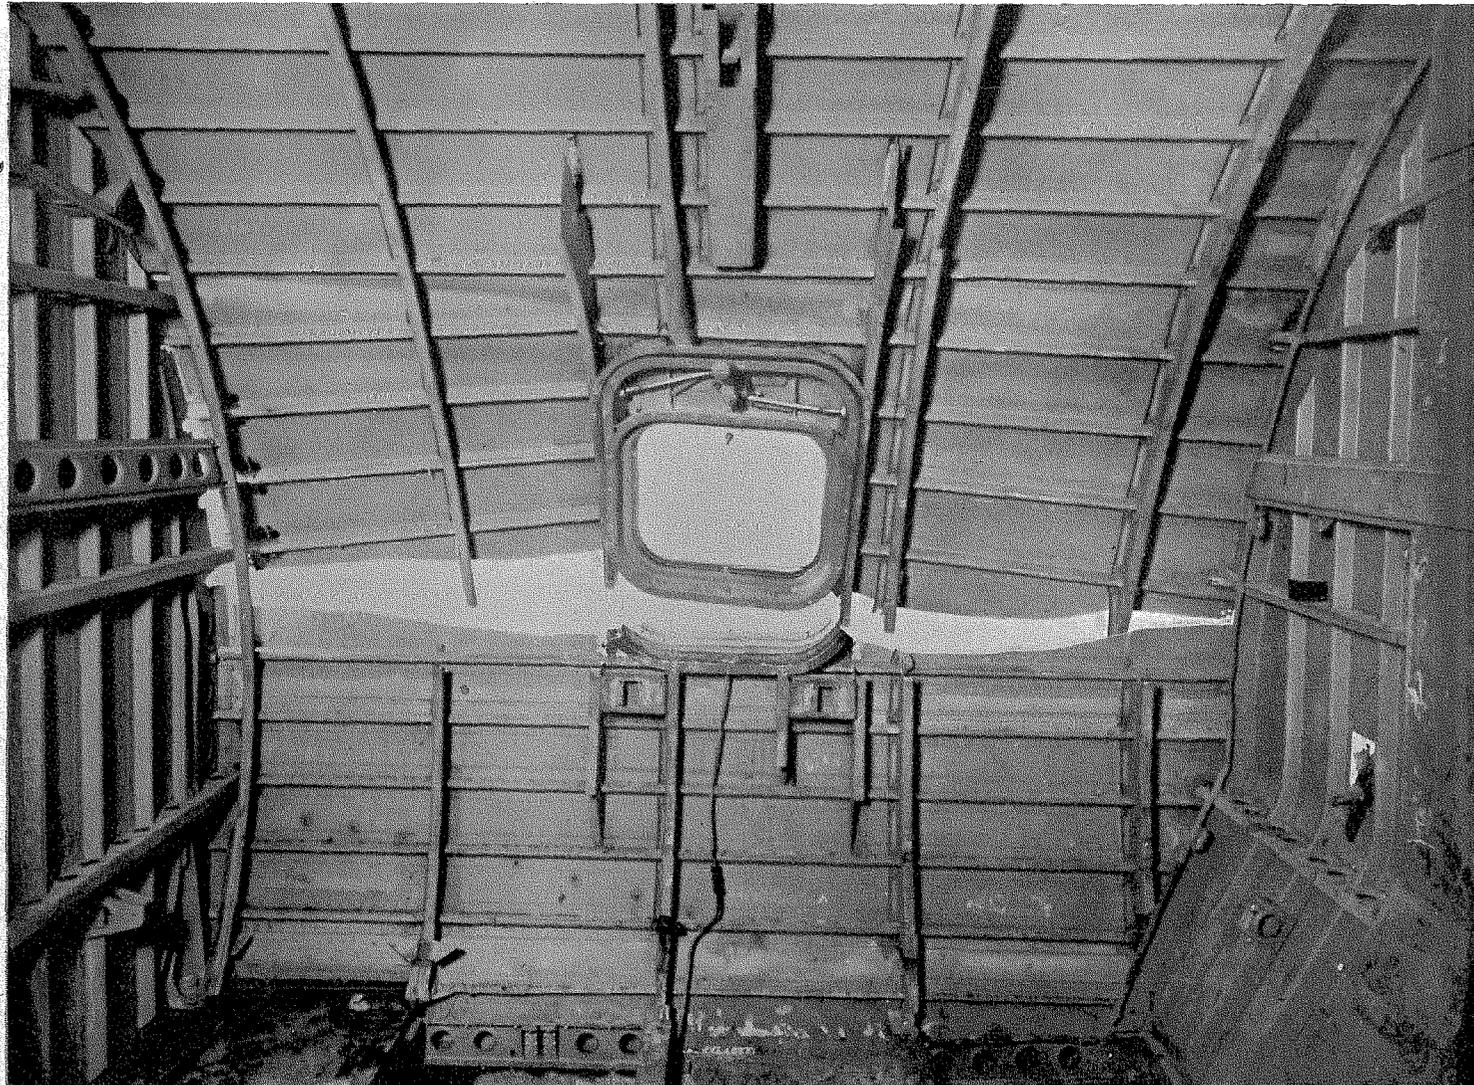
FIG. 7. VIEW FROM INSIDE OF FAILURE AT THE FORWARD ESCAPE HATCH ON THE PORT SIDE—COMET G-ALYU

64. Yoke Uncle had made 1,230 pressurised flights before the test and after the equivalent of a further 1,830 such flights, making a total of 3,060, the cabin structure failed, the starting point of the failure being the corner of one of the cabin windows (see Figures 7 and 8). The fact that the failure occurred during one of the proving tests to 11 lb./sq. in. is not thought significant since the crack would have spread in very much the same way after a few more applications of the working pressure. Examination of the failure provided evidence of fatigue at the point where the crack would be most likely to start, namely near the edge of the skin at the corner of the window (see Figures 9 and 10). This was revealed

by the discolouration due to algae in the water which made it clear that the crack had endured several pressurisations before it spread catastrophically. It is important to note here that the sources of fatigue mentioned above, which were not reproduced in the tank test, all tend to increase the burden of fatigue and that, therefore, the life of a fuselage deduced from the test is longer than would be expected in service. It is not possible to do more than estimate the magnitude of this effect but it was suggested by Dr. Walker that a "life" of 3,060 flights in the test might be equivalent to about 2,500 in practice.

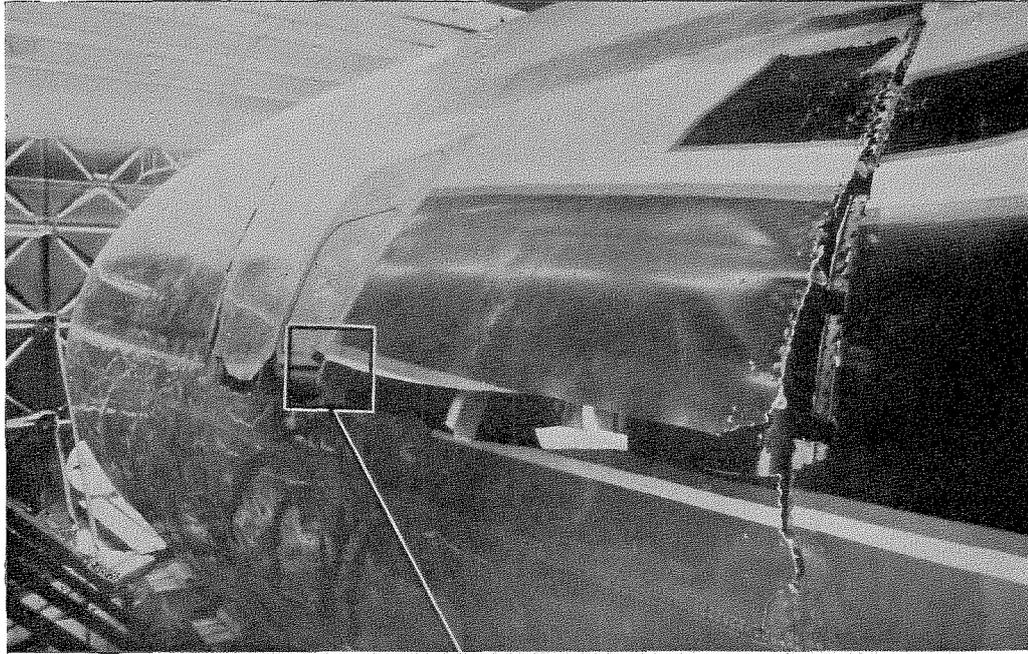
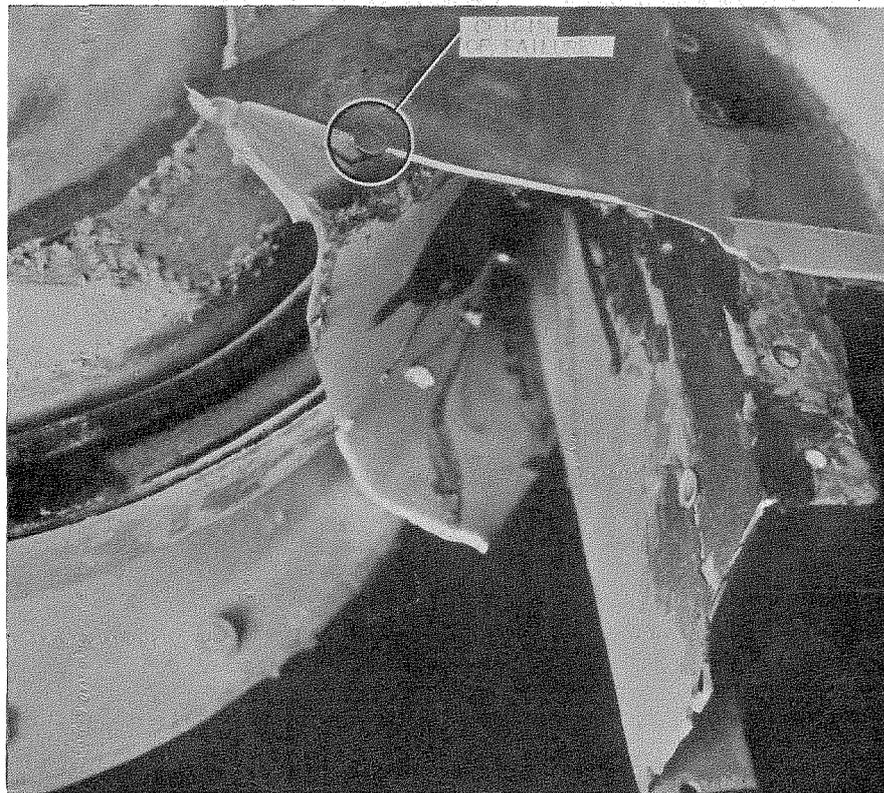
FIG. 9. FAILURE OF FRONT FUSELAGE AT 10.4 lb/in<sup>2</sup> (3057 TOTAL FLIGHTS)—G-ALYU.

a. GENERAL VIEW LOOKING FORWARD.

b. CLOSE-UP OF SKIN AT BOTTOM REAR CORNER OF ESCAPE HATCH.

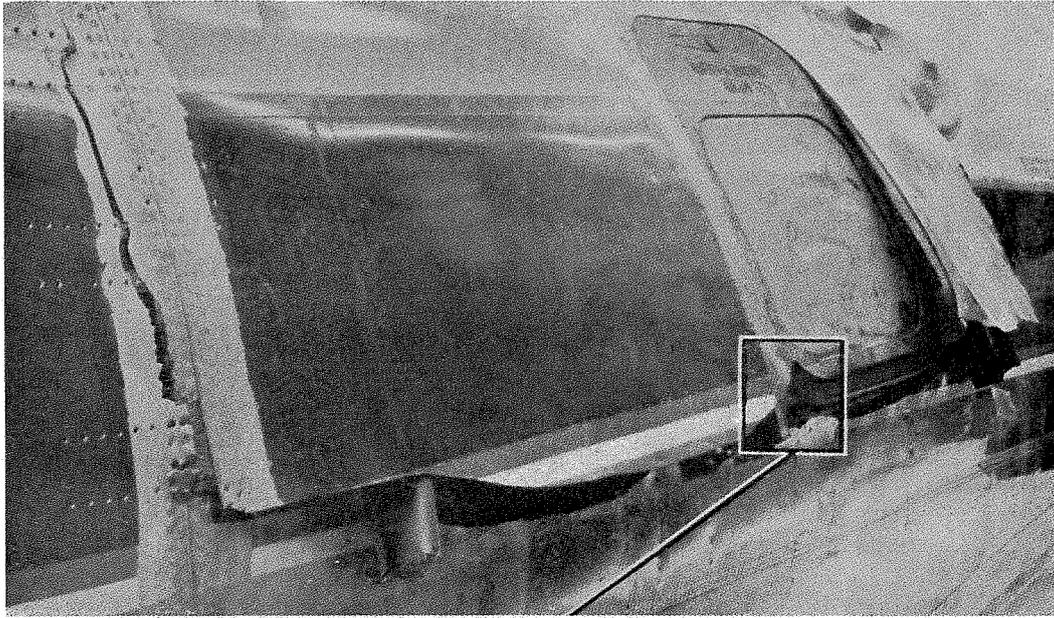
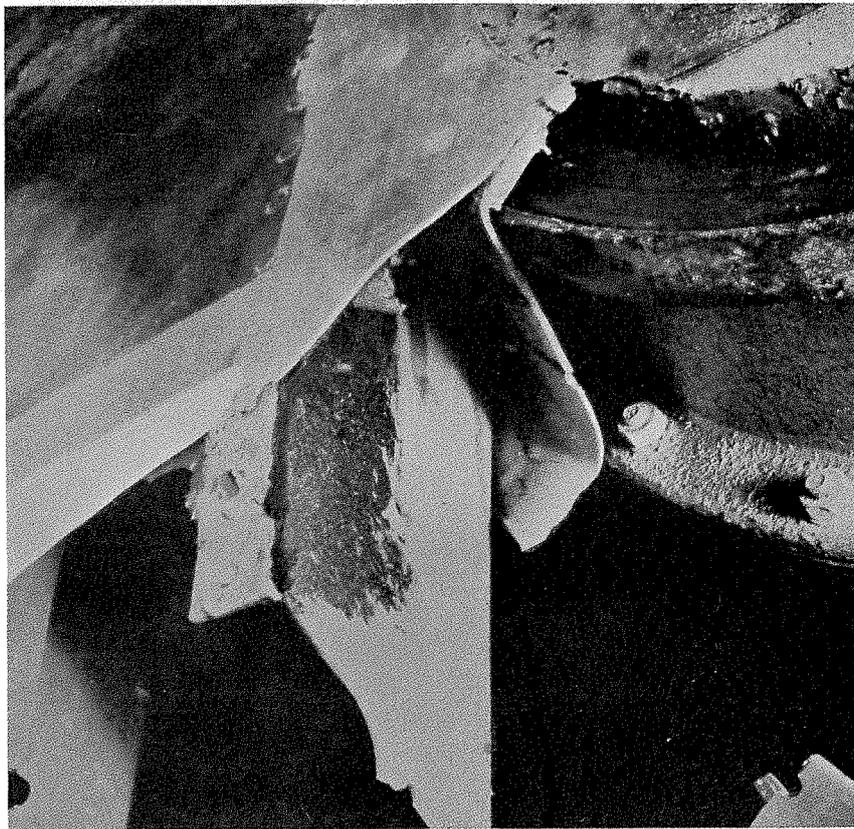
FIG. 10. FAILURE OF FRONT FUSELAGE AT  $10.4 \text{ lb/in}^2$  (3057 TOTAL FLIGHTS)—G-ALYU.

a. GENERAL VIEW LOOKING AFT.

b. CLOSE-UP OF SKIN AT BOTTOM FRONT CORNER OF ESCAPE HATCH.

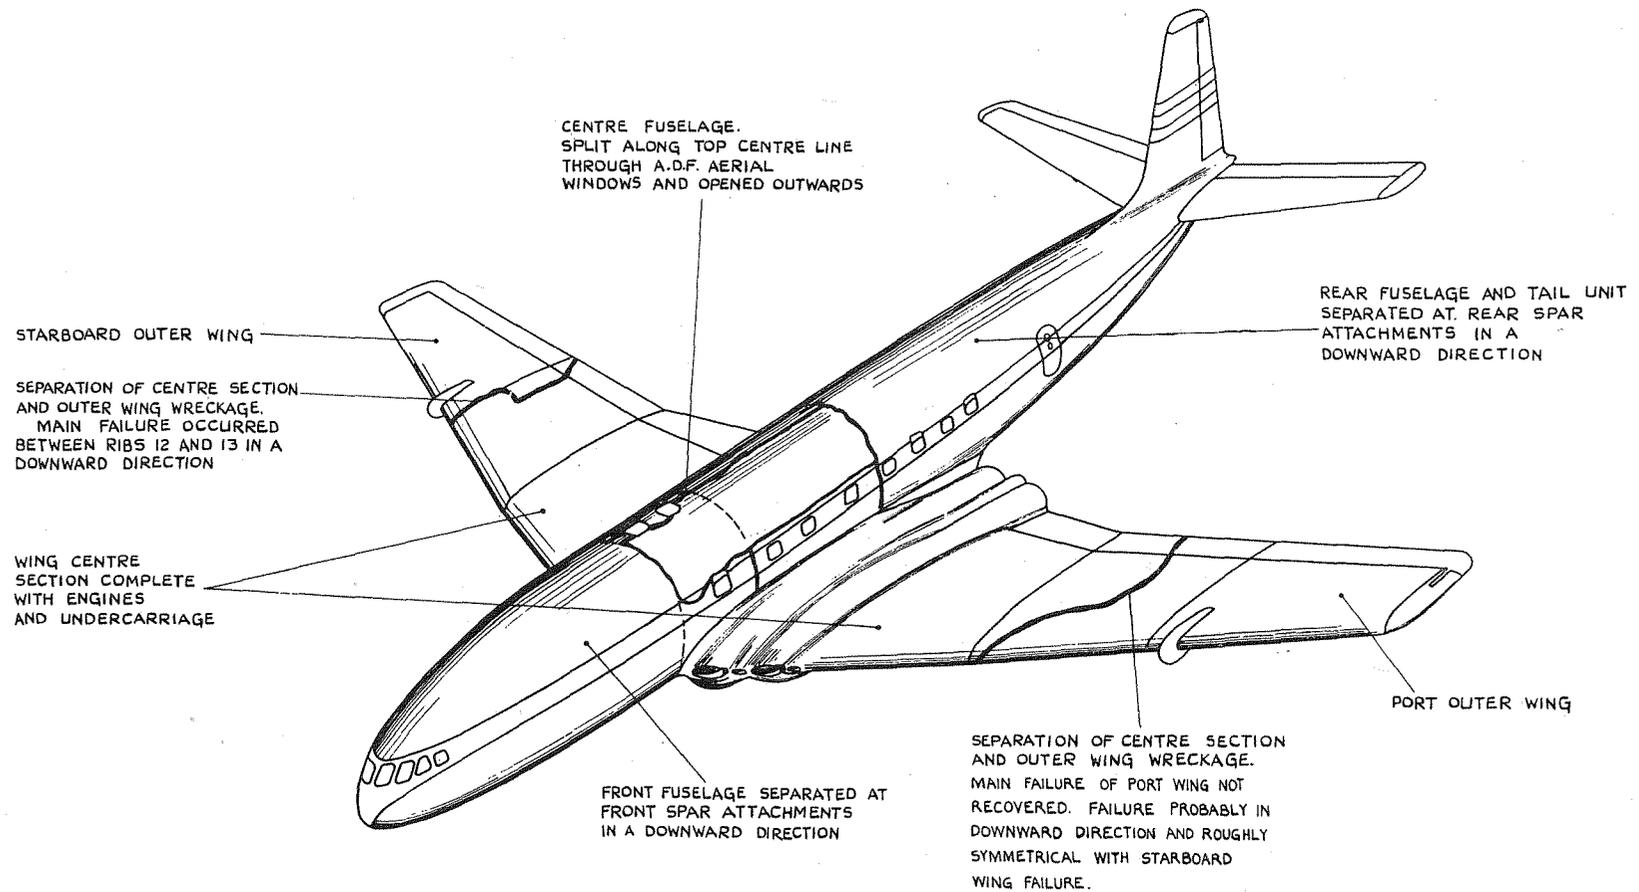
FIG. II. LOCATION AND DIRECTION OF MAIN FAILURES—G-ALYP.

DIRECTION OF  
PROPAGATION  
OF MAIN  
FAILURES

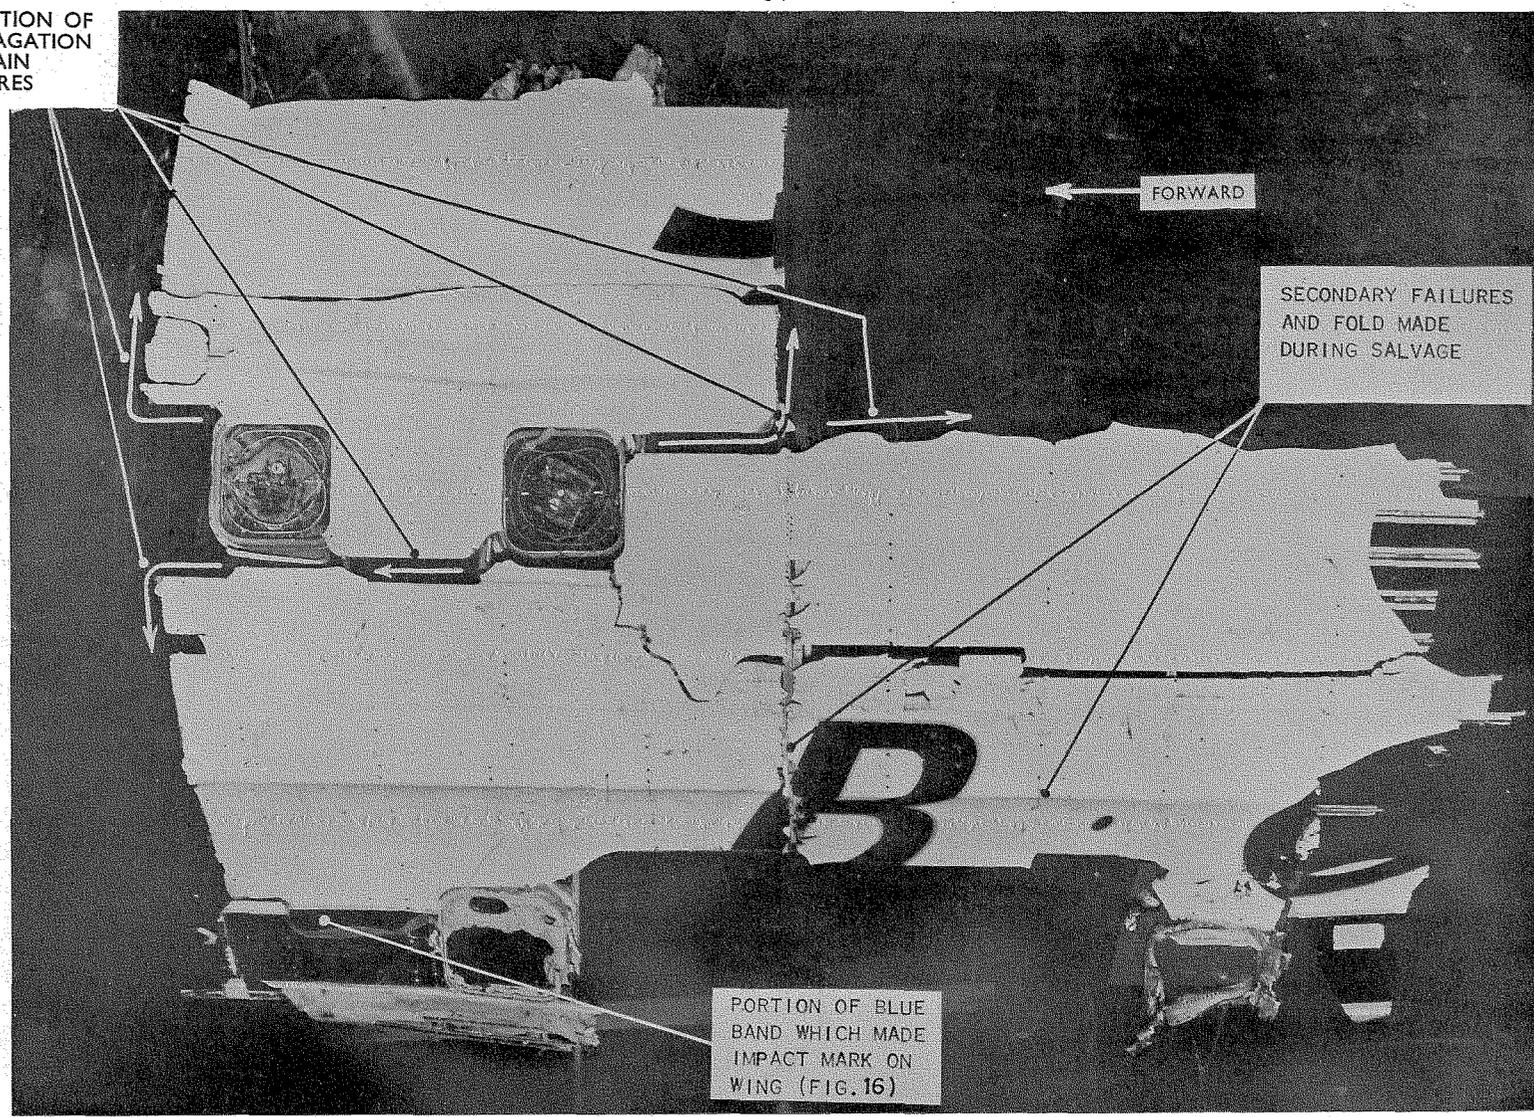
FIG. 12. PHOTOGRAPH OF WRECKAGE AROUND ADF AERIAL WINDOWS—G-ALYP.

SECONDARY FAILURES  
AND FOLD MADE  
DURING SALVAGE

PORTION OF BLUE  
BAND WHICH MADE  
IMPACT MARK ON  
WING (FIG. 16)

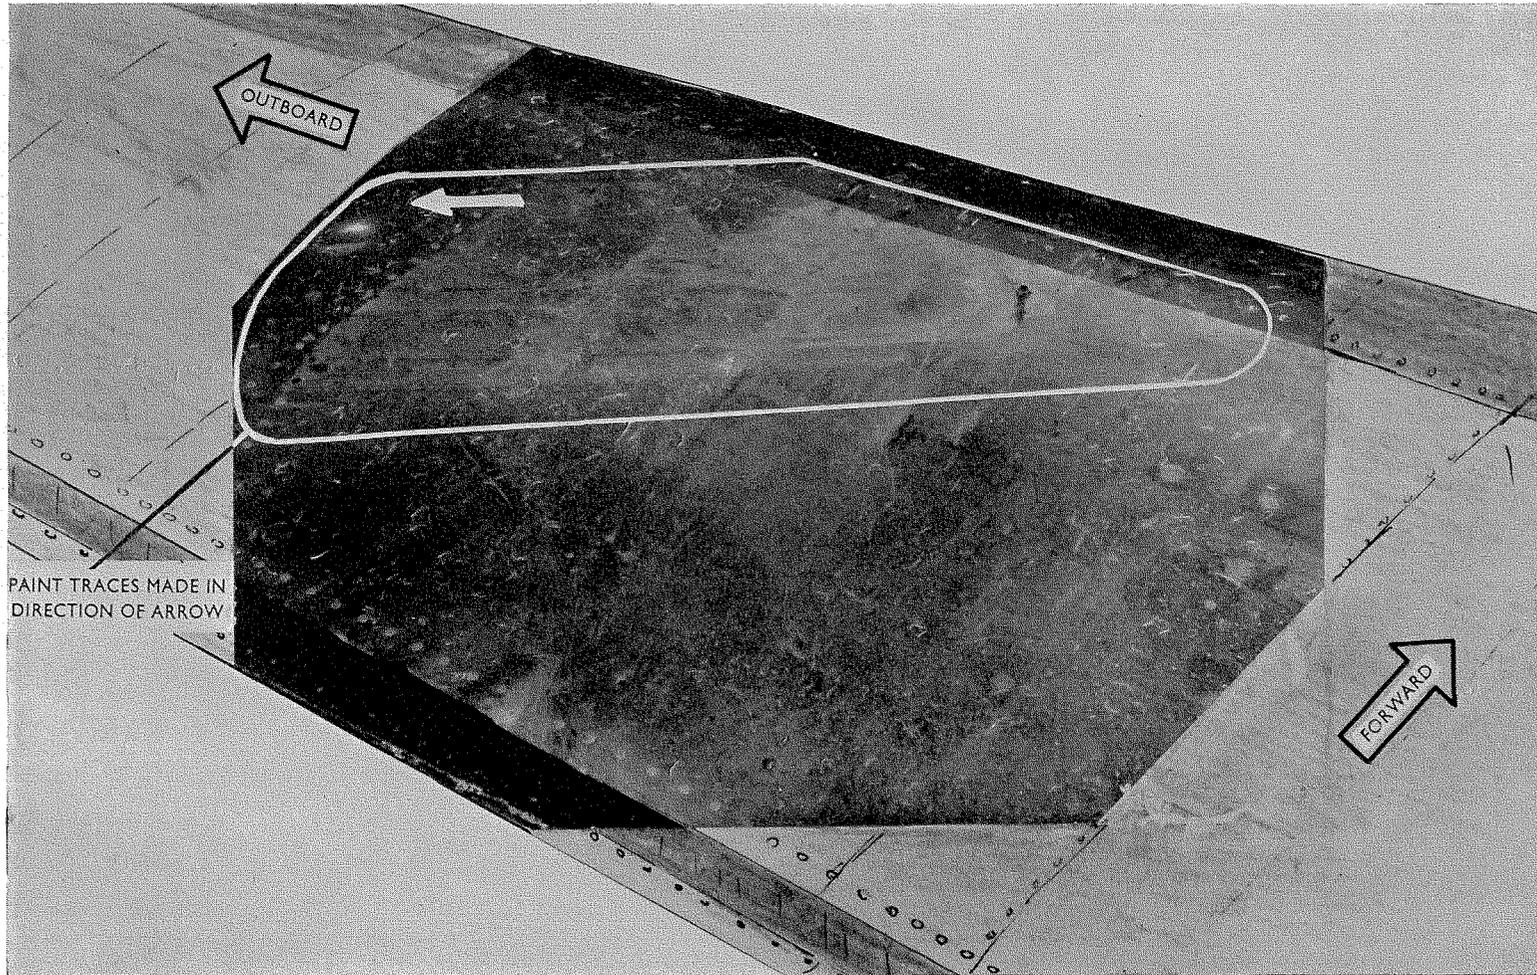
FIG. 13. PAINT TRACES OVER PORT AILERON UPPER SURFACE—G-ALYP.

(FOR LOCATION ON AILERON SEE FIG. 16.)

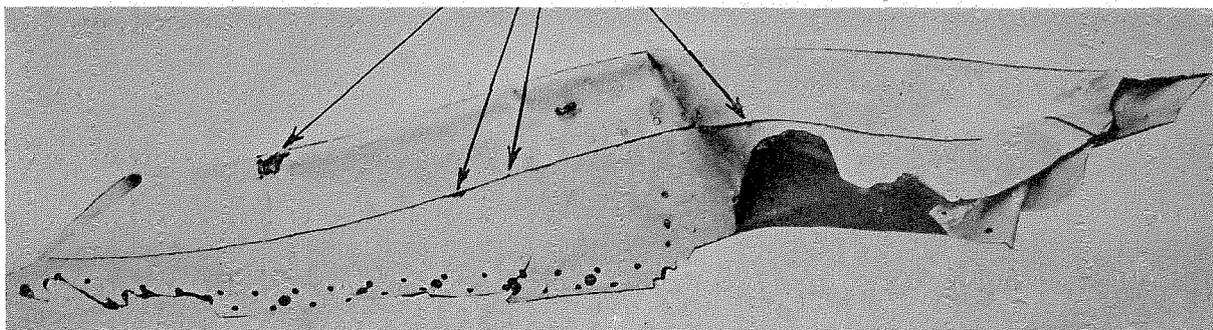
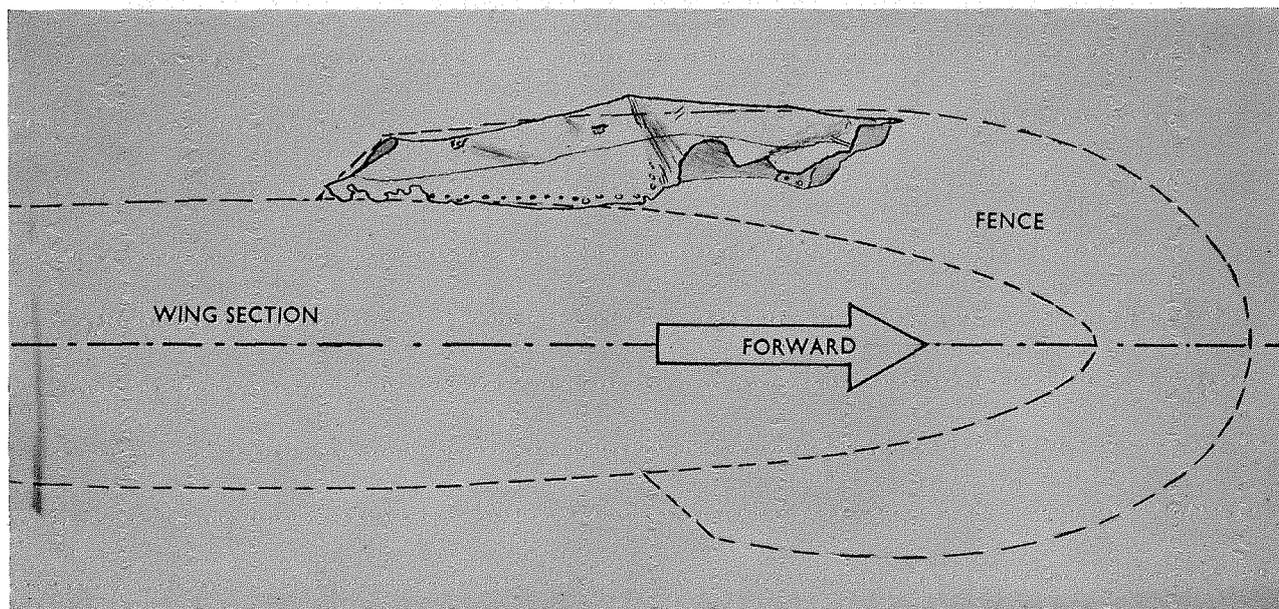
FIG. 14. PORT BOUNDARY LAYER FENCE, IMPACT DAMAGE TO INBOARD FACE—G-ALYP.

PARTICLES OF FIBREGLASS AND WOOD JAMMED INTO SKIN AND UNDER LAP JOINT PROBABLY FROM FUSELAGE CABIN FLOORING

GENERAL PATTERN OF METALLIC SCORES AND PAINT TRACES OVER INBOARD FACE PROGRESSING FROM WING SKIN TO UPPER EDGE OF FENCE

NO COMPARABLE DAMAGE ON OUTBOARD FACE OF FENCE

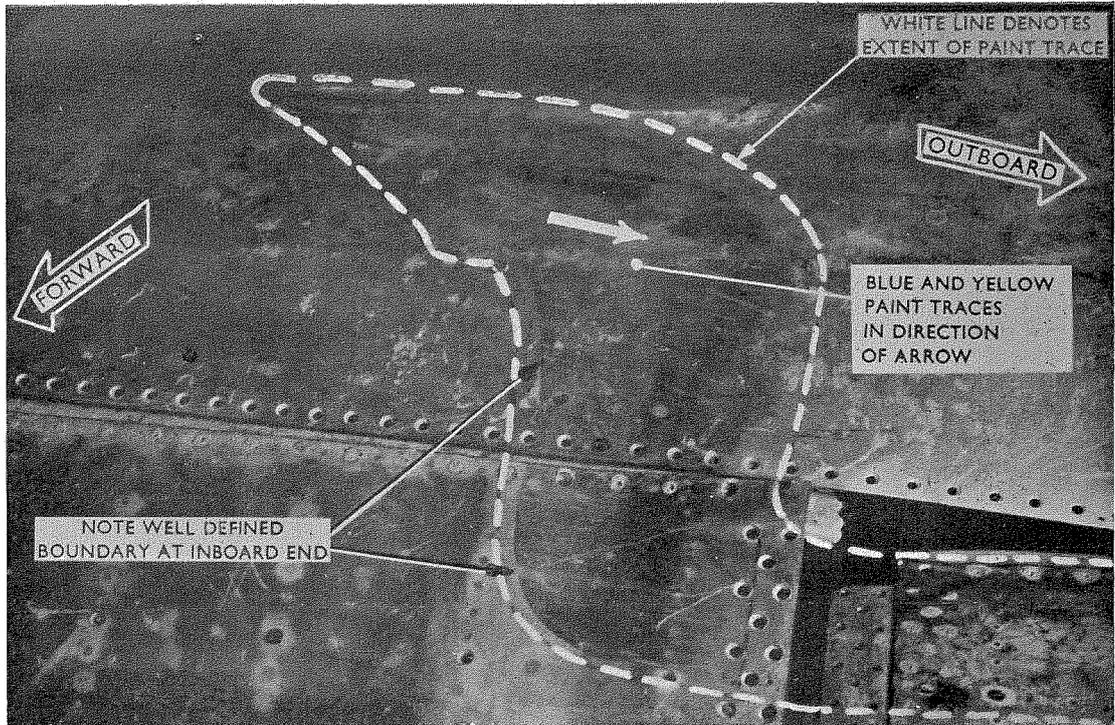
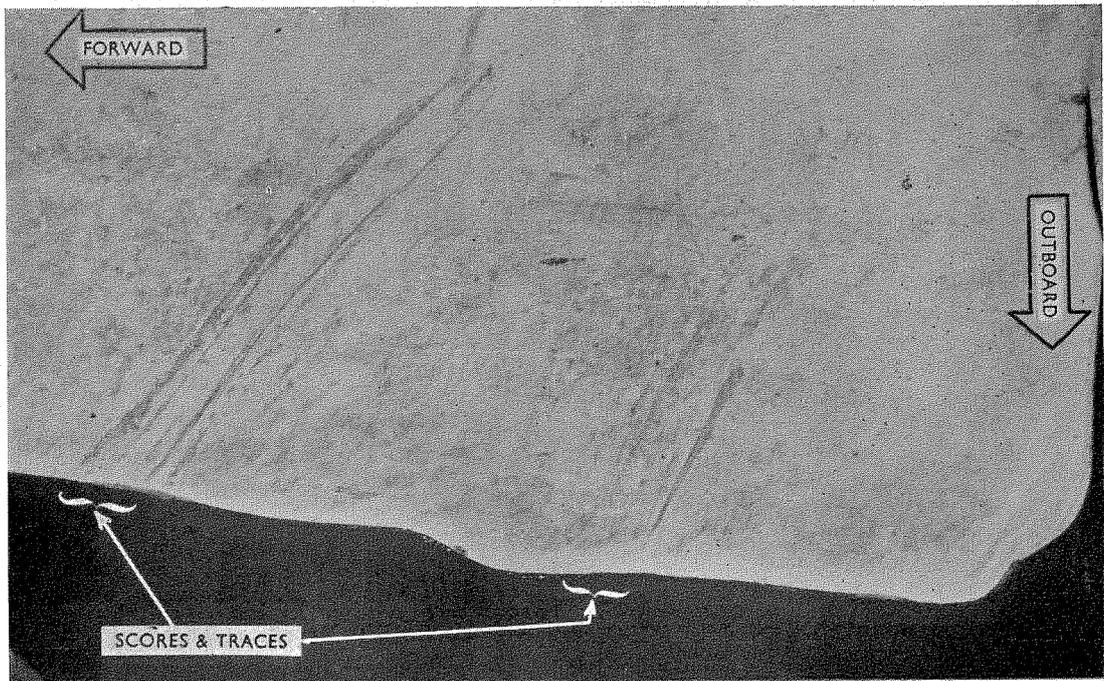
FIG. 15. PAINT TRACES ON PORT WING UPPER SURFACE—G-ALYP.

PAINT TRACES MADE BY PORTION OF CABIN WALL  
(FOR LOCATION SEE FIG. 16).

HEAVY METALLIC SCORING WITH BLUE PAINT TRACES CONTINUOUS OVER FRACTURE EDGE  
(FOR LOCATION SEE FIG. 16).

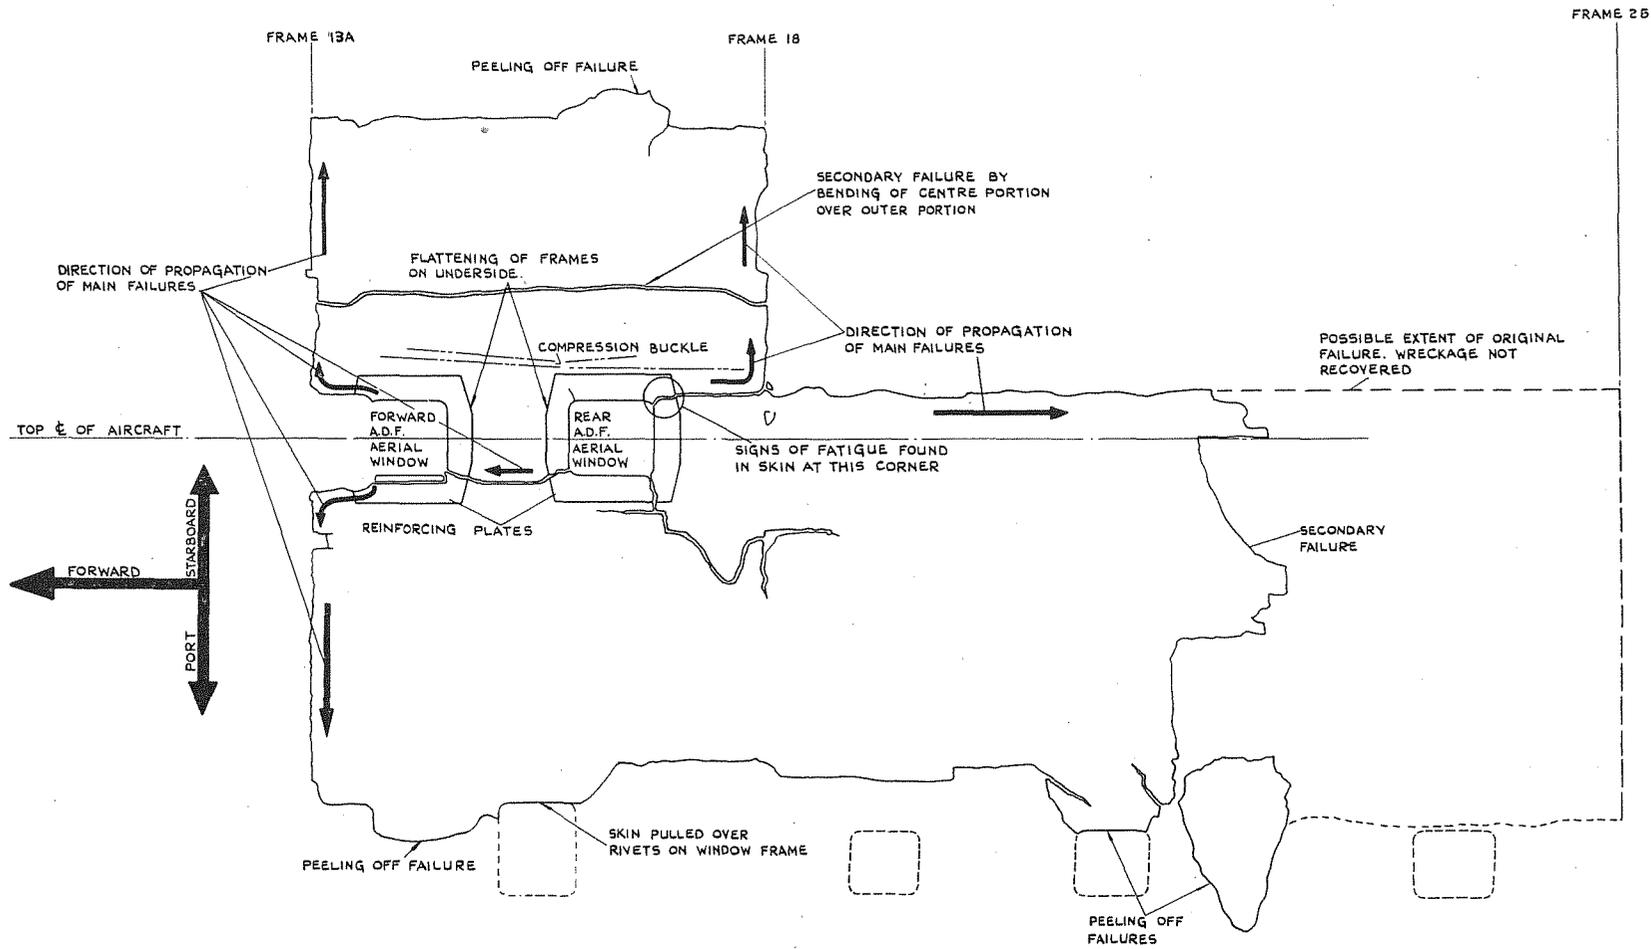
FIG. 17. SALIENT FEATURES OF DISRUPTION OF PRESSURE CABIN—G—ALYP.

DEVELOPMENT DRAWING SHOWING LOCATION OF THESE  
 PANELS IN RELATION TO SURROUNDING WRECKAGE IS  
 GIVEN ON FIG.18.  
 PHOTOGRAPH OF PANELS IS GIVEN ON FIG.12.

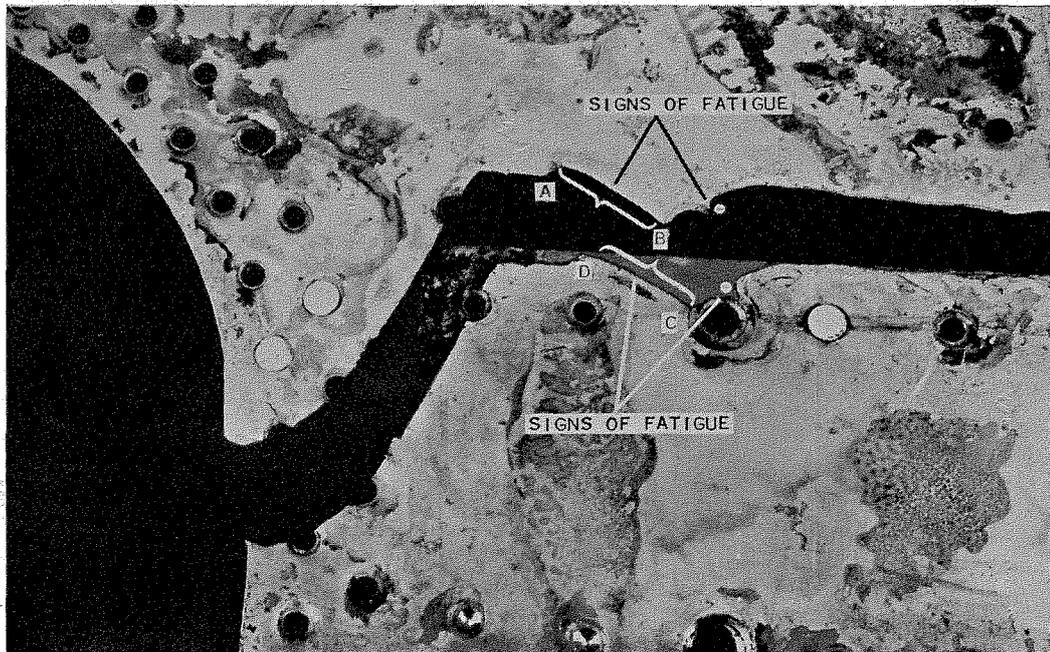
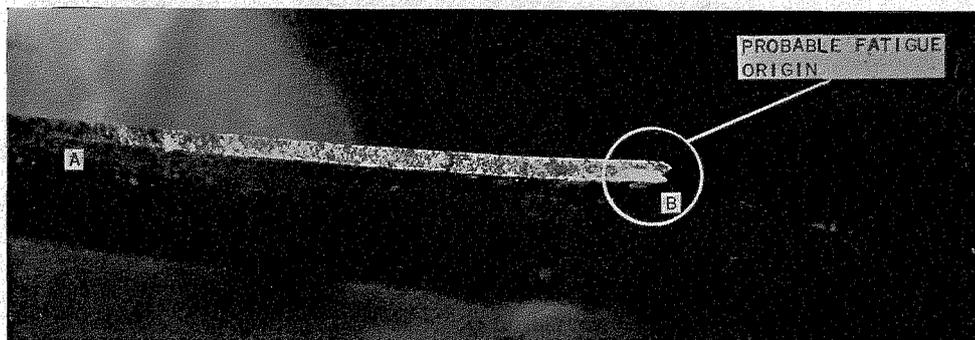
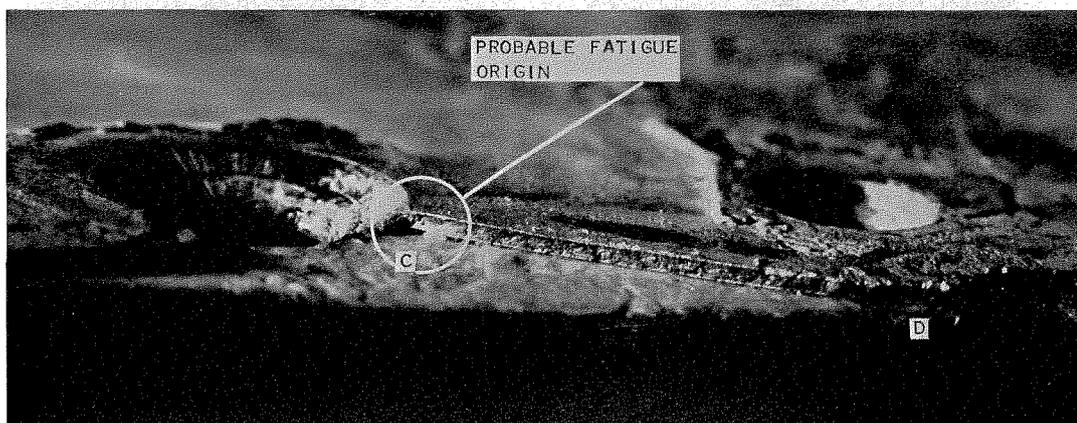
FIG. 19. SIGNS OF FATIGUE IN SKIN AT STARBOARD REAR CORNER OF REAR ADF AERIAL WINDOW—G-ALYP.

(a) PLAN VIEW OF FAILURE IN SKIN.

(b) VIEW OF EDGE A B.

(c) VIEW OF EDGE C D.
