# Brunswick Centre

University of Westminster

Architecture and Environmental Design MSc

Semester 1 - Evaluation of Built Environment Module:

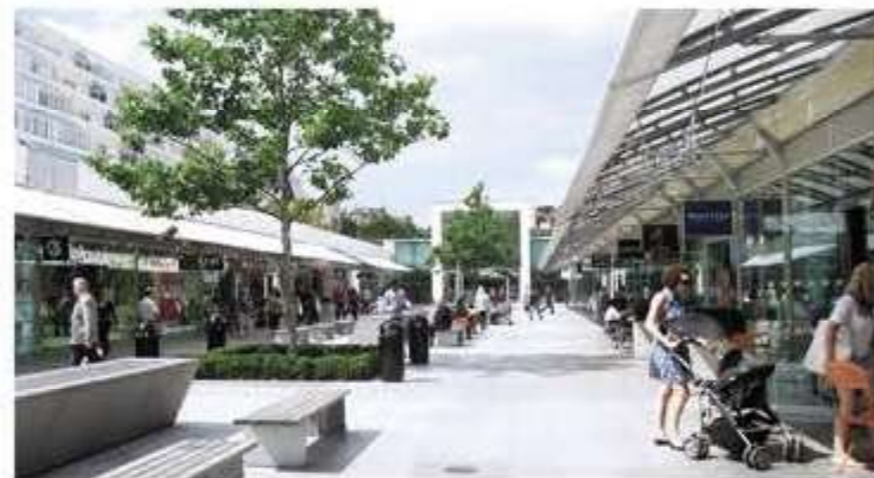
Fig. 13 Plaza at present

- Brunswick is a great piece of **postwar housing modernist architecture**.
- 
- The **plaza was repaved in 2006** in granite-alternating polishes and semi-polished paving creating a chequer-board pattern and a new series of water features by Susanna Heron, seatings and raised planters were designed (Fig. xx).
- Opening of several branches of **high street chain stores** and **restaurants** after the refurbishment.
- The concrete was repaired and the **blocks were painted** in their originally-planned cream colour in 2006.
- The **refurbishment changed** the **microclimate** of the plaza making it a comfortable space.
- Double glazing were installed in the sloping area

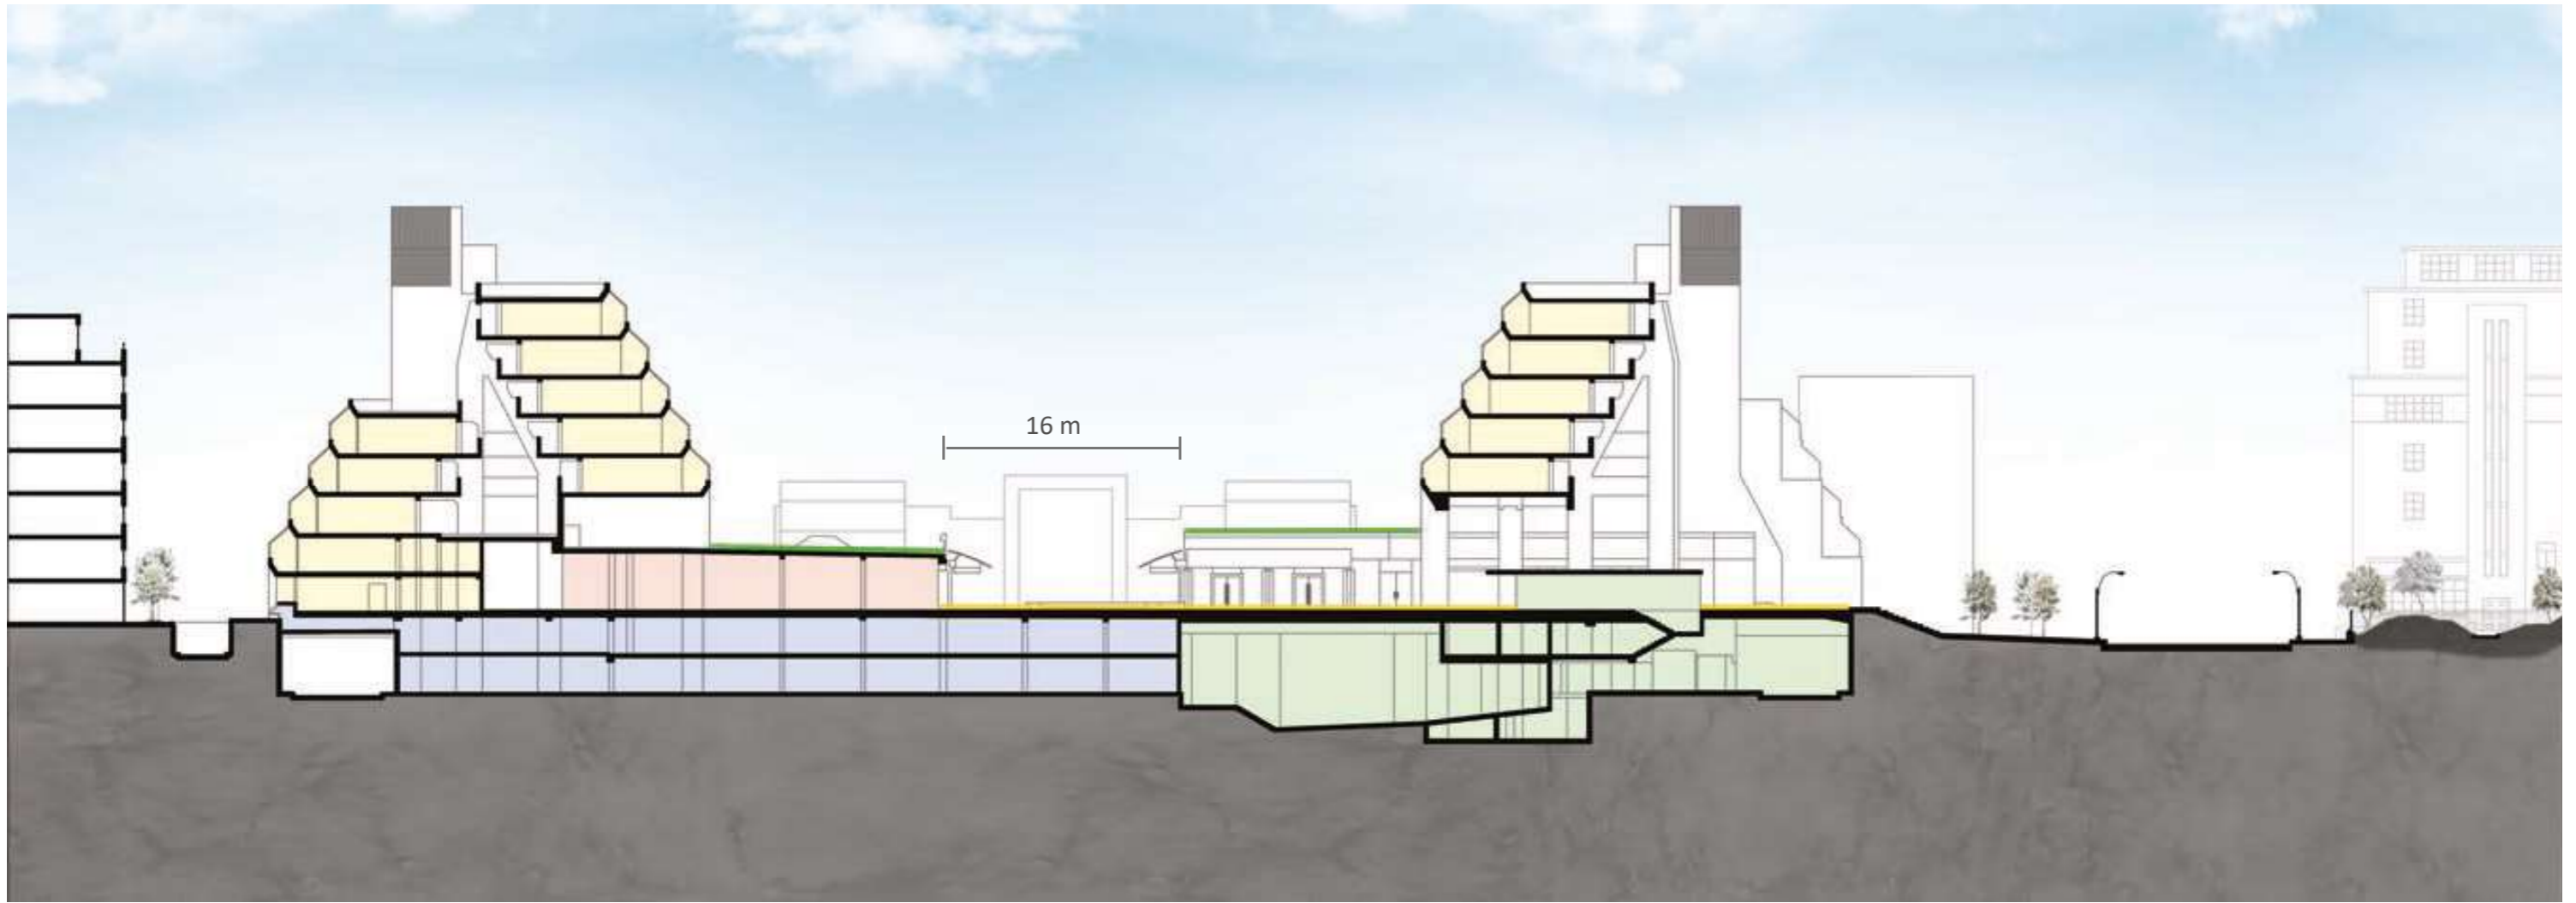
Fig. 20 Actual section through the plaza

Parking Space
  Cinema
  Residential Space
  Retail
  Plaza Level
  Terraced Level

- **Plaza** acts as a spine of the site, linking the two sides together. It is lined with retail spaces on either sides of the central pedestrian walkway
- **Terraces** run around the inner court at the first floor level
- **Housing** is formed in two blocks running the length of the site

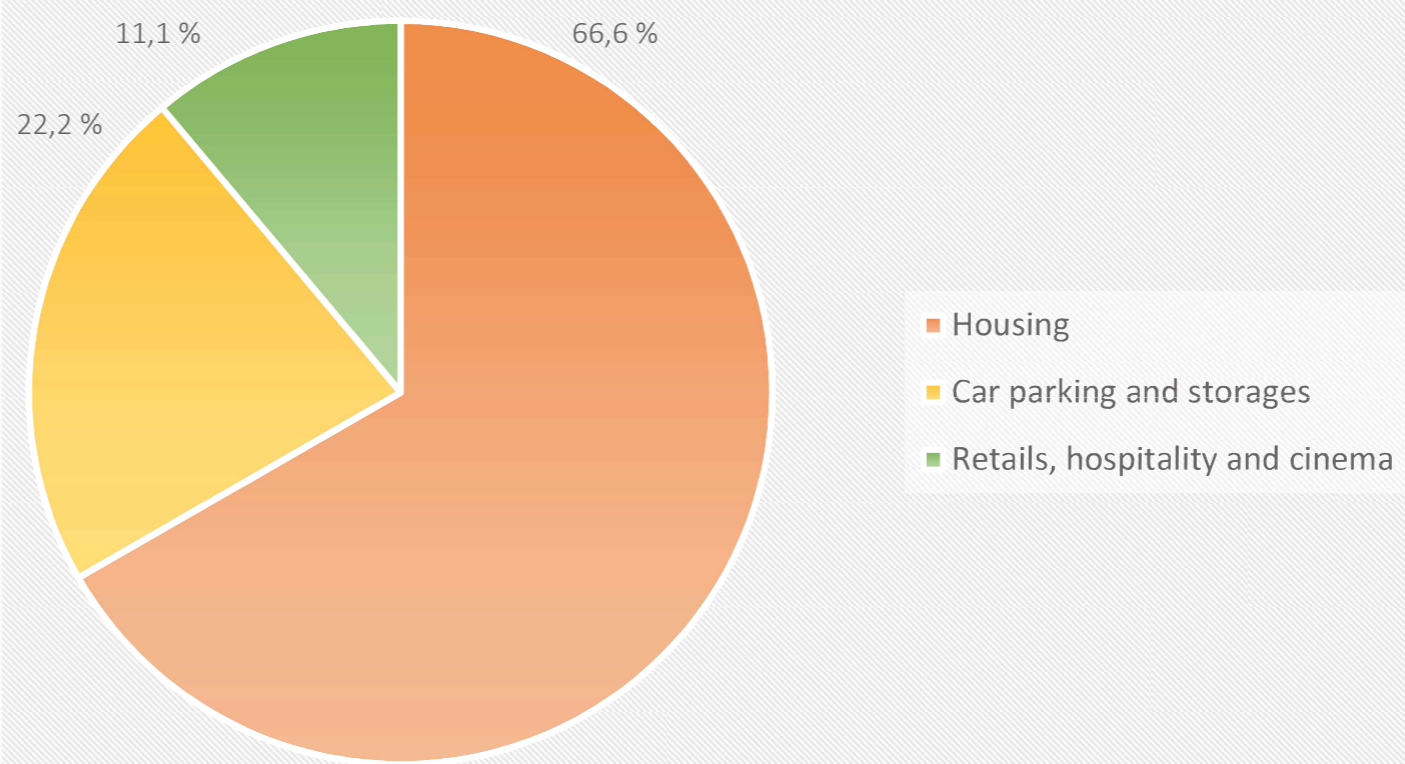
Fig. 22 Building organisation graph (%)

- **Overall** development is **9 floors**
- **2 underground floors:** car parking, retail storage and loading bays
- **Entrance level:** retail units, hospitality and a cinema
- **6 Upper floors:** housing

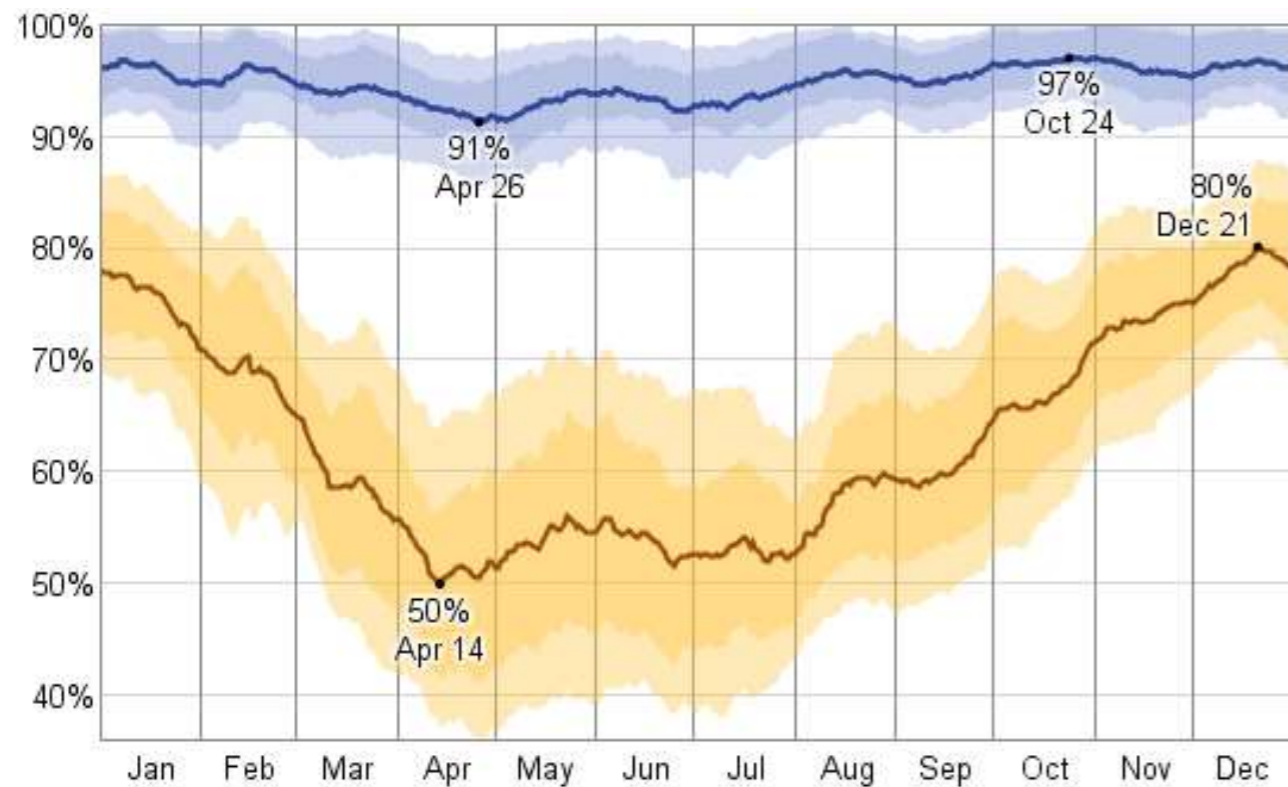
Fig. 24 Monthly Average Relative Humidity (%) (Source: Weatherspark.com)

The air is driest around April 14, at which time the relative humidity drops below 56% (mildly humid); it is most humid around October 24, exceeding 95% (very humid). The average daily high (blue) and low (brown) relative humidity with percentile bands.

- Higher **Solar Radiation** between May and September.
- **Relative humidity** typically ranges from **50%** (comfortable) to **97%** (very humid), rarely dropping below 36% (comfortable) and reaching as high as 100% (very humid).

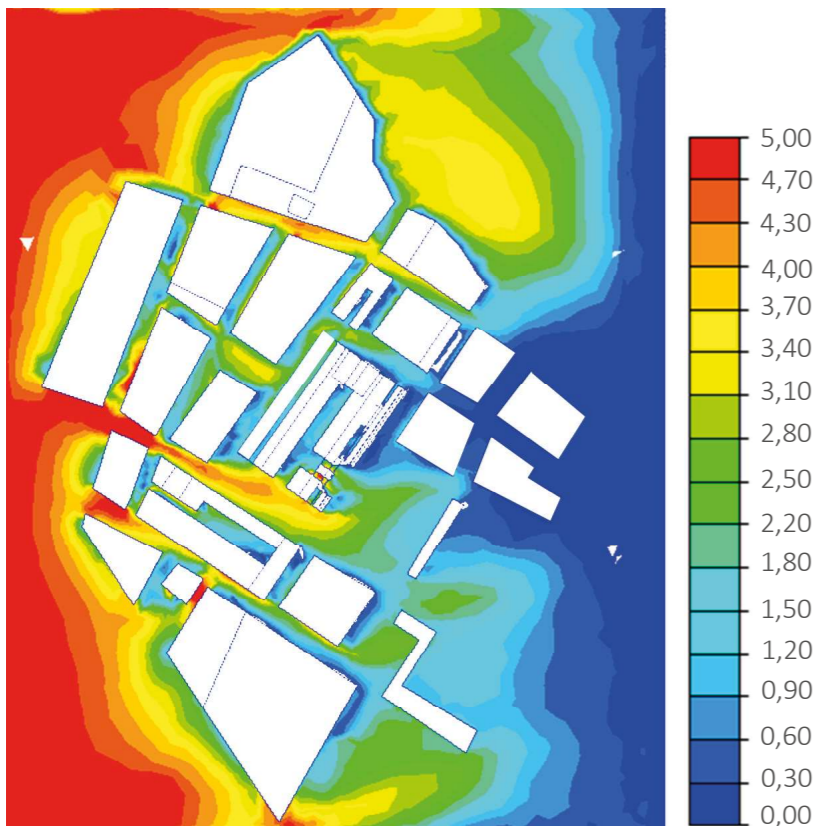
Fig. 34 Air Velocity Flow October (m/s)- South/West Direction (Source: CFD)

- **Air Velocity Range (CFD):** 0,00- 3,50 m/s)
- Brunswick Centre has a linear built mass which shields the plaza from the **prevailing West and South-West winds**, maintaining the plaza air flow between 0,00 and 1,50 m/s (Light breeze)
- CFD simulation confirmed that the plaza is mainly exposed to a comfortable air flow over the year, technically defined as calm and light air
- Due to the light breeze plaza will be nicely ventilated during the warm season
- During the cold season plaza is protected from the building masses and consequently comfort in the plaza will not be affected from strong and cold air

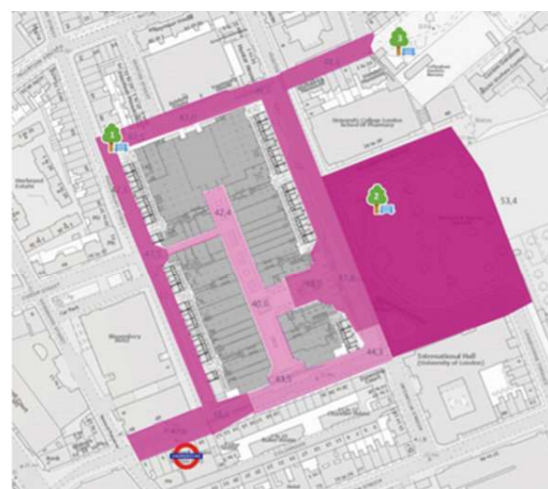
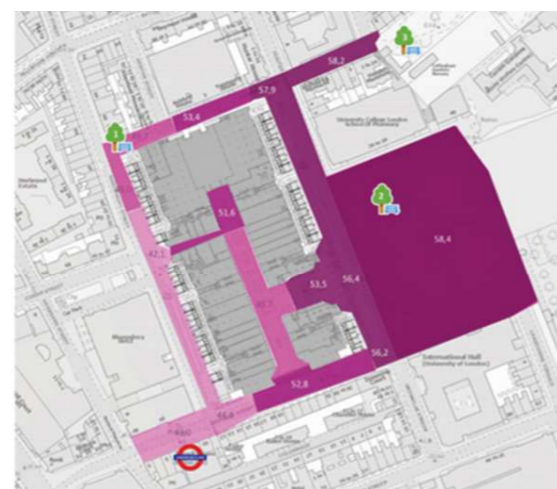
Fig. 29/30 Outdoor Relative Humidity **Sunny/Cloudy Day**- 5<sup>th</sup> October 2016/ 6<sup>th</sup> October 2016 (%)

- < 40 %
- 40 - 45 %
- 45 - 50 %
- 50 - 55 %
- 55 < %

The relative humidity has to be below 80% and to achieve the comfort zone, it has to be between 30 to 65%. Brunswick Centre has the relative humidity between 40 to 55%, which means this area is comfortable enough for the relative humidity measurement.

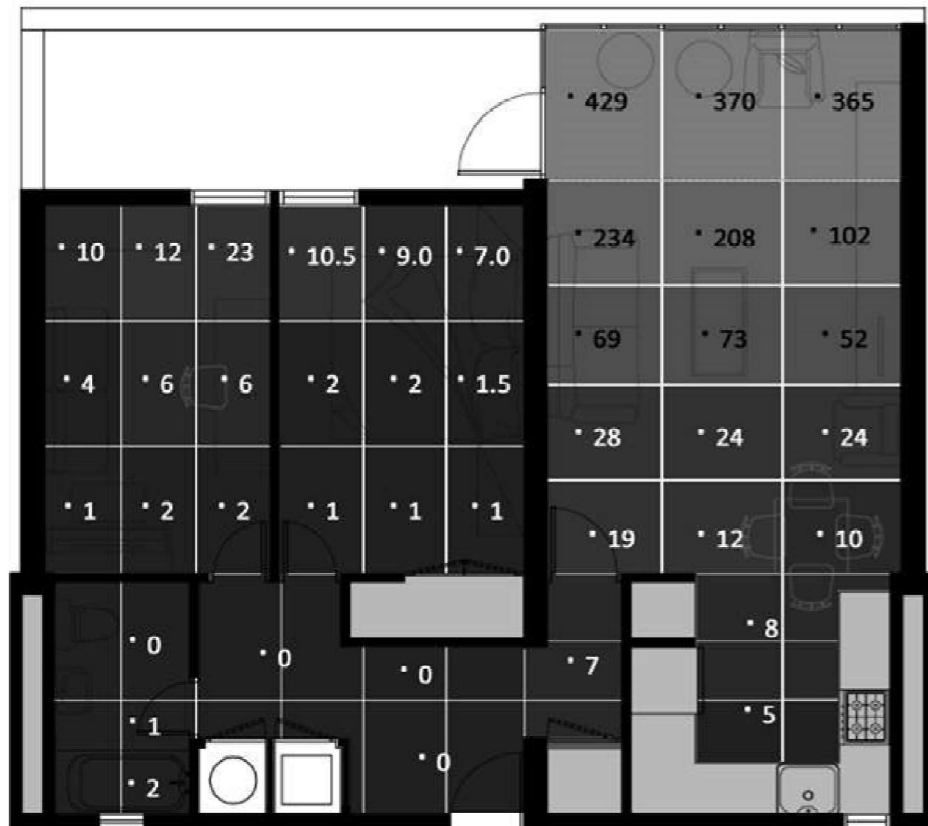
## ILLUMINANCE MEASUREMENT

The living room and two bedrooms are facing to south west. Especially, living room is fully glaze so its illuminance is relatively higher than the others. Also, kitchen is partly opened to the living room to have day light. On the other hand, bath room is quite bright peculiarity although it is facing to the north east. This is because the flat is located in top floor so that it could have skylight.

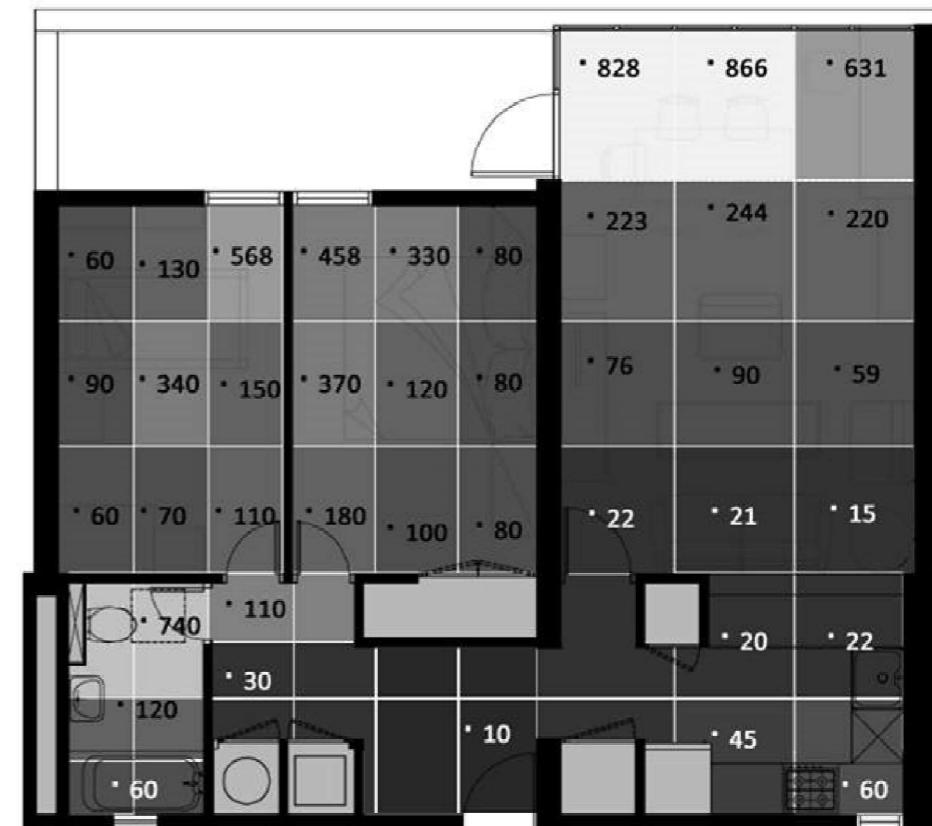
## ILLUMINANCE MEASUREMENT

The living room and two bedrooms are facing to North east. Especially, living room is fully glaze so its illuminance is relatively higher than the others. Also, kitchen is open planed to the living room to have day light. On the other hand, two bedrooms, bath room and hall way are quite dark compare with flat 133. Apart from living room and kitchen, flat 133 has less day light than flat 61, which means it has more energy loads to make it bright.

- The flat 61 was supposed to have the worse performance than the flat 133 because it is facing to south west.

- However, the measurements show that the flat 133 has a worse performance. We believe that it happened for the following reasons:

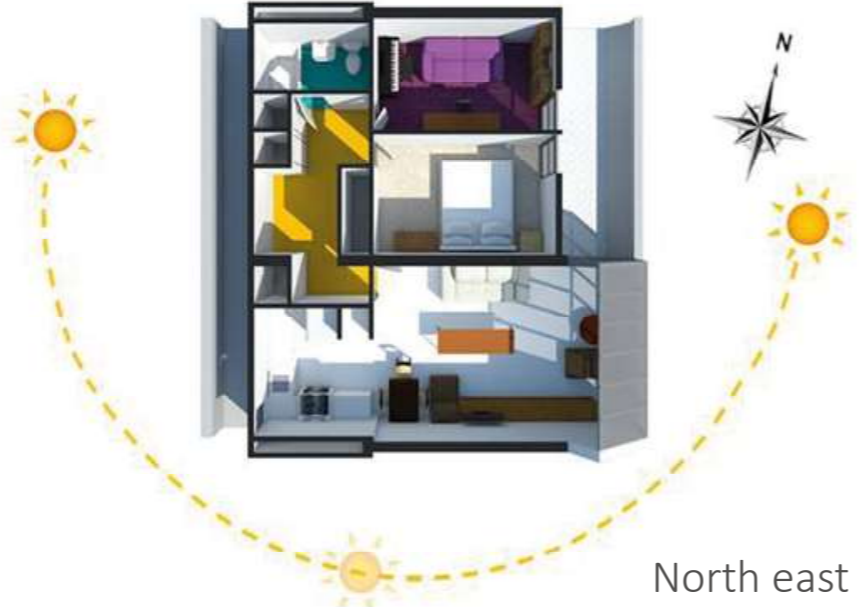
<p>North east facing</p>

Mean illuminance	0 ~ 429 lux	10 ~ 866 lux
Mean Temperature	19.4 °c	17.5 °c
Satisfaction	1 2 3 4 5 <b>6</b> 7	1 2 3 <b>4</b> 5 6 7
Recommendation	Install Insulation on walls	Install Insulation on walls and ceiling, Tinted window film

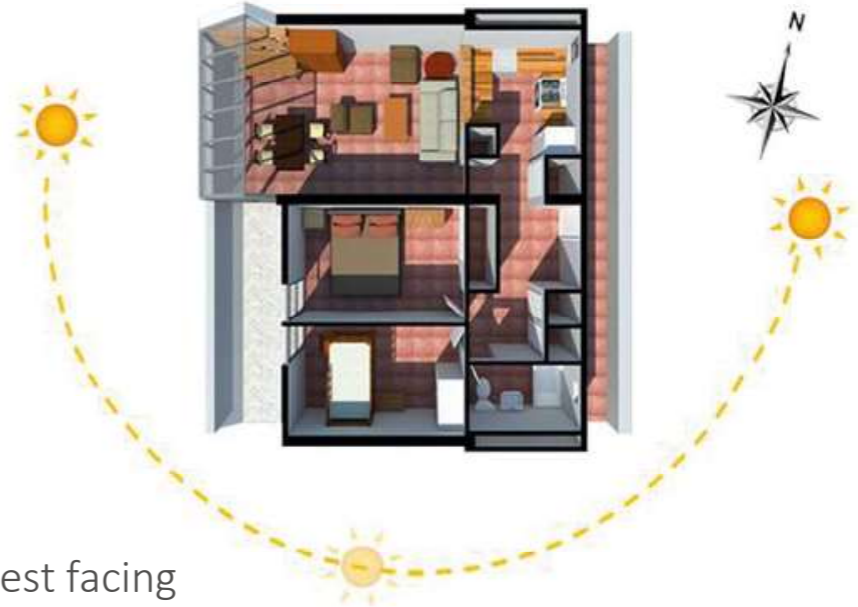
<p>South west facing</p>
Location
