Golden Lane Estate

GOLDEN LANE ESTATE

History

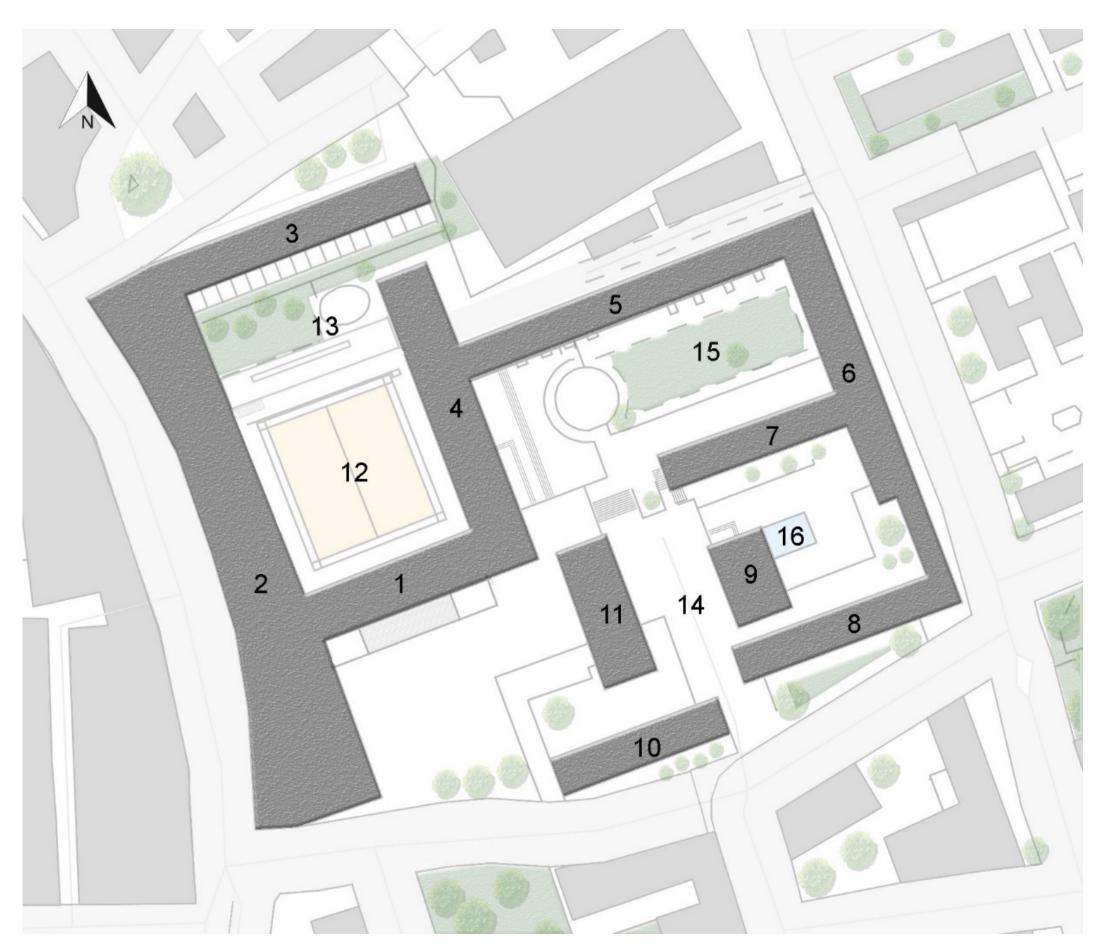
SITE PLAN

- 1. CULLUM WELCH HOUSE
- 2. CRESCENT HOUSE
- 3. HOTFIELD HOUSE
- 4. SWIMMING POOL/ BATH
- 5. BASTERFIELD HOUSE
- 6. STANLEY COHEN HOUSE
- 7. BAYER HOUSE
- 8. BOWATER HOUSE
- 9. COMMUNITY BUILDING
- 10. CUTHBERT HARROWING
- 11. GREAT ARTHUR HOUSE
- 12. TENNIIS COURT
- 13. PLAY AREA
- 14. OPEN PARKING
- 15. GARDEN
- 16..POND

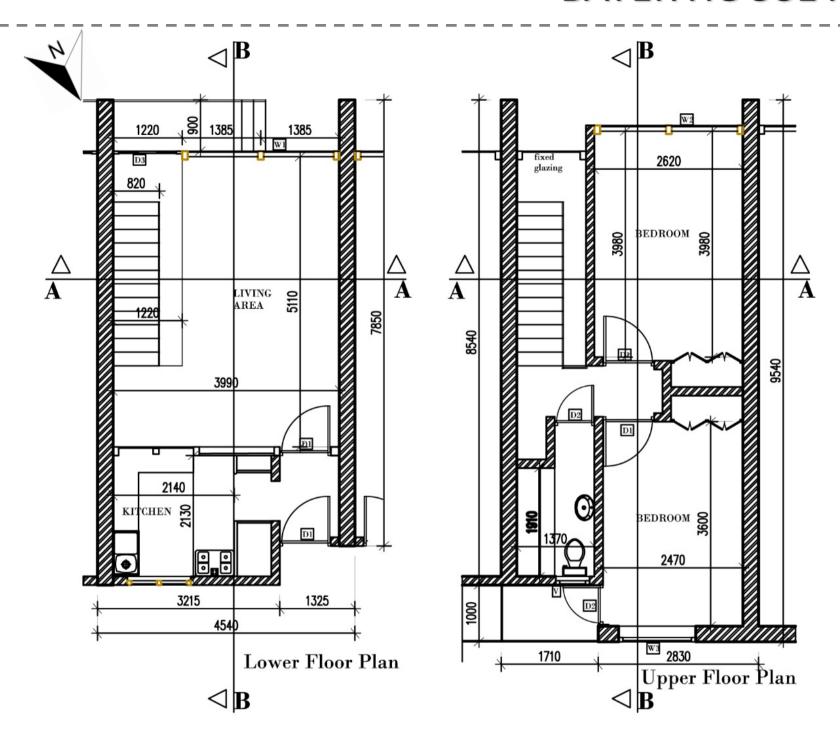
BAYER HOUSE FLAT NO. 4

Planning characteristics

- 1. Large glass opening on south east side
- 2. Brick wall on North side and between units
- 3. Service spaces on North side
- 4. Almost in original state
- 5. Single glazed windows

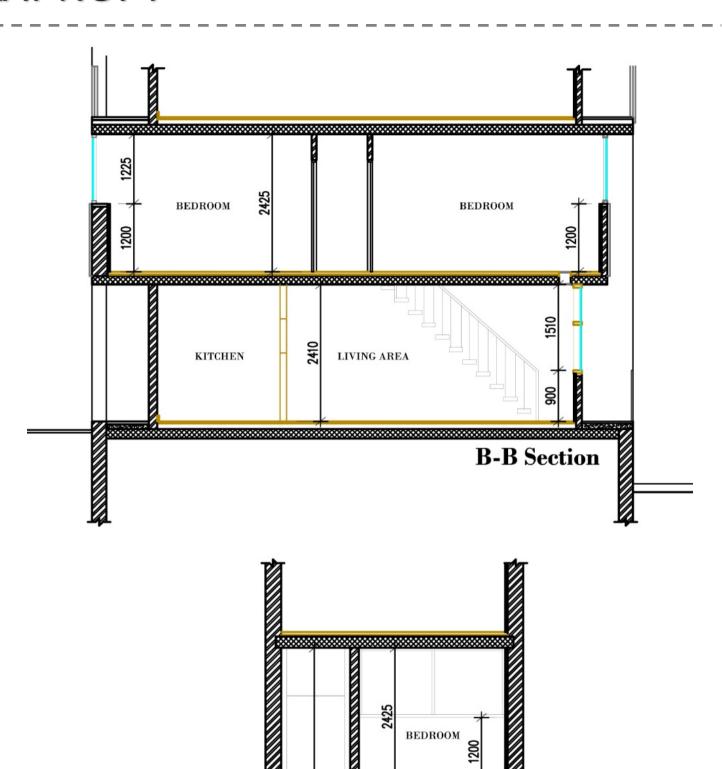
A-A Section

LIVING AREA

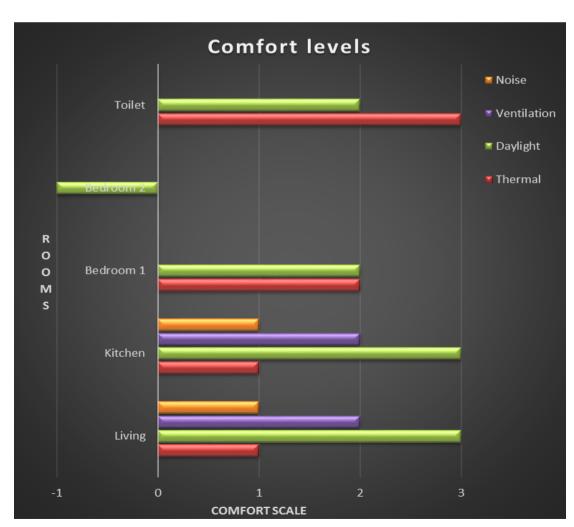
Bar chart showing the comfort levels in different Rooms for different parameters

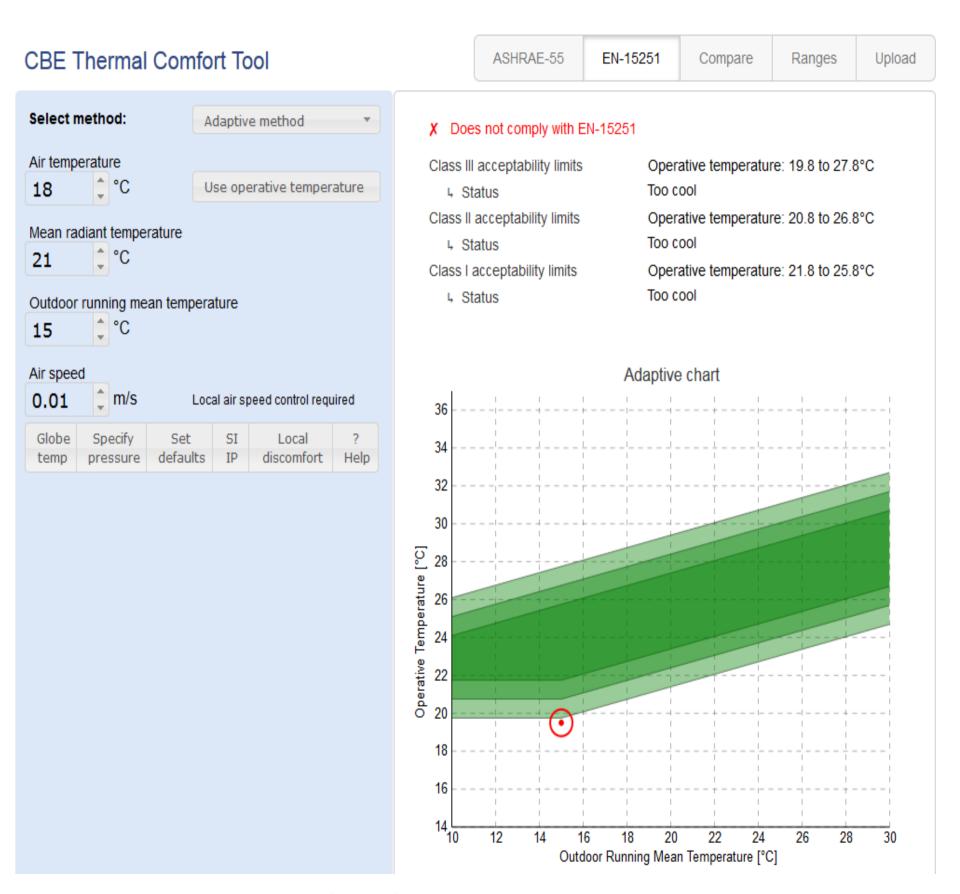
Computation of Comfort index using adaptive method

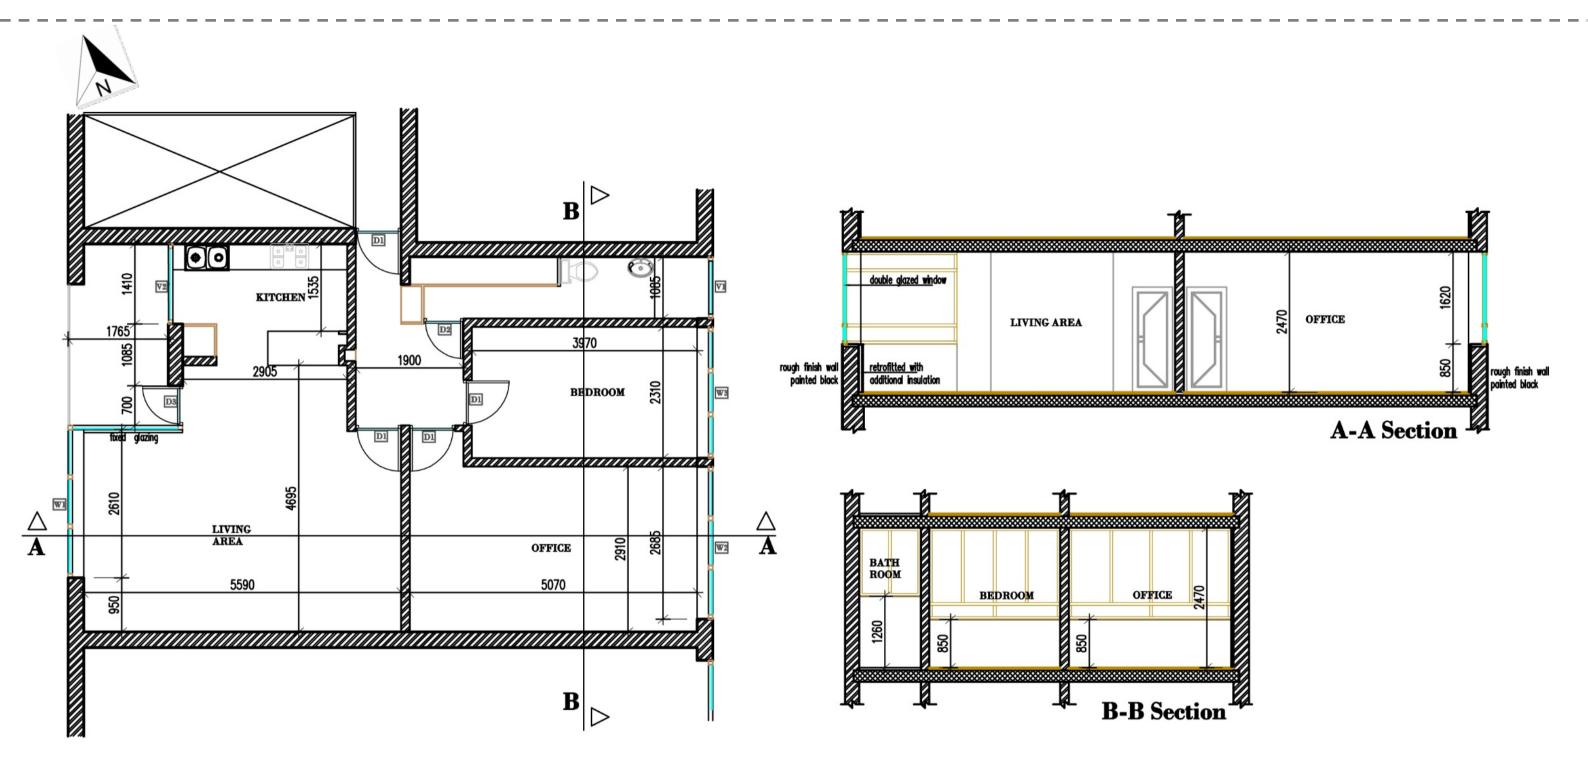
STANLEY COHEN HOUSE FLAT NO.10

Planning characteristics

- 1. North east –south west orientation
- 2. Black painted external walls
- 3. Bedrooms along external street
- 4. Renovated flat with double glazing and wall insulation

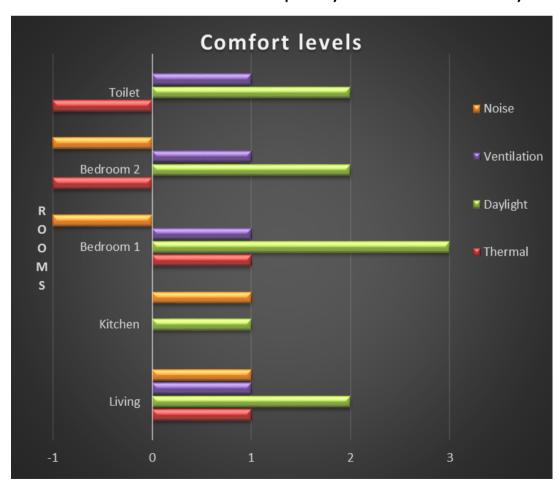
Bar chart showing the comfort levels in different Rooms for different parameters

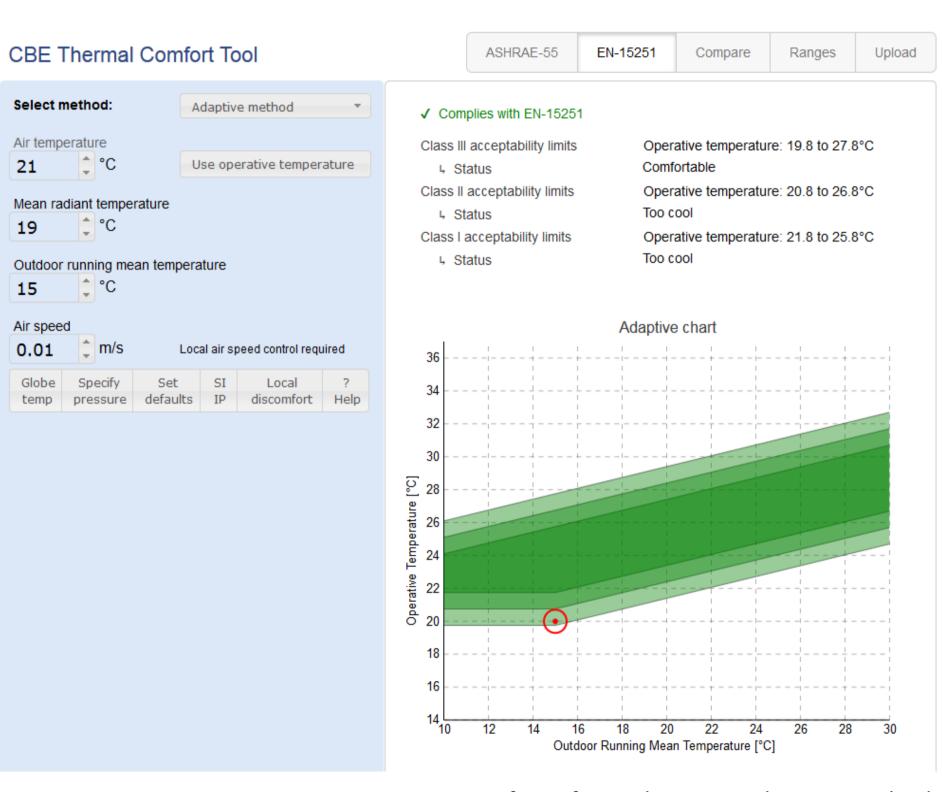
Computation of Comfort index using adaptive method
