PNV 3511

**Poluição dos Oceanos: Avaliação,
Controle e Prevenção**

AULA 4

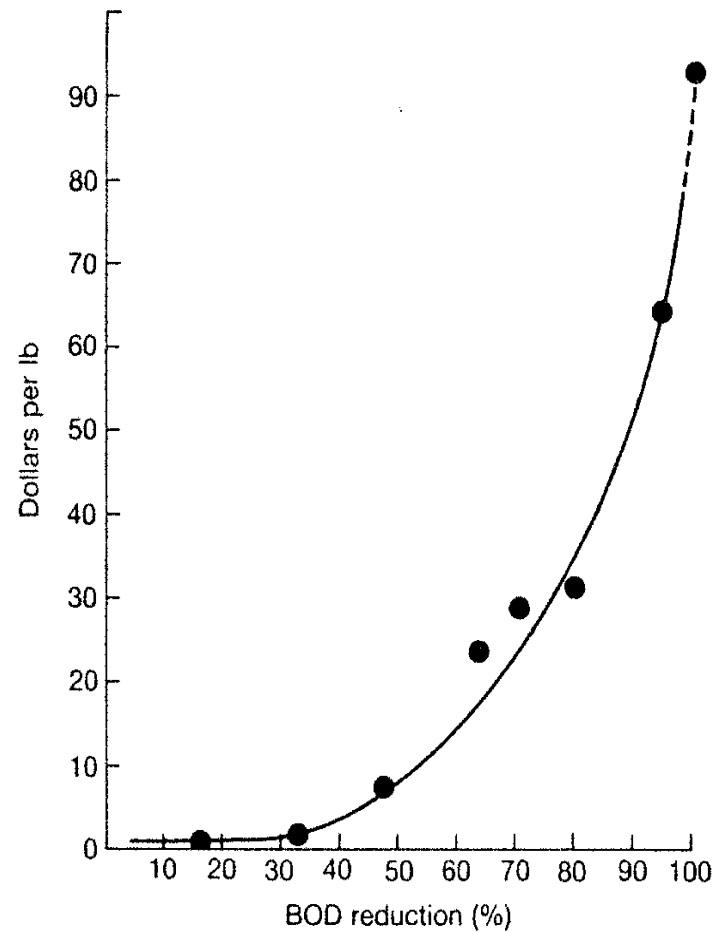
Fig. 1.1. Cost of reducing the organic content (as measured by BOD) of the wastes from a sugar beet factory.

Exemplo: Usina de Açúcar com 2700 ton/dia de esmague, poderia despejar material orgânico num rio, que exige uma carga de Oxigênio para sua degradação bacteriana. (BOD)

Um sistema de tratamento antes do despejo custaria:

30% de remoção – USD 1,0 por kg de BOD

65% de remoção – USD 15 por kg de BOD

90% de remoção – USD 40 por kg de BOD

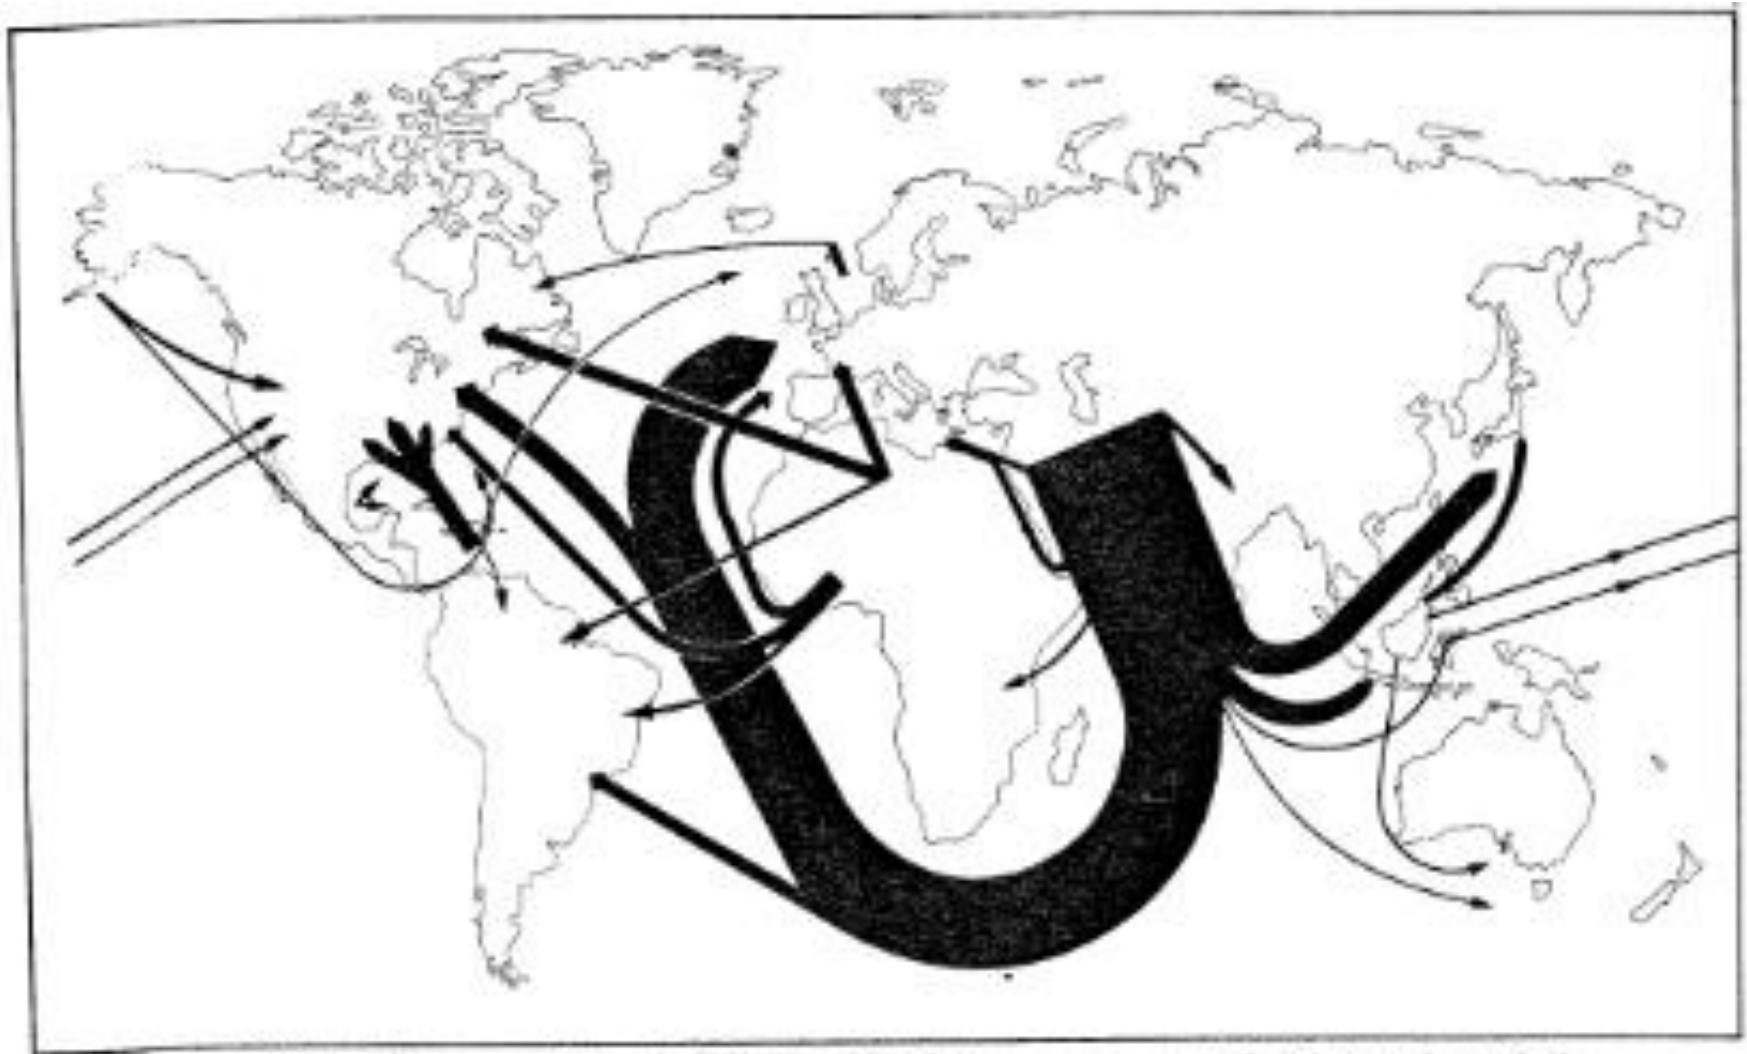
Fig. 3.1. Major oil movements at sea in 1979. The width of the arrows represents the relative volume of oil.

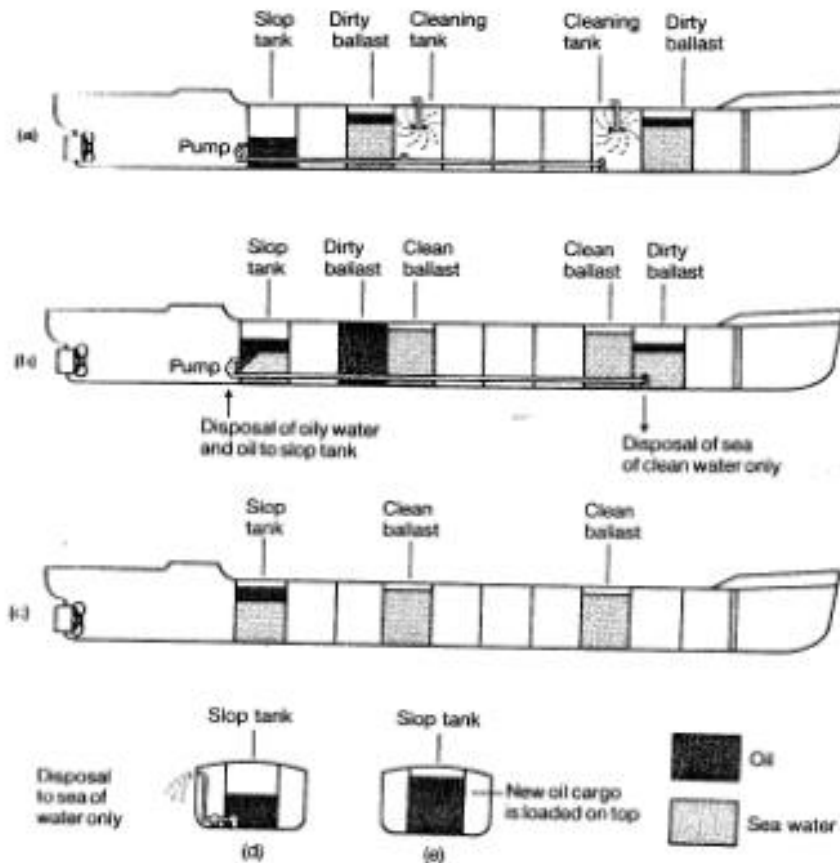
Fig. 3.2. Load on top: (a) empty tanks are cleaned by water jet and the washings transferred to the slop tanks, (b) oil floats to the top in tanks containing dirty ballast; the water is discharged to sea and oil transferred to the slop tank, (c) eventually the ship carries only clean ballast and oil in the slop tank floats to the surface, (d) underlying water is pumped out and (e) new cargo is loaded on top of the oil remaining in the slop tank.

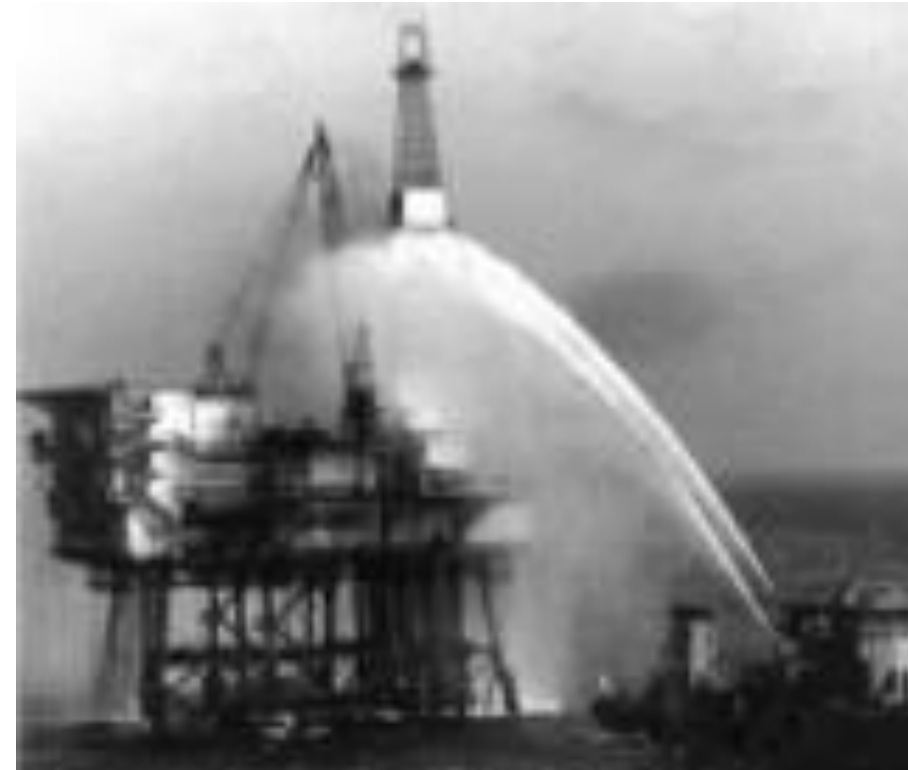
Rig:	Ekofisk Bravo Platform
Date:	22 April 1977
Location:	Ekofisk Field, Norwegian Continental Shelf
Operator:	Phillips Petroleum Company

The Ekofisk field was discovered in 1969, with production coming on-stream in 1971, and the field has since been extensively developed. The Ekofisk Bravo platform is situated to the north of the Ekofisk field and is one of two wellhead production facilities at Ekofisk. On 22 April 1977, it was the location of a blowout and North Sea's biggest oil spill.

The Ekofisk B blowout occurred during a workover on the B-14 production well, when about 10,000 feet of production tubing was being pulled. The production christmas tree valve stack had been removed prior to the job and the BOP had not yet been installed. The well then kicked and an incorrectly installed downhole safety valve failed. This resulted in the well blowing out with an uncontrolled release of oil and gas. The personnel were evacuated without injury via lifeboats and were picked up by a supply vessel.

The initial flow was estimated at 28,000 bpd with a calculated total release of 202,380 bbls. Up to 30 to 40% of the oil was thought to have evaporated after its initial release and the Norwegian Petroleum Directorate reported a total spill estimate between 80,000 bbls and 126,000 bbls.

The well was capped after seven days on 30 April 1977. Rough seas and higher than average air temperatures aided the break up of much of the oil. Later investigations reported no significant environmental damage and no shoreline pollution. There was also no significant damage reported to the platform.

The official inquiry into the blowout determined that human errors were the major factor which led to the mechanical failure of the safety valve. These errors included faults in the installation documentation and equipment identification and misjudgements, improper planning and improper well control. The blowout was significant because it was the first major North Sea oil spill. Also significant was that the ignition of the oil and gas was avoided and that there were no fatalities during the evacuation.
