Hydropower Refurbishment – Alstom's Methodology and Case Studies

Jean-Pierre Sungauer, Head of Engineering, Alstom Products India Ltd, Vadodara, India

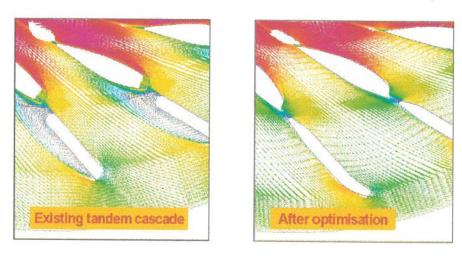
Examples of the CFD analysis for static components can be observed in the Figures 1 and 2. Figure 1 shows the velocity fields for the stay guide vanes in the existing condition and with the new profile. A smoother flow transition is obtained due to the better stay-vane profile.

Figure 1. Velocity field an stay vane and guide vane [2]

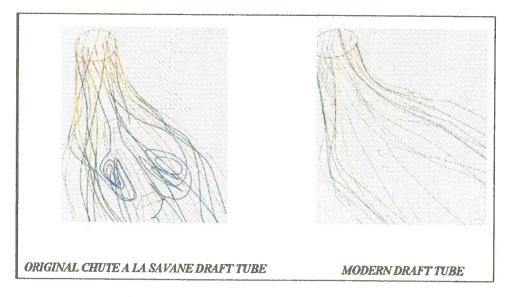
Figure 2 presents the comparison between draft-tube streamlines. It is possible to see the different behavior between each condition. In this case the modification in the draft tube was restricted to decreasing the elbow outlet height by covering the lower part of the draft tube.

Figure 2. Original and modified draft tube behavior [2]

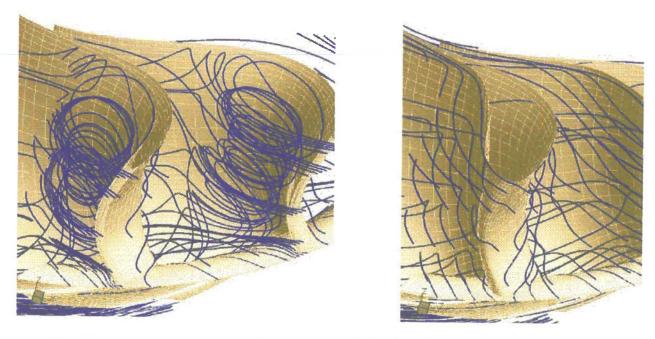
After finishing the analysis of the spiral case, distributor and draft tube and determining the other modifications that will be done to the existing condition, a new runner needs to be developed. For the runner development, there are several boundary conditions imposed by the existing dimensions and hydraulic conditions. In this stage, sophisticated methodologies are used to have the best possible design for the refurbishment conditions. In recent projects, Alstom has used a genetic optimizing tool and CFD viscous calculation to define the profiles and analyze the flow. Hydraulic experts can select the parameters and the degrees of freedom that tool will modify. The optimizer then selects the values for the geometrical parameters. The results of this process have produced high-performance runners for refurbishment designs. Figure 3 shows one example where the optimizer tool presented a surprising inlet profile for Shasta Powerplant refurbishment.

Figure 3 - Comparison between first profile and final profile defined by the optimizer

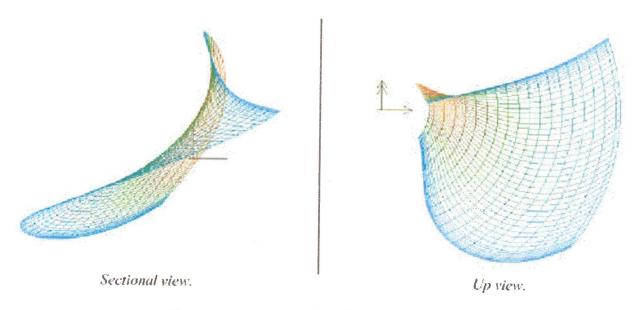
The methodology was applied and the main modifications in this refurbishment were the runner. To achieve the targets defined by the customer in relation to cavitation, output and efficiency a complete CFD calculation was performed for all components of the turbine. For cavitation, different numerical investigations were done for the analysis of existing hydraulic components. With good accuracy, the results predicted the flow angles, and consequently, a blade design able to perform well in the operational range defined by the customer. Based on these results, a new runner was developed. The blades have a twisted shape, as presented in Figure 4. Cavitation behavior is presented in Figure 5.

Figure 4. Modern profile of a propeller blade

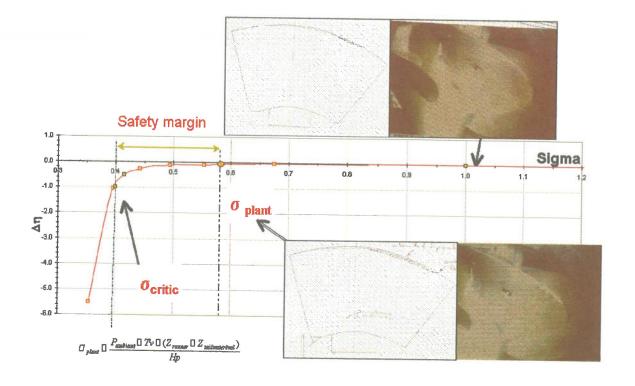
Figure 5. Sigma break curve at full load up to maximal flow near the nominal net head

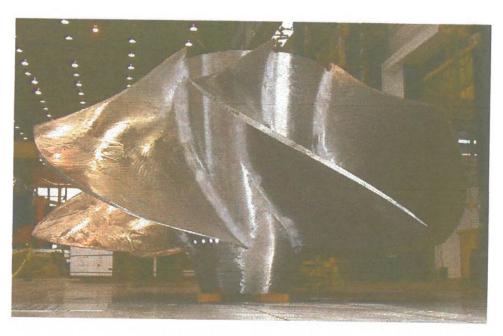
The model tests in the Alstom and EPFL laboratories confirm the CFD simulation. During the manufacturing the runner profile was done by a 5-axis machine, to assure that the geometry calculated is accurately reproduced. The final runner is showed in the Figure 6.

Figure 6. Finished runner

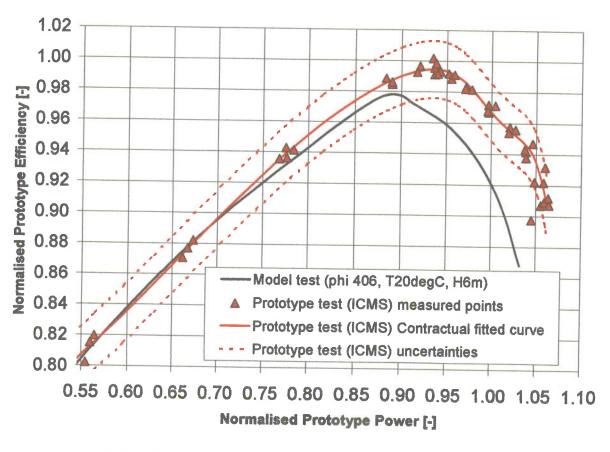
The prototype test confirmed the model test results and it was possible to show the efficiency and output targets were reached. Figure 7 presents the comparison.

Figure 7. Comparison of model and prototype efficiency
