PROCESS INDUSTRIES CORROSION

Fracture Analysis Diagram Procedures for the Fracture-Safe Engineering Design of Steel Structures⁽¹⁾

W. S. PELLINI and P. P. PUZAK*

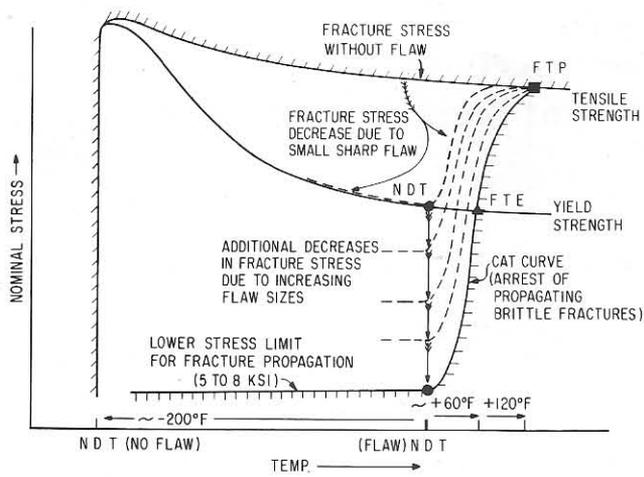
FIGURE 1 — Transition temperature features of steels.

The significance of the NDT temperature may be brought out by discussion of the general effects of temperature on the fracture stress transition of steels (Figure 1). A flaw-free steel is illustrated to develop a gradually increasing tensile strength (TS) and yield strength (YS) with decreasing temperature; the increase in yield strength is greater than that of the tensile strength, resulting in coincidence at some very low temperature. At the temperature of coincidence, tensile ductility as measured by elongation or reduction of area (plastic flow) is decreased to essentially zero or nil value. This temperature may be considered as the NDT temperature in the *absence* of a flaw. If a small, sharp flaw is placed in the test specimen, such as a plate, a decreased level of fracture stress is obtained in the transition range as indicated by the dashed curve labeled "fracture stress decrease due to small, sharp flaw." The highest temperature at which the decreasing fracture stress for fracture initiation due to the small flaw becomes contiguous with the yield strength curve of the steel is defined as the nil ductility transition (NDT) temperature. Below the NDT temperature the fracture stress curve for the small flaw follows the course of the yield strength curve, as indicated by the continuation of the dashed curve to lower temperatures. The arrows pointing down from the NDT point indicate that increases in the flaw size result in progressive lowering of the fracture stress curve to lower levels of nominal stress. As an approxima-

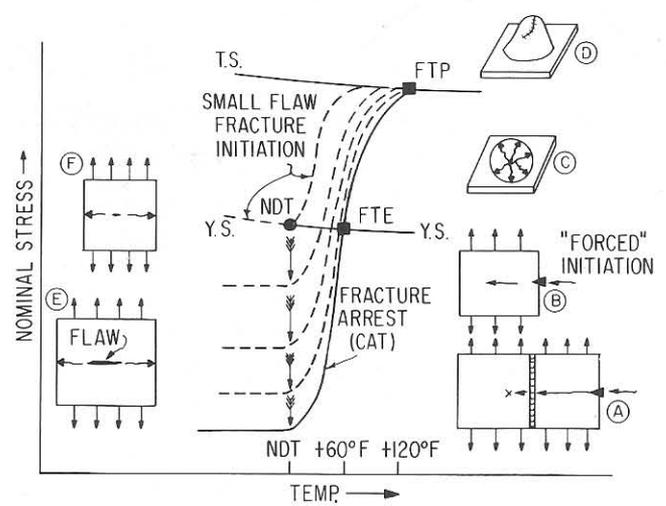
FIGURE 2 — Features of large-scale fracture initiation and fracture arrest tests.

The various types of tests which have provided data required to chart this diagram are illustrated in Figure 2. Crack arrest tests may be conducted with a composite plate comprising a brittle plate welded to a "test" plate, sketch (A). After the assembly is brought to a specific temperature and stress level, "forced" initiation of a fracture in the brittle plate by wedge impact is used to develop a rapidly running brittle fracture. The fracture continues through the "test" steel or stops, depending on whether the temperature is below or above the CAT for the steel at the specific stress level of the test. A series of tests are conducted to establish the boundary of the "run" and "stop" temperatures. Variations of this test include wedge impact starting of a fracture in the test plate itself, sketch (B), or in a prolongation of the test plate, which is cooled to low temperatures. Data on crack arrest properties at stresses and temperatures above the FTE point have been obtained primarily by the use of crack-starter explosion tests,

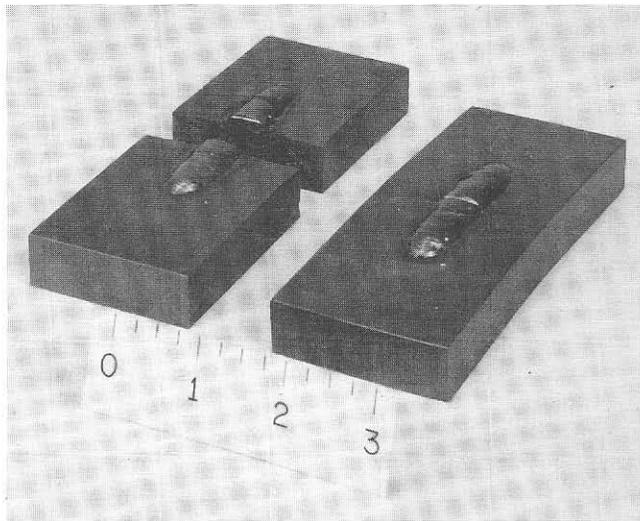
FIGURE 3 — Drop-weight test specimen (2 x 5 x 5/8 inch) before test (right) and after test at, or below, the NDT temperature (left), illustrating the function of the brittle weld as a “crack starter” flaw.

The importance of the NDT temperature as a reference point for the generalized diagram resides in the fact that it may be determined easily by the use of the drop-weight test. Figure 3 illustrates a drop-weight test specimen before and after test below the NDT temperature. The drop-weight test features the use of a brittle weld bead which cracks on “bend” loading to the yield point of the test plate surface. The resulting brittle crack represents the starting flaw or notch. The size of this flaw (approximately $1/2 \times 1/4$ inch) characterizes the test as a “small flaw” initiation test. A stop placed beneath the center point of the specimen span restricts the test loading to stress conditions involving incipient yielding. The specimen shown represents the smallest size of a series of sizes that may be used.^{1,2} Figure 4 illustrates the simplicity of the test equipment; details of the anvil are evident from the enlargement. The samples are brought to a desired temperature, placed on the test anvil, and the weight released to provide for loading to the point controlled by the stop. As illustrated by Figure 5, a series of specimens are tested at 10 F intervals—the highest temperature of “break” indicates the NDT of the steel. The sharp transition from “break” to “no break” at the NDT temperature results from the marked increase in the levels of deformation required for fracture initiation at temperatures above the NDT. This feature is illustrated by the steep

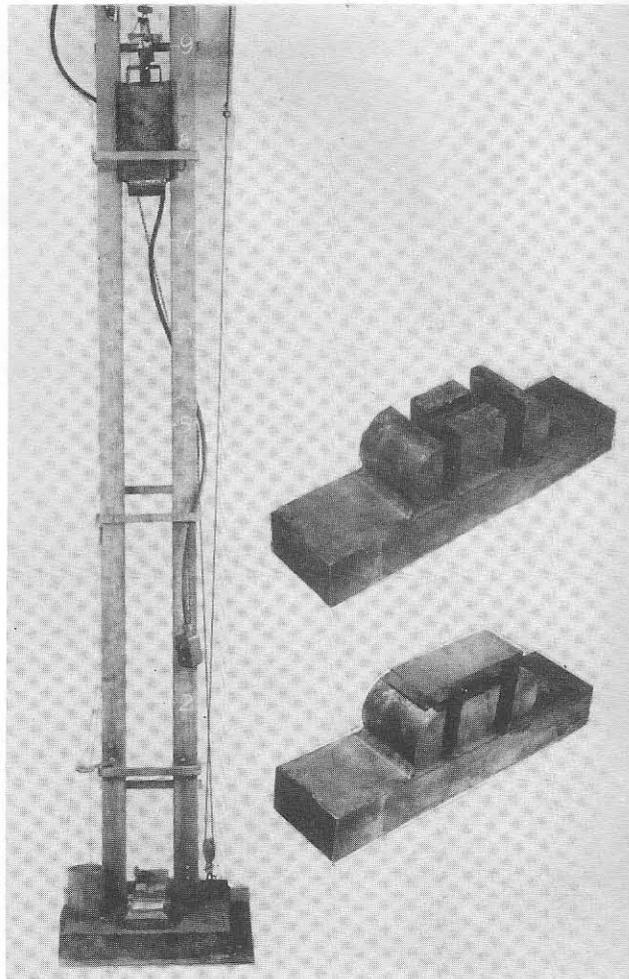
FIGURE 4 — Drop-weight test equipment (left); details of anvil for 2 x 5 x 5/8 inch specimens (right).

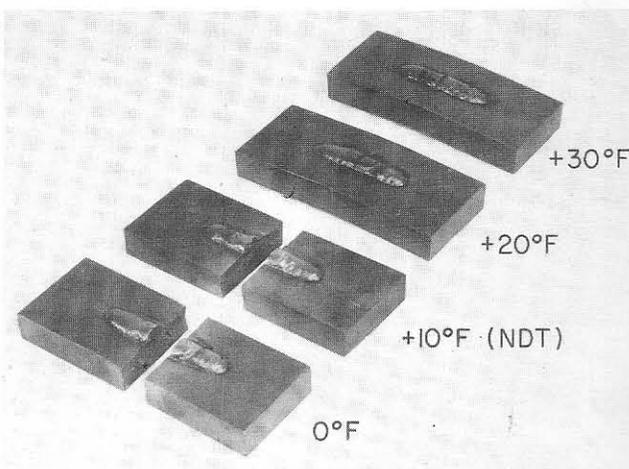
FIGURE 5 — Typical drop-weight test series, illustrating an NDT at 10 F.

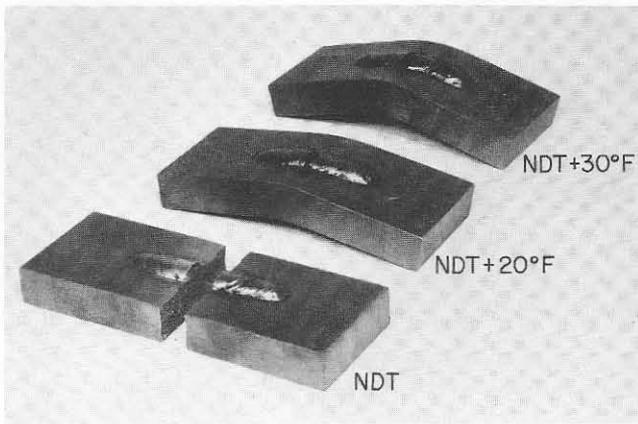
FIGURE 6 — Open anvil test series illustrating bend deformation (ductility) developed at temperatures above the NDT temperature as compared to the "flat break" at and below the NDT temperature.

Figure 6 documents the high resistance to fracture initiation exhibited by the same steel shown in Figure 5 for

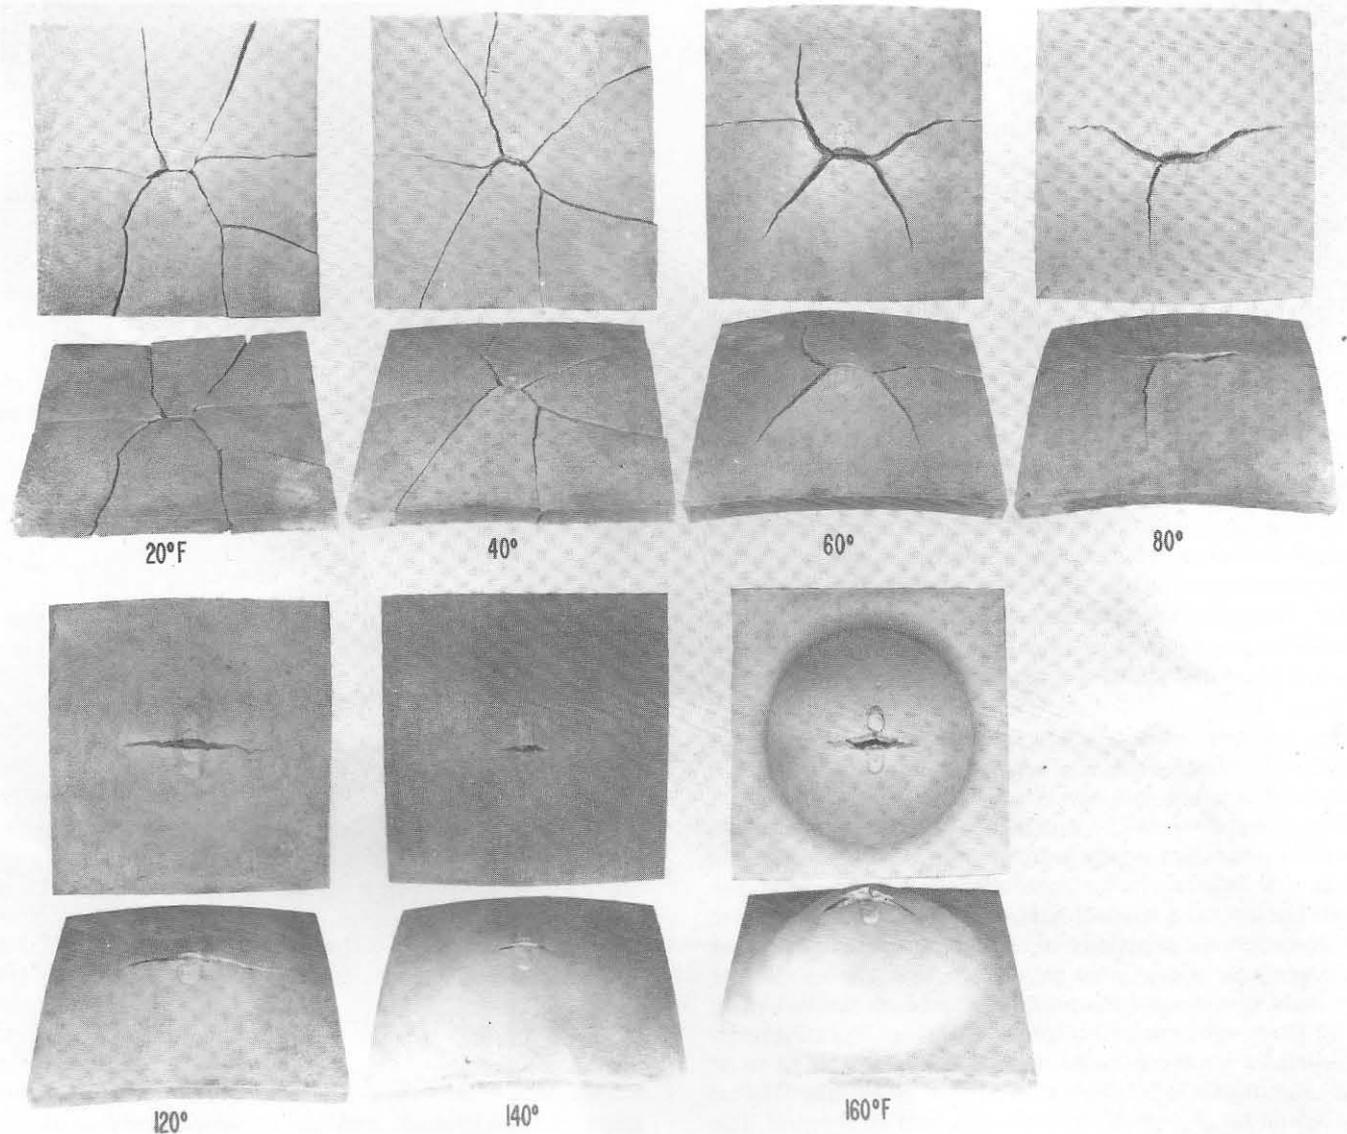
FIGURE 7 — Explosion crack-starter test series in 20 F steps illustrating the dramatic increase in fracture toughness of steels above the NDT temperature (for the steel shown, NDT = 20 F, FTE = 70 F, and FTP = 140 F).

Figure 7 presents a panoramic view of the dramatic temperature effect in 20 F steps, for a World War II ship plate steel test series. At and below the NDT temperature (20 F for this steel), the test plates break “flat.” Above the NDT temperature the plates *bulge* before fracture, indifficult (plastic strain required) starting of the fracture. In conformance with the plastic strain-temperature relationships of the small flaw fracture initiation curve at temperatures above the NDT temperature, the level of pre-fracture bulging (plastic stress levels) increases continuously with increasing temperature in the NDT to FTP range. The fractures, once started, run through the “hold down” regions of the bulge (elastically loaded die supported regions) at all temperatures below the FTE. At temperatures above the FTE, the fractures are entirely contained in the *plastic* loaded regions of the bulge (short fractures). Above the FTP temperature only short, ductile tears are developed, even with the intentional forcing of deformation to a complete hemisphere, as shown by the 160 F test plate of the series. The FTP temperature is approximately 120 F above the NDT temperature. These results have been confirmed for a wide variety of steels and for plates up to 3 inches thick.

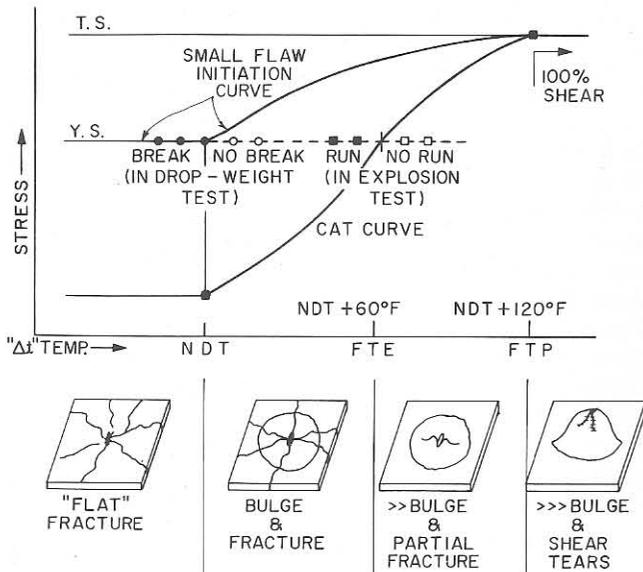
FIGURE 8 — Drop-weight and explosion crack-starter test series related to the generalized fracture diagram.

By reference to Figure 8, we may now relate drop-weight and explosion test performance to the fracture analysis diagram, as follows:

1. Nil ductility (fracture of drop-weight specimens and flat break in explosion tests) occurs at and below the NDT temperatures.
2. Levels of prefracture bulge deformation increase as test temperatures are raised above the NDT temperatures.
3. Above the FTE temperature, fractures do not run through the elastic load or “hold down” regions, thus indicating the CAT for yield stress loading has been exceeded.
4. Propagation of partially brittle fractures through the plastically deformed center regions of bulge are developed in the range between the FTE and FTP temperatures.
5. Short, shear tears are developed above the FTP

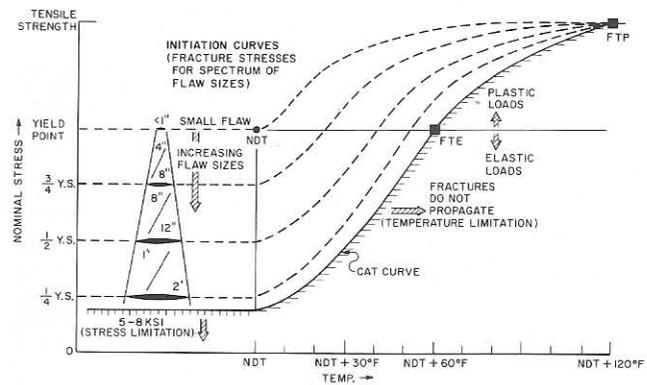
FIGURE 9 — Generalized fracture analysis diagram, as referenced by the NDT temperature.

The approximate range of flaw sizes required for fracture initiation at various levels of nominal stress are illustrated by the generalized fracture analysis diagram of Figure 9. The flaw size data have been derived from a wide variety of small flaw tests, from limited studies of tensile tests with large flaws introduced into 1 and 3/4 inch thick plates, and from theoretical fracture mechanics concepts developed by G. R. Irwin.³ Validation is provided by a large amount of failure and structural test data, to be presented. The generalized diagram presents a family of fracture initiation curves relating to a range of flaw sizes. These range from flaws of less than 1 inch (top dashed curve) to flaws in the order of 1 to 2 feet (bottom dashed curve). It should be noted that all initiation curves have been drawn to show a rapidly increasing requirement for higher stresses with increasing temperature above the NDT temperature. The actual slope and shape of the “rising” portions of the initiation curves represent estimates based on the general slope of the crack arrest curve.

The diagram predicts that for a given level of stress, larger flaw sizes will be required for fracture initiation above the NDT temperature. For example, at stresses in the order of 3/4 YS, a flaw in the order of 8 to 10 inches may be sufficient to initiate fracture below the NDT temperature; however, at NDT + 30 F, a flaw of 1-1/2 to 2 times this size may be required for initiation. To the right of the CAT, there is “no flaw” that is of sufficient size to initiate fracture because propagation of brittle fractures is not possible. It should be noted that the nominal stress plotted in this diagram is the stress acting on the volume of material within which the flaw resides. Thus, for a flaw residing in the shell region of a pressure vessel, the nominal stress is the

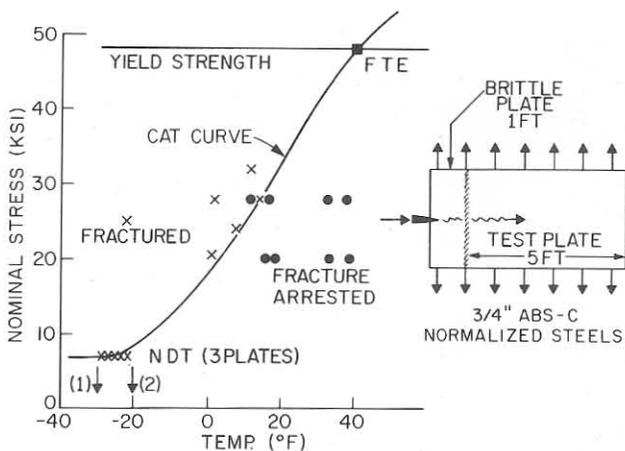
FIGURE 10 — Correlation of CAT data obtained by Mosborg⁴ with NDT temperatures of the test steels. The data relate to three separate plates from one heat.

We shall first discuss the basis for the shape of the CAT curve and of its position with respect to the NDT temperature. The basis is found in a compilation of all available crack arrest data for steel plates that also had been tested with the drop-weight test to establish the NDT temperature. Figure 10 illustrates a typical correlation of NDT and CAT data resulting from tests conducted by

Mosborg.⁴ A series of combination plates comprising a 3/4 inch thick ABS-C test plate of 5 foot width welded to a 1 foot wide "crack-starter" plate provided the necessary specimens. These assemblies were loaded to stress levels in the order of 1/2 the yield strength of the test steel and a hammer blow was applied to a wedge inserted in a notch located at the edge of the brittle "crack-starter" plate. A brittle fracture was thereby initiated which propagated across the starter plate and either stopped on entering the test plate or continued through to complete fracture, depending on the test temperature. The data presented in Figure 10 illustrate a sharp cutoff in fracture propagation at temperatures in the range of 30 to 35 F above the NDT temperatures of the three plates from the same heat which were used to fabricate the specimens. At temperatures below the indicated CAT curve, all tests resulted in complete fracture, while at higher temperatures the fracture stopped on entering the test plate.

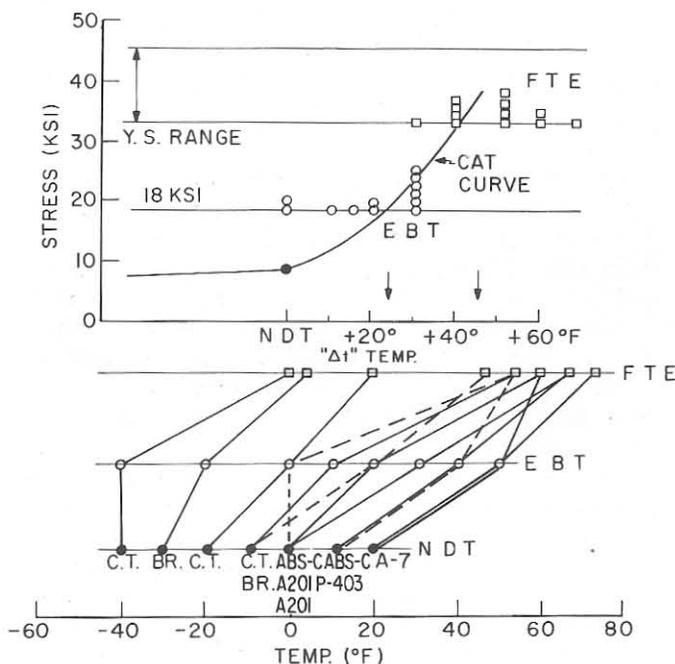
FIGURE 11 — The lower graph illustrates the temperature determined for the NDT, EBT, and FTE for 12 steels; the data relating to each steel are connected by a reference line. The " Δt " relationships of the EBT and FTE to the NDT temperature are summarized in the upper graph. The crack arrest curve drawn in the top graph represents the "mean position" CAT curve indicated by the " Δt " data points.

A summary of Esso brittle temperature (EBT) crack arrest data for a wide variety of 3/4 to 1 inch structural steel plates is provided in Figure 11. The EBT test differs from the Mosborg type test in that the brittle "starter" plate is not used, fracture initiation is obtained in the test plate by the application of a local "overstress," due to the wedge action. The test plate width is ordinarily in the order of 16 inches; however, tests also have been conducted for 6 foot wide plates. The EBT tests were conducted at the 18-ksi stress level, i.e., at approximately 1/2 the yield strength of the test steels. These steels are commonly used in the fabrication of large storage tanks in the United States and in England (full details are available from Reference 5). The NDT and FTE tests were conducted by the authors using material provided by the Esso authors.

The lower graph provides the individual data points for each steel. The diagram at the top of the figure summarizes the " Δt " temperature relationship of the EBT and FTE temperatures to the NDT temperatures. The EBT crack arrest point for the 18-ksi stress level as defined by these tests appears to have a mean position of 25 F above the NDT. The FTE crack arrest point for the yield stress level has a mean position of 45 F above the NDT.

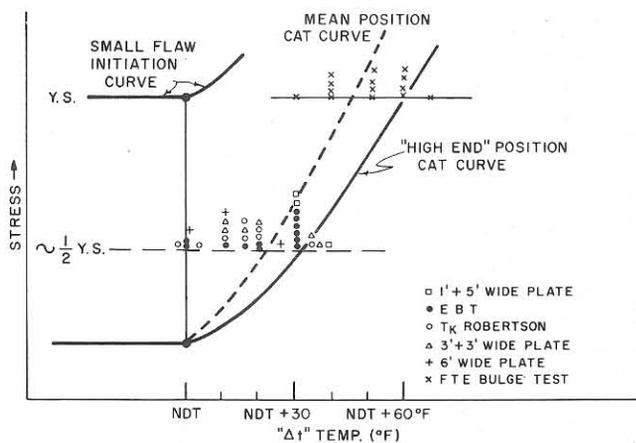
FIGURE 12 – Summarization of “ Δt ” CAT data for 32 steels, representing a wide variety of tests conducted at stress levels of approximately 1/2 the yield strength level of the various steels. A total of 14 steels were also tested by the explosion crack starter test to establish the “ Δt ” FTE (CAT for YS level). These data represent the bases for the fracture analysis diagram location of the CAT curve referenced to the NDT point.

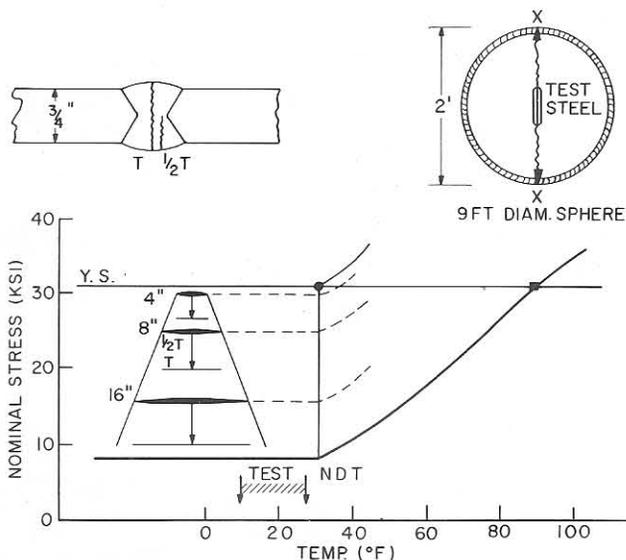
FIGURE 13 – Summary of hydrostatic test shell stresses required for the initiation of fracture for flaws of 4, 8, and 16 inch dimensions. All tests were conducted at temperatures ranging from 5 to 20 F below the NDT temperature of the test steel (a 3/4 inch thick ship plate).

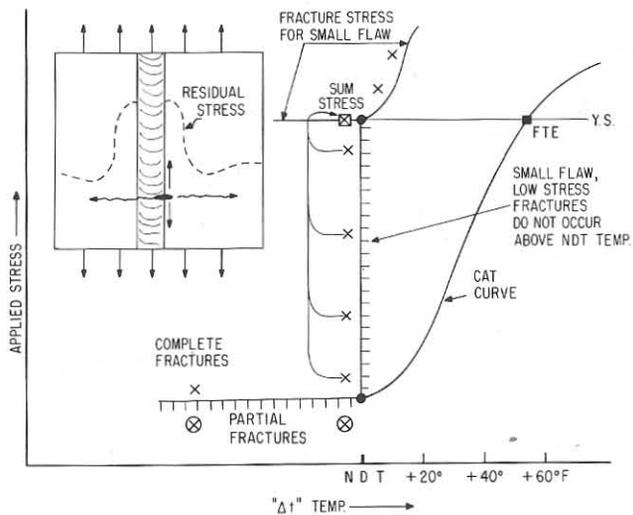
FIGURE 14 — Illustrating the fracture analysis diagram prediction that the NDT represents the highest temperature for the initiation of "low-stress" fractures in the presence of high residual stress fields. Complete fractures are predicted for conditions such that the applied stress level exceeds 5 to 8 ksi; short fractures result if the applied stress level is less than this value.

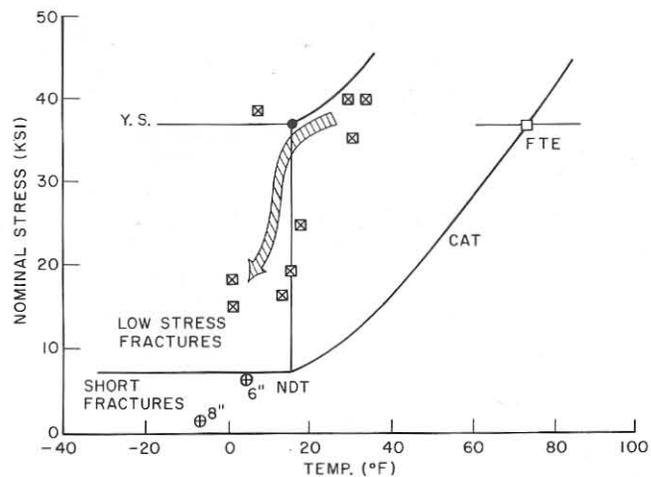
FIGURE 15 — Wells⁸ data points which define the critical edge temperature for low-stress fracture superimposed on the fracture analysis diagram of the test steel: 1 inch plate, 0.14% C, 1.07% Mn, 0.02% Si.

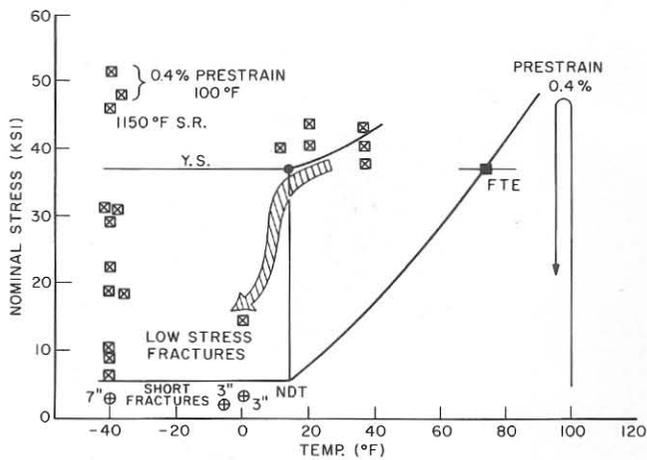
FIGURE 16 — Hall, Nordell, and Munse⁹ data points which define the critical edge temperature for low-stress fracture superimposed on the fracture analysis diagram for the test steel: 1 inch plate, ASTM A212-B, 0.30% C, 0.76% Mn, 0.26% Si.

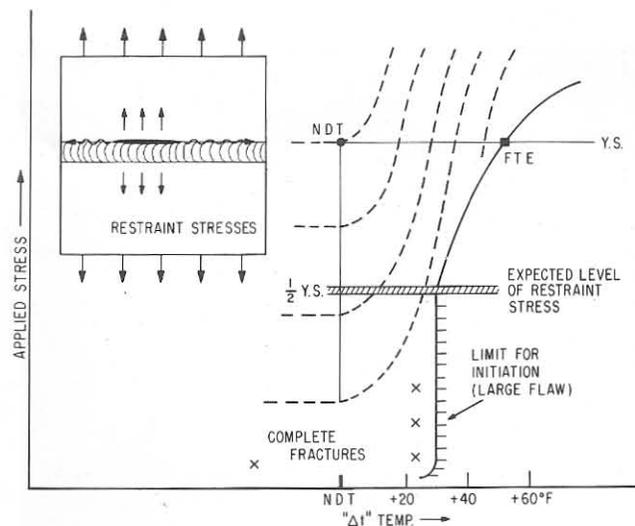
FIGURE 17 — Illustrating the fracture analysis diagram prediction that large flaws located in restraint stress fields (of 1/2 the yield strength) may result in low-stress fracture initiation at temperatures below the CAT (NDT + 30 F).

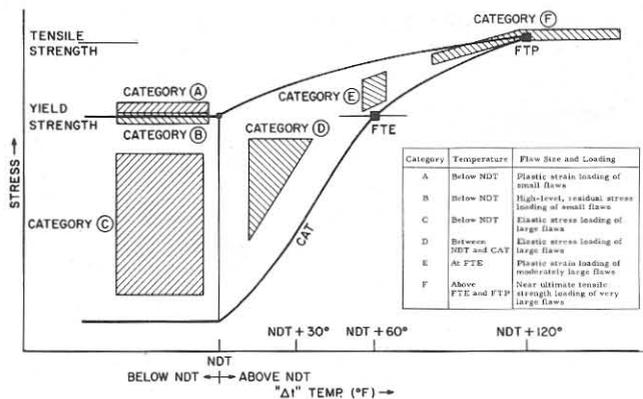
FIGURE 18 — Sequence of the discussion of failure-analysis cases is indicated by categories A to F referenced to various zones of the fracture analysis diagram.

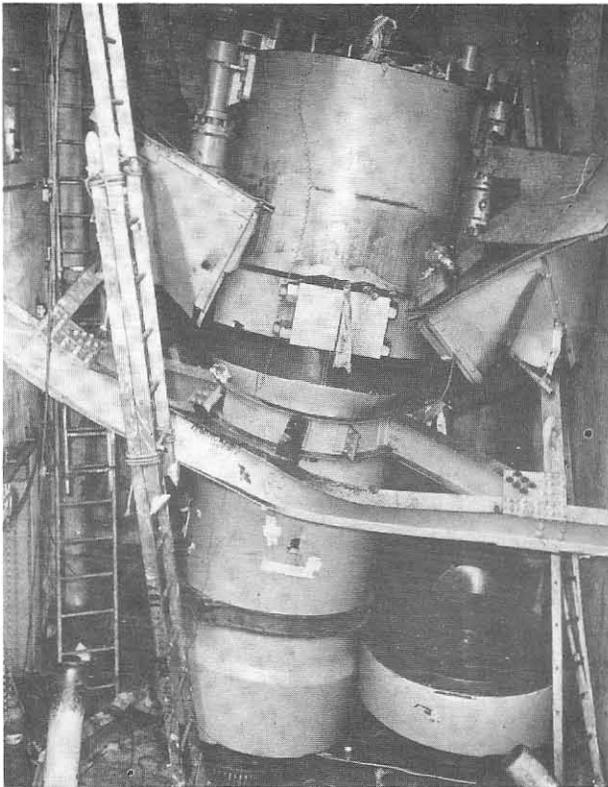
FIGURE 19 — (Case A1) Fracture of a 100-ton pressure vessel; the bottom head, shown at right, swung out bottom-side up prior to the fall of the vessel. The ladders indicate the size.

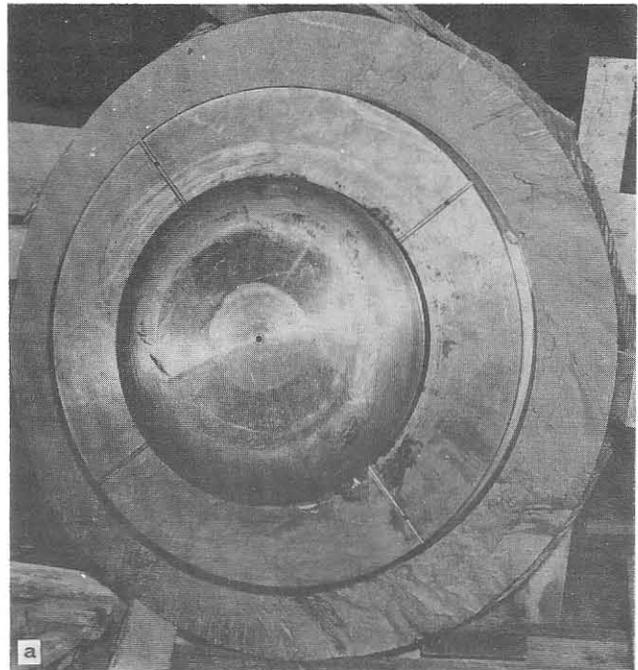
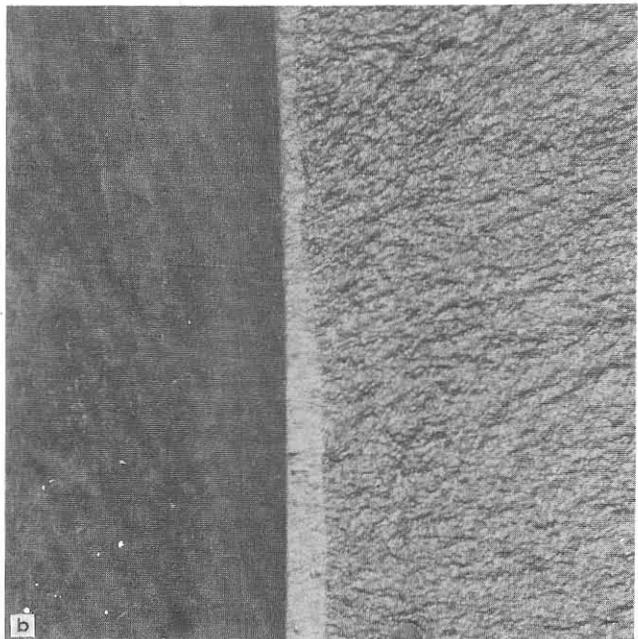
FIGURE 20 — (Case A1) Brittle fracture face of the 9-1/2 inch shell wall of the 100-ton pressure vessel. The enlargement shows the 1/8 inch deep fatigue crack (shiny region) located at the root of the thread.

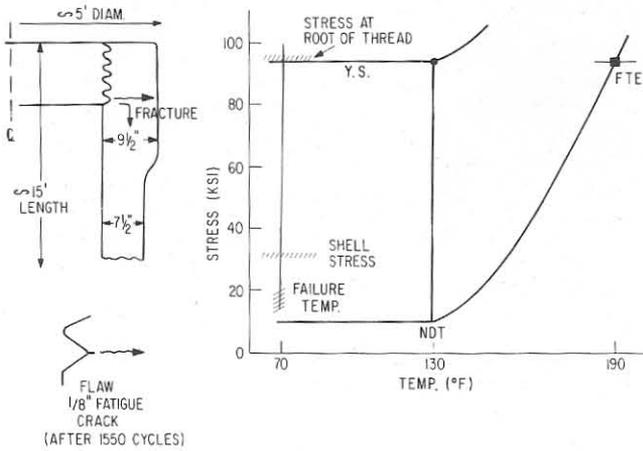
FIGURE 21 — (Case A1) Fracture analysis relating to the service failure of the 100-ton, forged, ASTM A293 pressure vessel.

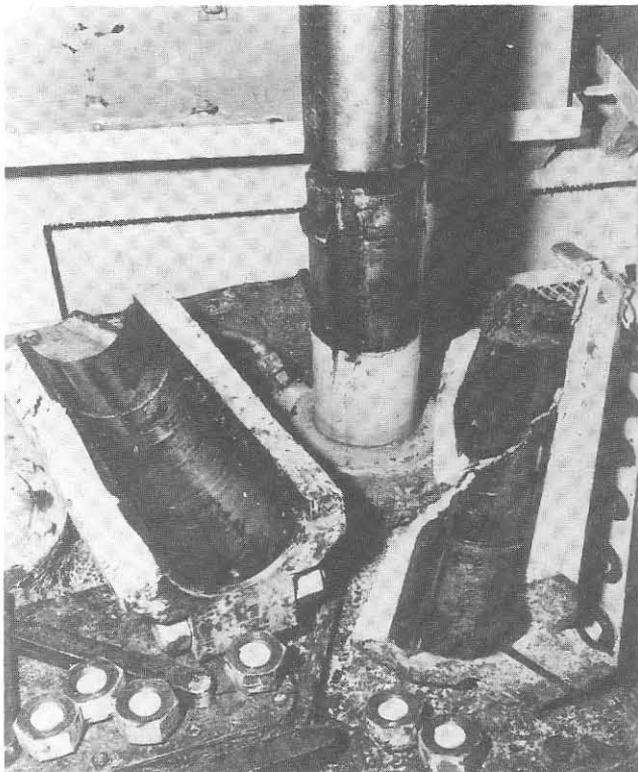
FIGURE 22 — (Case A2) Fracture of an anchor windlass-shaft coupling.

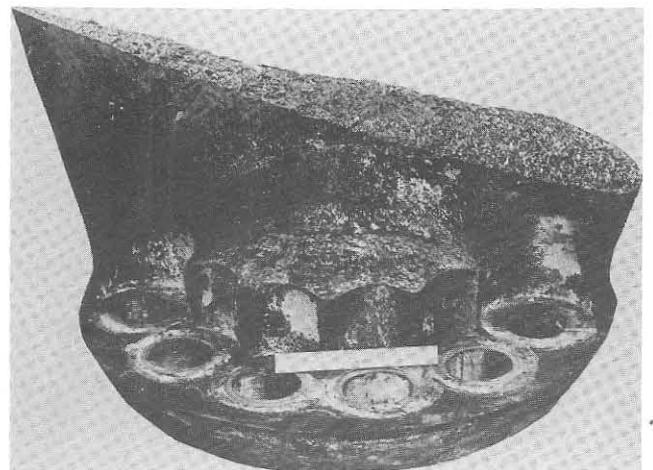
FIGURE 24 — (Cases A3 to A7) Typical fracture of cast 12% chromium stainless steel propellers previously used for icebreaker service. Dimensions are indicated by the 12 inch rule.

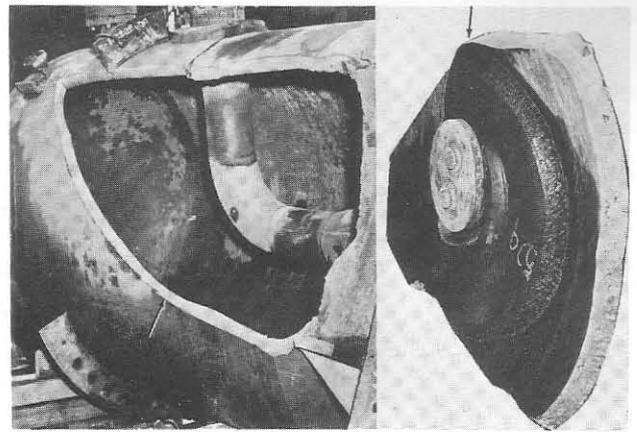
FIGURE 26 – (Case A8) Hydrostatic test fracture of a 7.5 foot diameter, 3 inch thick, stress relieved, ASTM A302-B pressure vessel. The fracture origin is indicated by the arrows.

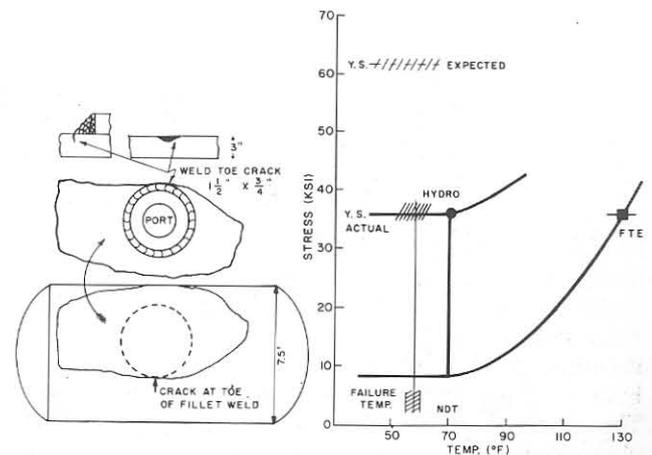
FIGURE 27 – (Case A8) fracture analysis relating to the hydrotest failure of the stress relieved ASTM A302-B pressure vessel. The steel was given an annealing heat treatment by error which resulted in hydrotest shell stresses equal to the yield strength level.

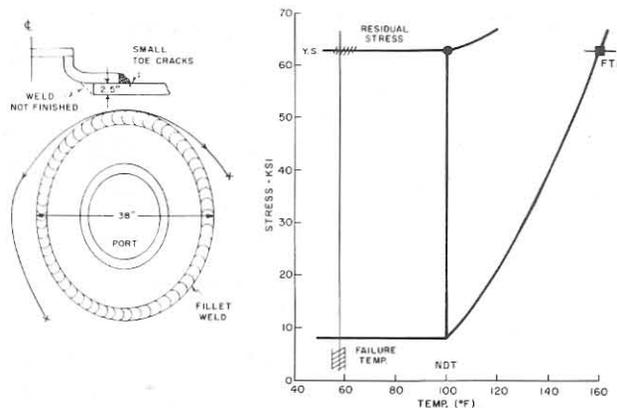
FIGURE 28 – (Case B1) fracture analysis relating to the spontaneous fracture of a partially-fabricated ASTM A302-B pressure vessel.

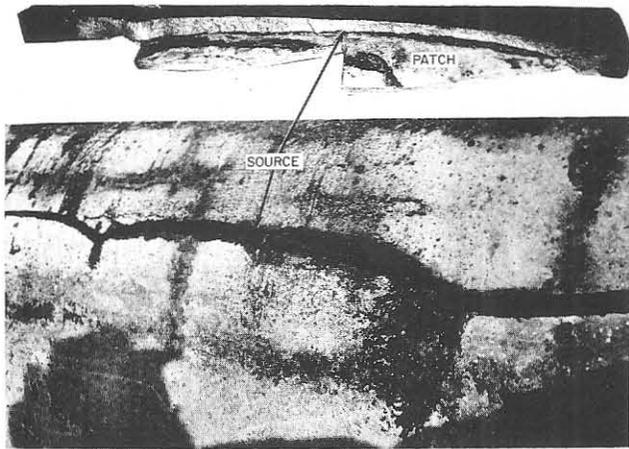
FIGURE 29 — (Case B2) Hydrotest fracture of a 20-year-old pressure vessel following patch plate salvaging repair of the inside surface; the fracture origin is shown above.

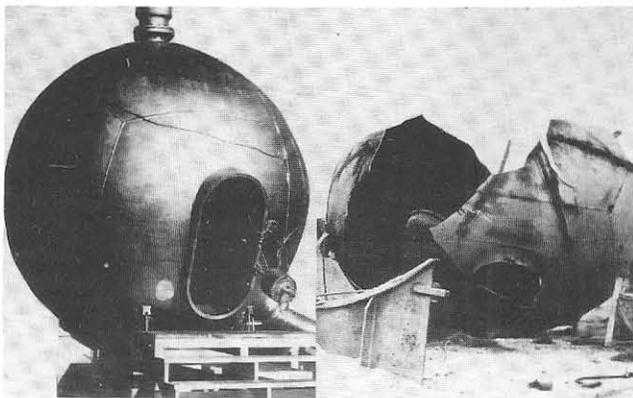
FIGURE 31 — (Case B3) Blast chamber prior to fracture (left) and after fracture (right).

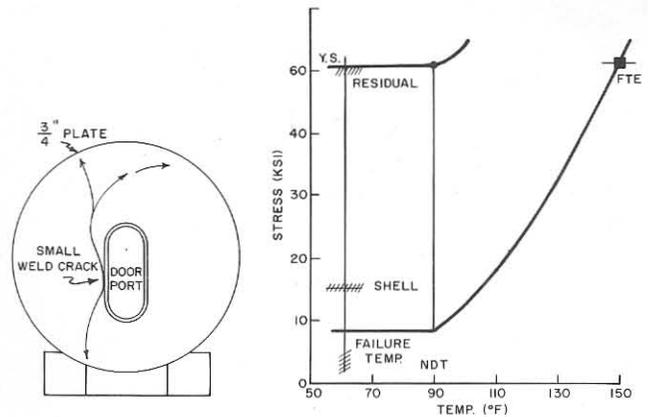
FIGURE 32 — (Case B3) Fracture analysis relating to service failure of the ASTM A285-C blast chamber. The vessel was not stress relieved.

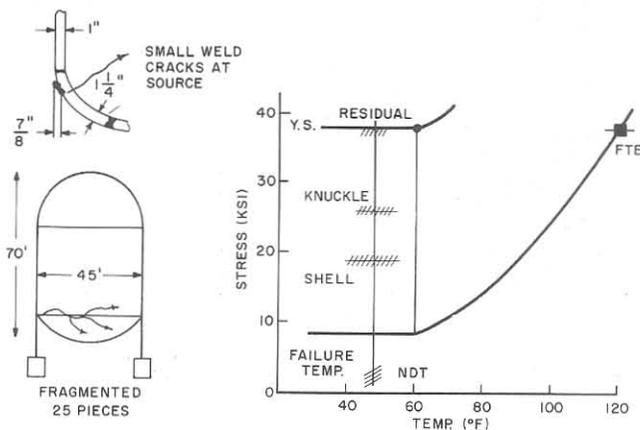
FIGURE 33 — (Case B4) Fracture analysis relating to hydrotest failure of a 45 foot diameter ASTM A285-C storage tank. The vessel was not stress relieved.

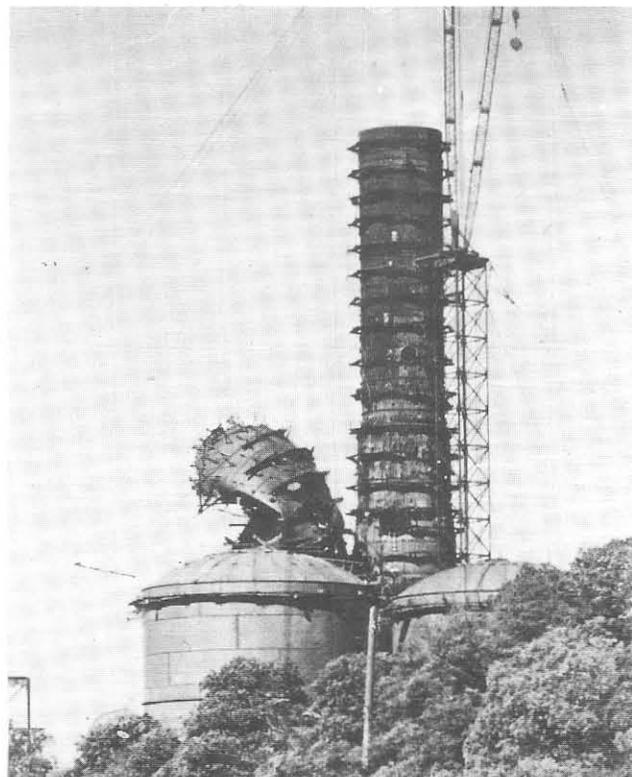
FIGURE 34 — (Case B4) Hydrotest failure of the 45 foot diameter, ASTM A285-C storage tank. The top region of the vessel was crumpled because of the vacuum which developed within by the efflux of water from the shattered bottom head (hot visible).

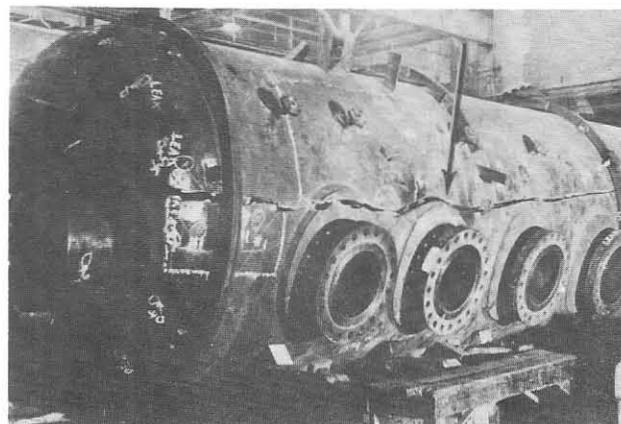
FIGURE 35 — (Case B5) Fracture of a 7.5 foot diameter CO converter pressure vessel. The arrow points to the fracture source region.

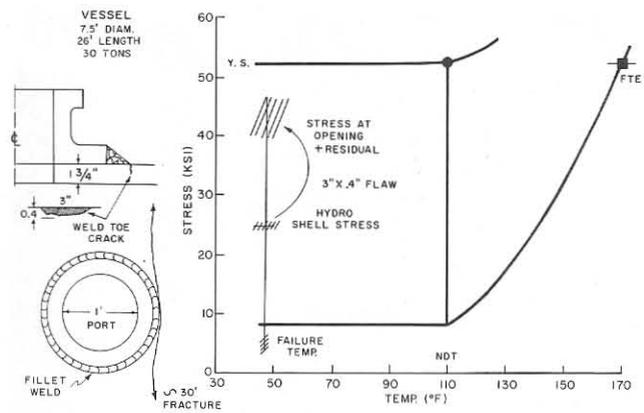
FIGURE 36 — (Case B5) Fracture analysis relating to the hydrostatic test failure of the CO converter pressure vessel. The data relate to the ASTM A204 portion, which was the initiating point. The vessel was given an inadequate stress relief at 950 F.

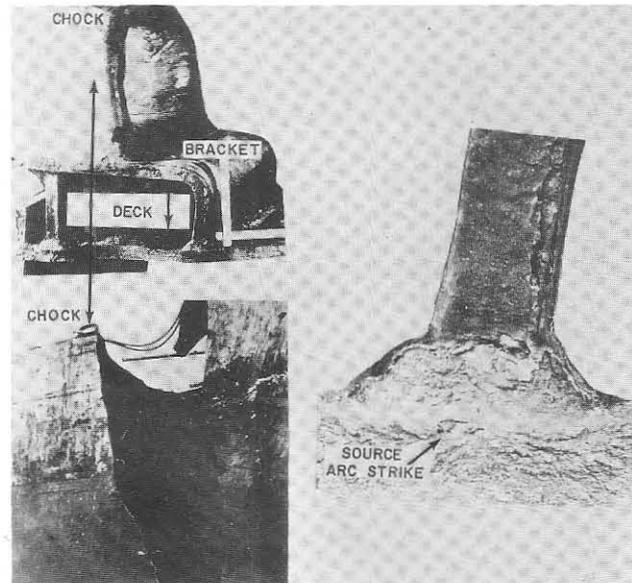
FIGURE 37 — (Case B6) Fracture of the T-2 tanker Ponaganset. The fracture origin was traced to an arc strike, located in the deck plate as indicated (bottom right).

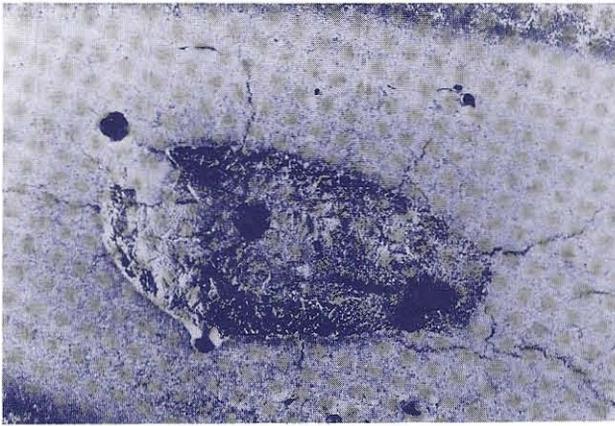
FIGURE 39 — Network of 1/8 to 1/4 inch cracks generally associated with arc strikes. The crater dimensions are approximately 1/4 inch by 1/8 inch. The small size of the flaws that are sufficient to trigger failure in the presence of high residual stress fields at temperatures below the NDT temperature is emphasized by this illustration.

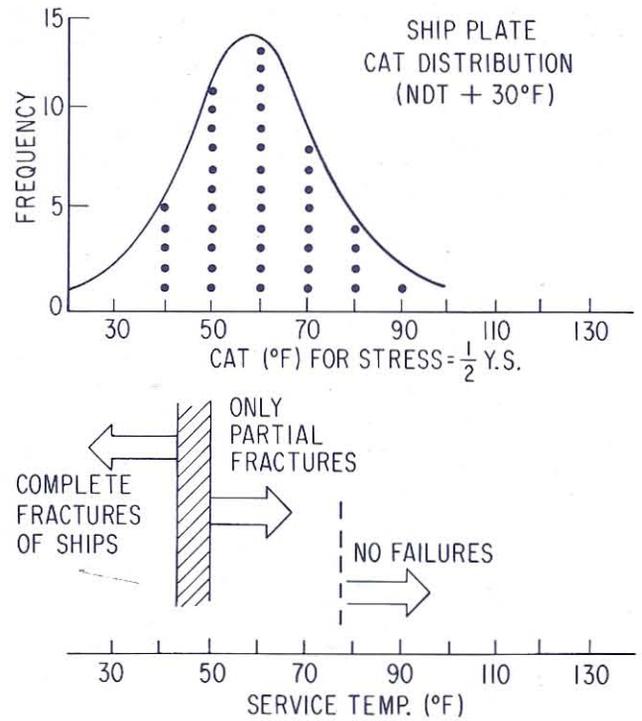
FIGURE 41 — Illustrating that complete failure of ships occurred only at temperatures such that essentially all of the ship steels were below their respective CAT.

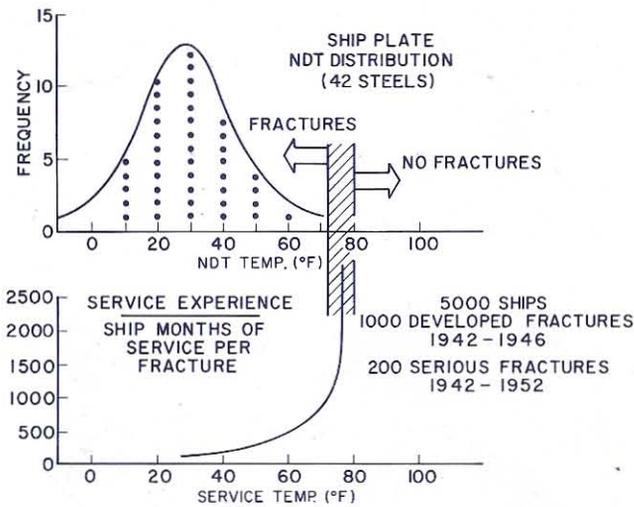
FIGURE 40 — Illustrating that no failures of World War II ships occurred at temperatures above the 70 F upper limit of the NDT frequency distribution range of World War II ship steels. A high rate of fracture per month of service occurred at temperatures of 30 to 50 F, for which 20 to 50% of the steels were below their NDT temperatures.

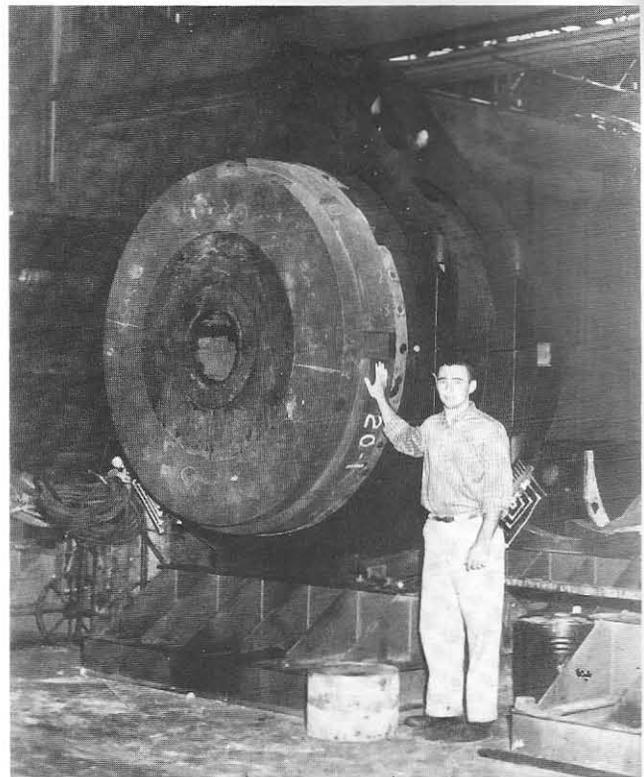
FIGURE 42 – (Case B7) General view of a retaining ring forging, representing an external ring which is shrink fitted over the (dark) core of an extrusion chamber section. The chamber assembly comprises five adjoining rings.

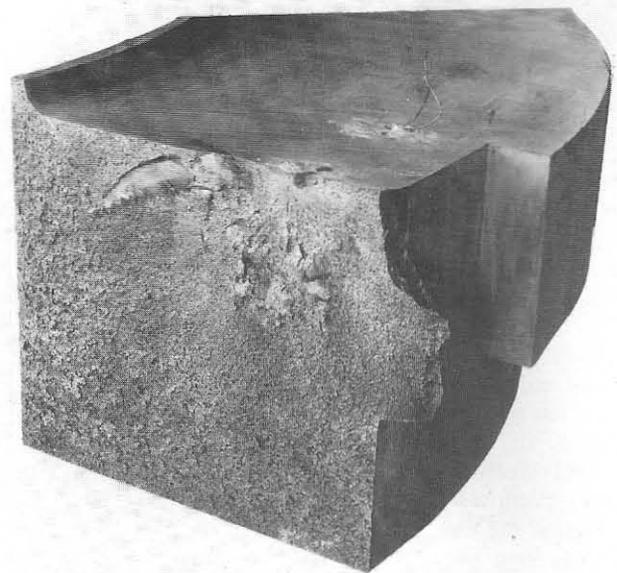
FIGURE 43 – (Case B7) Fracture face (12 x 13 inches) of the extrusion chamber retaining ring. Fracture source markings are at one of the positions of thermocouple attachment by brazing; note a companion thermocouple.

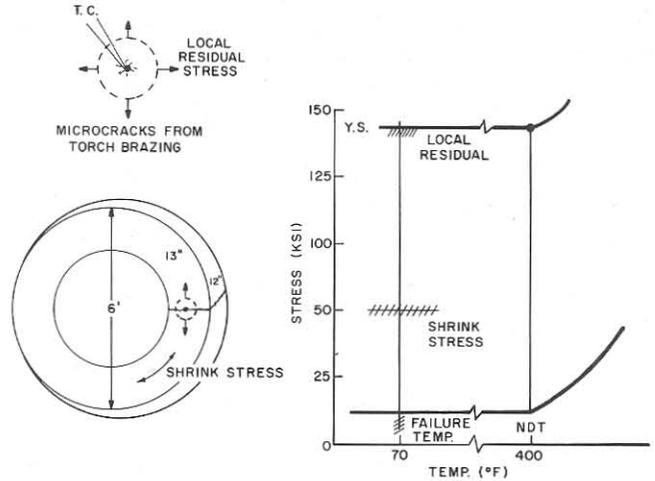
FIGURE 44 – (Case B7) Fracture analysis relating to the spontaneous fracture of the ASTM A293 retaining ring forging.

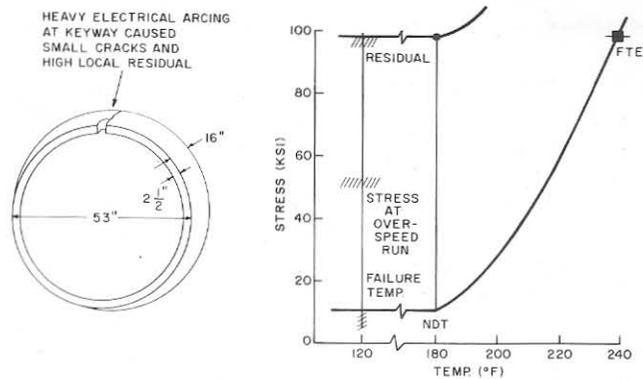
FIGURE 46 — (Case B8) Fracture analysis relating to the overspeed run failure of the SAE 3335 retaining ring forging. Data by Greenberg.^{1,2}

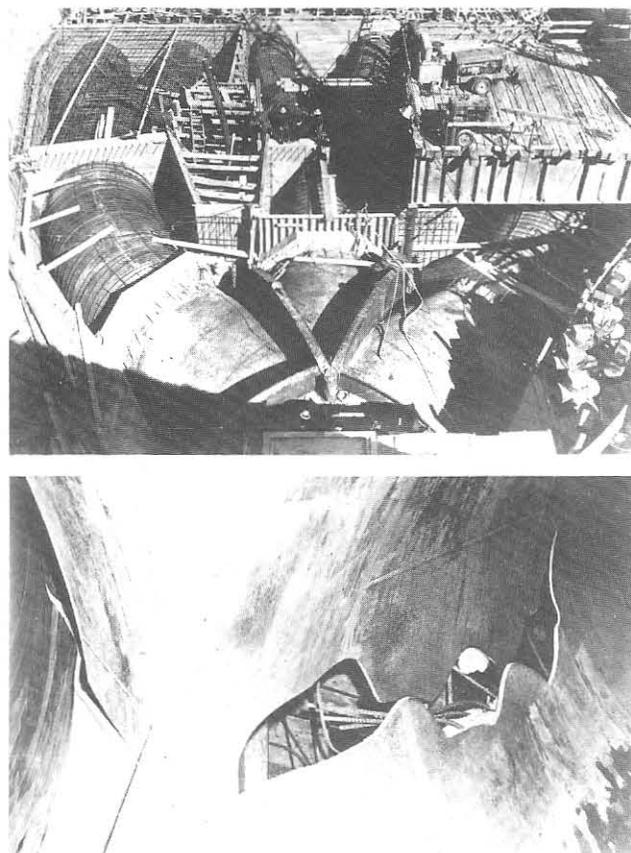
FIGURE 47 — Arrangement of hydroelectric power dam outlet manifold and piping system prior to time of failure (top) and extent of fracture in outlet manifold (bottom).

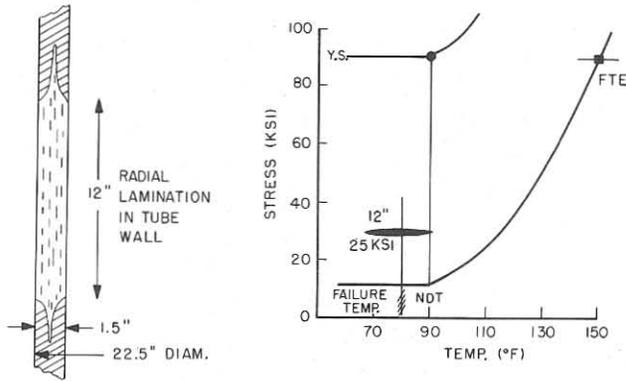
FIGURE 51 — (Case C3) Fracture analysis relating to the air-leak test failure of an ASTM A372-IV high pressure air flask.

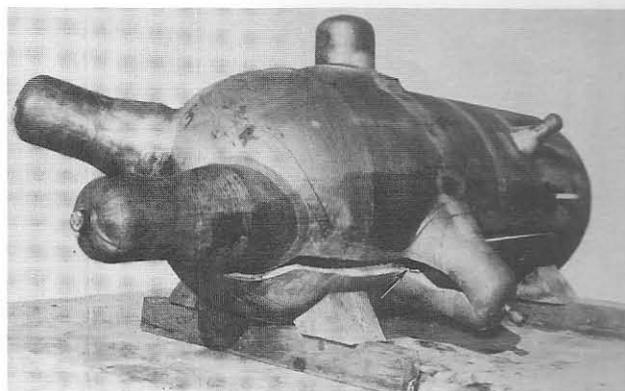
FIGURE 56 – (Case E1) Failure of the 3 foot diameter, low cycle fatigue test vessel PVRC No. 1. The arrow indicates the location of the 6 inch fatigue crack which initiated the fracture.

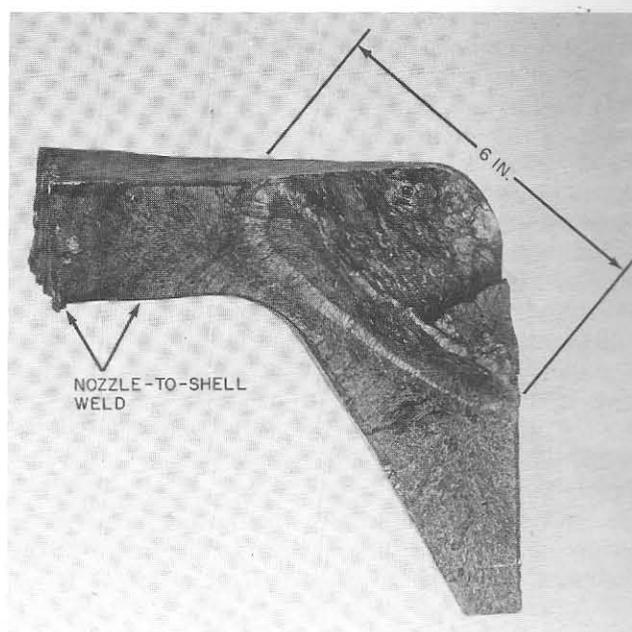
FIGURE 57 – (Case E1) PVRC No. 1 vessel fracture surface illustrating the 6 inch fatigue crack at the nozzle source point (located by the arrow in Figure 54).

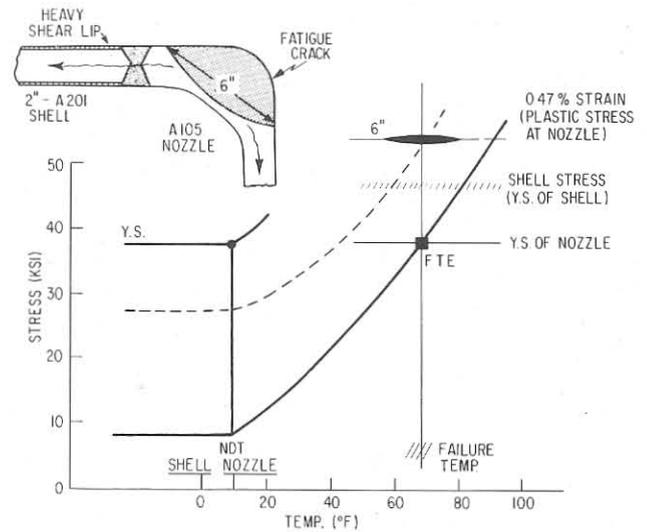
FIGURE 58 — (Case E1) Fracture analysis relating to the failure of the PVRC No. 1 vessel which originated from a 6 inch fatigue crack in a forged ASTM A105 nozzle.
