PROCESS INDUSTRIES CORROSION

Fracture Analysis Diagram Procedures for the Fracture-Safe Engineering Design of Steel Structures⁽¹⁾

W. S. PELLINI and P. P. PUZAK*

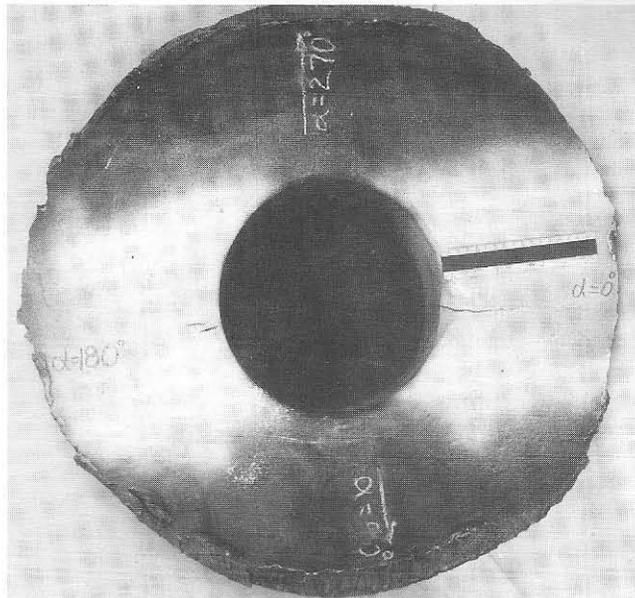
FIGURE 59 — (Case E2) Surface appearance of the fatigue crack (right) which penetrated the nozzle wall and resulted in leakage termination of the fatigue test for the PVRC No. 3 vessel.

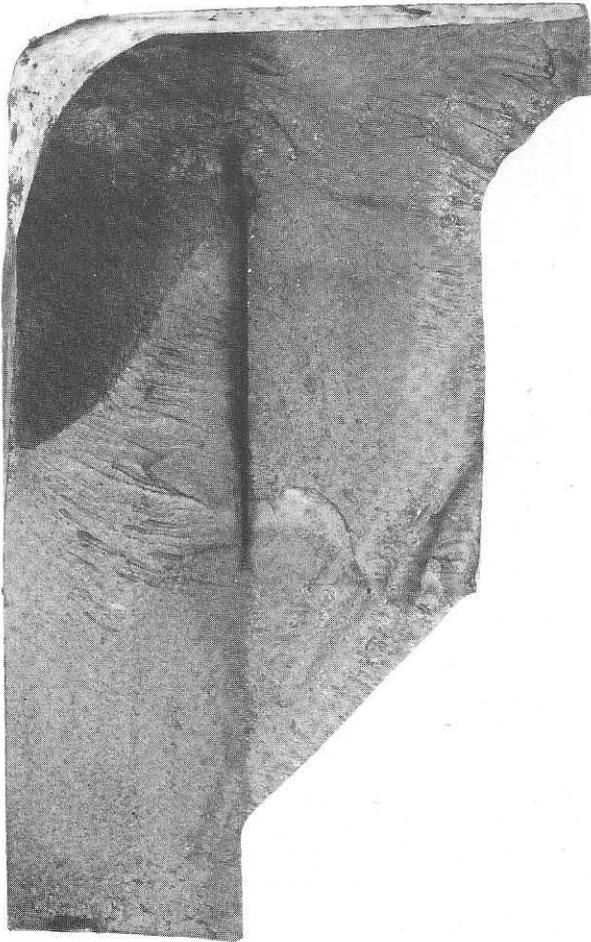
FIGURE 60 — (Case E3) Nozzle section shown in Figure 57 was cooled with liquid nitrogen and split open in the plane of the fatigue crack (dark region at top left of the fracture surface).

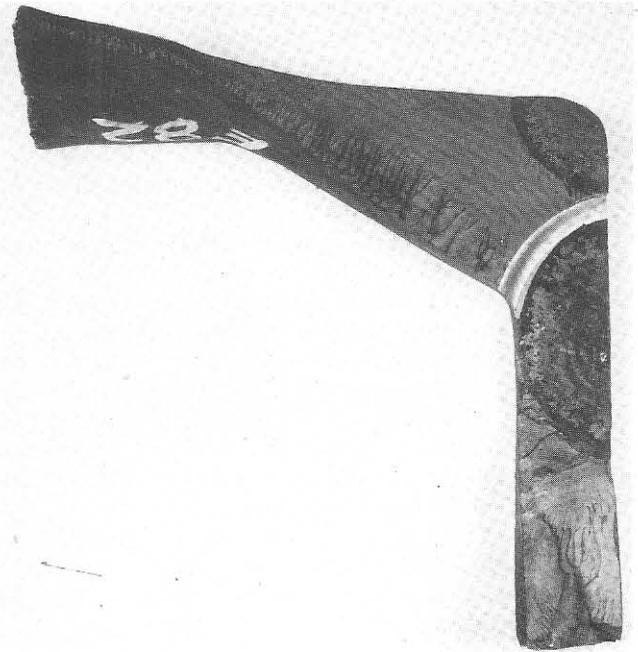
FIGURE 62 — (Case E4) Leakage region in the nozzle of the PVRC No. 4 vessel. The nozzle section was cooled with liquid nitrogen and split open in the plane of the two fatigue cracks (dark areas). The larger of the two fatigue cracks is noted to have penetrated through the thickness of the shell wall. The shiny arc between the cracks is a machine cut to remove a metal fin which covered a portion of the fatigue crack.

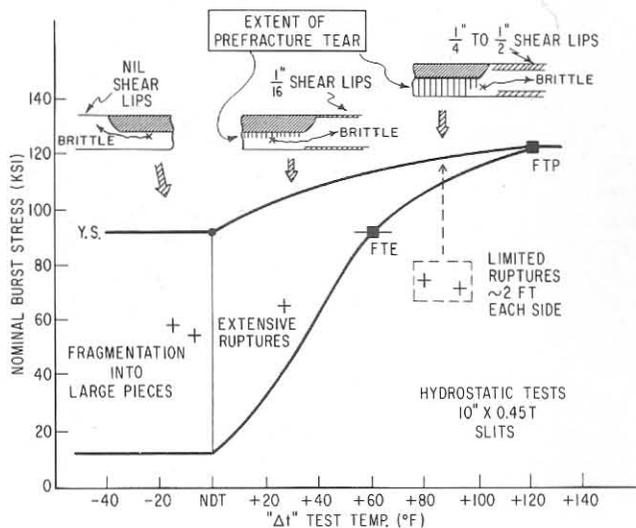
FIGURE 64 – (Cases F1 and F5) Summary of hydrostatic burst test data.

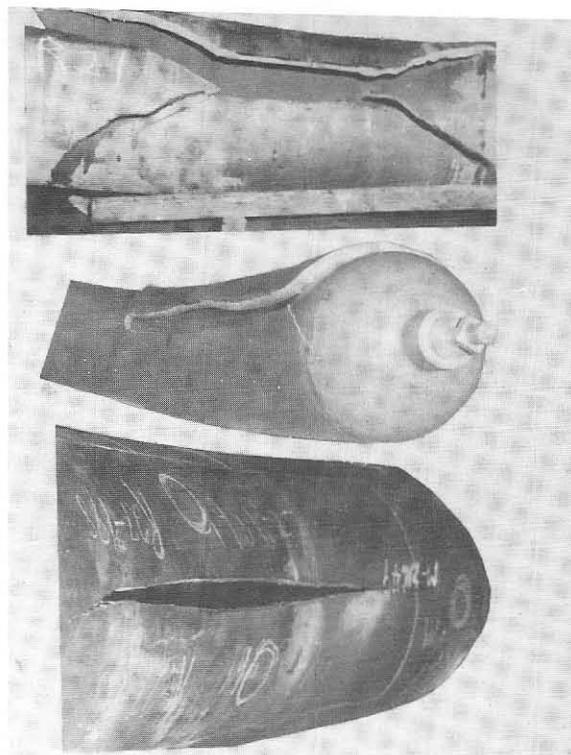
FIGURE 65 – Illustrating the general mode of failure of hydrostatically loaded pressure vessels featuring the presence of large flaws. Top: fragmentation into large pieces at temperatures at or below NDT. Middle: extensive ruptures at temperatures of NDT + 30 F to NDT + 50 F. Bottom: limited ruptures at temperatures of NDT + 80 F to NDT + 90 F.

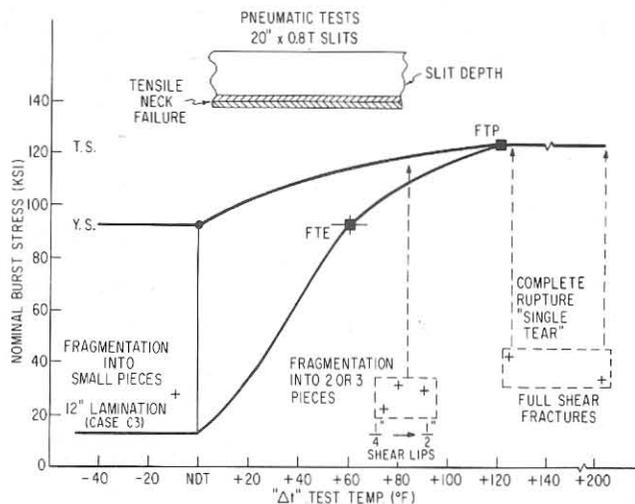
FIGURE 66 – (Cases F6 to F11) Summary of pneumatic burst test data.

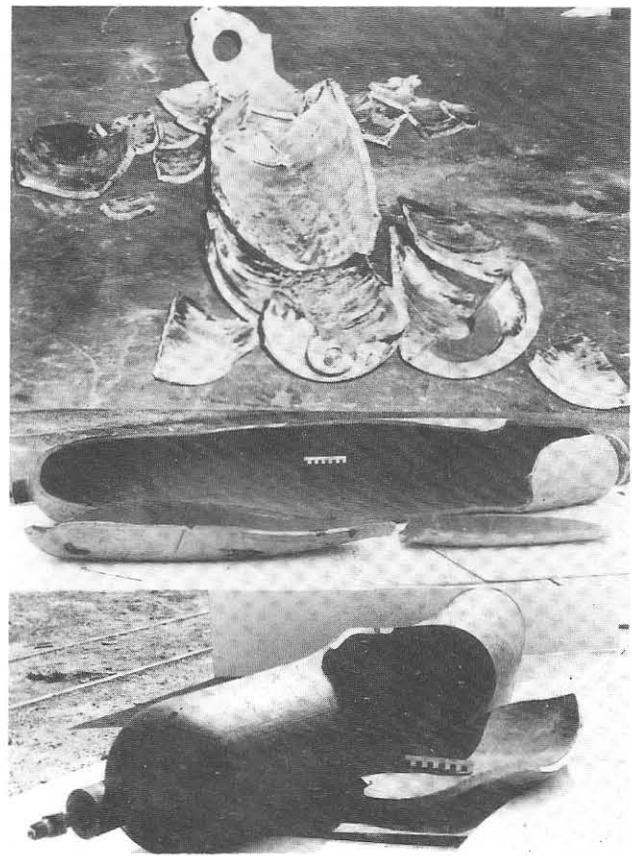
FIGURE 67 — Illustrating the general mode of failure of pneumatically loaded pressure vessels featuring the presence of large flaws. Top: fragmentation at temperatures below NDT. Middle—fracture into several large pieces at temperatures of NDT + 80 F. Bottom: ductile tear at temperatures of NDT + 120 F and higher.

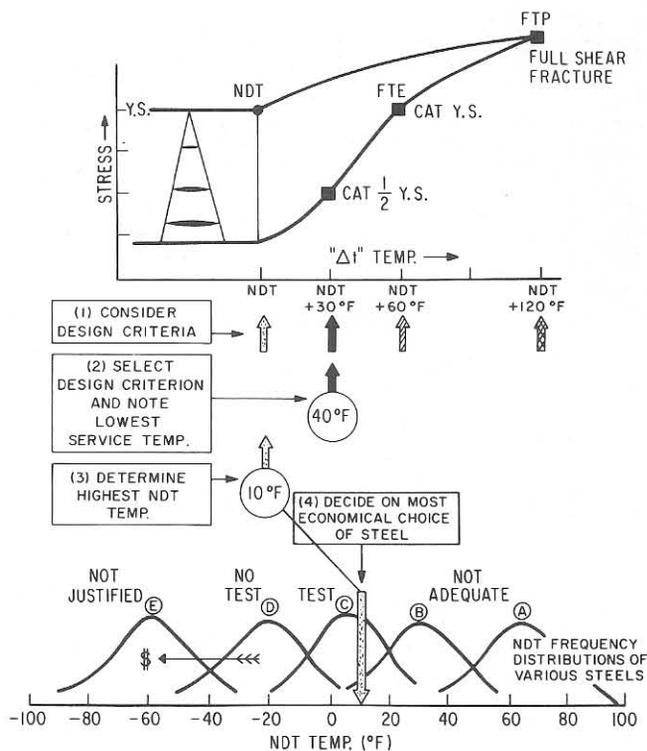
FIGURE 68 — An example illustrating the four simple steps for the engineering selection of fracture-safe steels based on the fracture analysis diagram concepts and a catalog of NDT data.

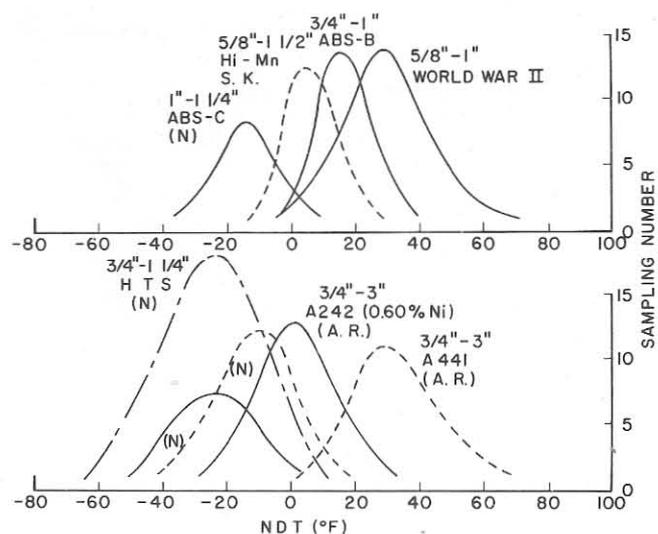
FIGURE 69 — Examples of NDT frequency distribution curves taken from the authors' files. The top set relates to ship plate steels. The bottom set relates to high tensile steels of 50 to 55 ksi yield strength.

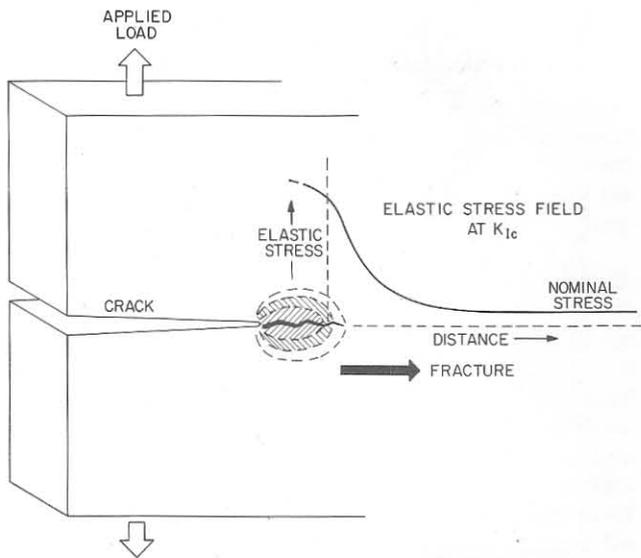
FIGURE 1 — Plastic zone and stress field at a crack tip for fracture at elastic stress levels.

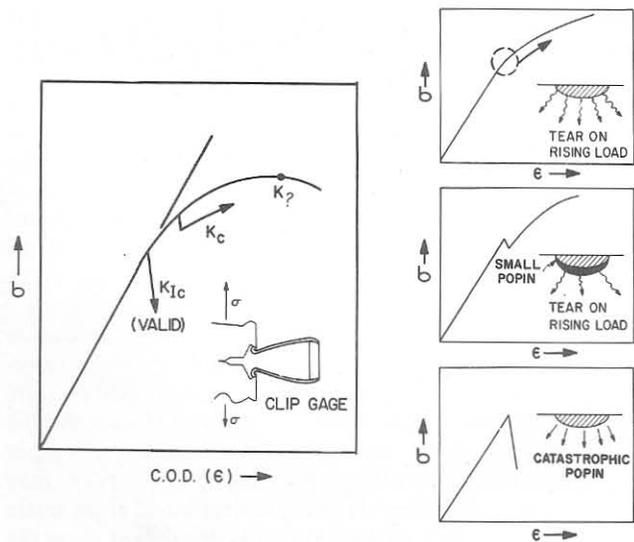
FIGURE 2 — Load-displacement relationships for three levels of fracture resistance: (lower) fast instability type fracture at elastic stress levels and plane-strain stress state; (center) mixed-mode or transition-type fracture with arrest of initial popin crack and rising load required for terminal fracture; (top) fracture propagates after extensive plastic strain and plastic overload condition in the net section.

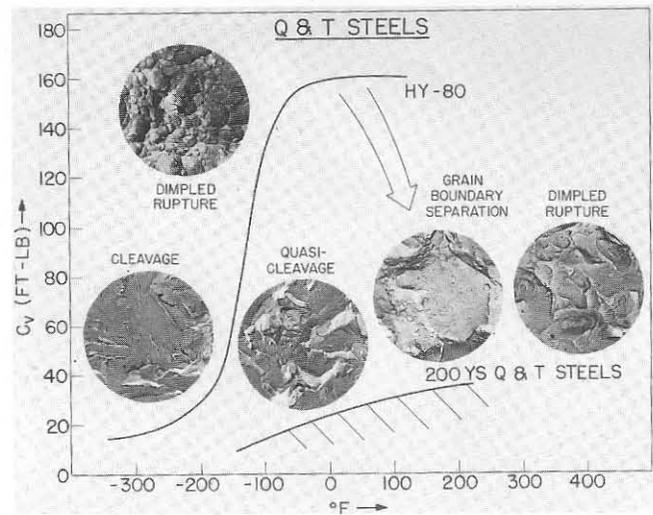
FIGURE 4 — Microfracture mechanisms of high-strength steels in relation to C_v curves. Approximately 4000X.

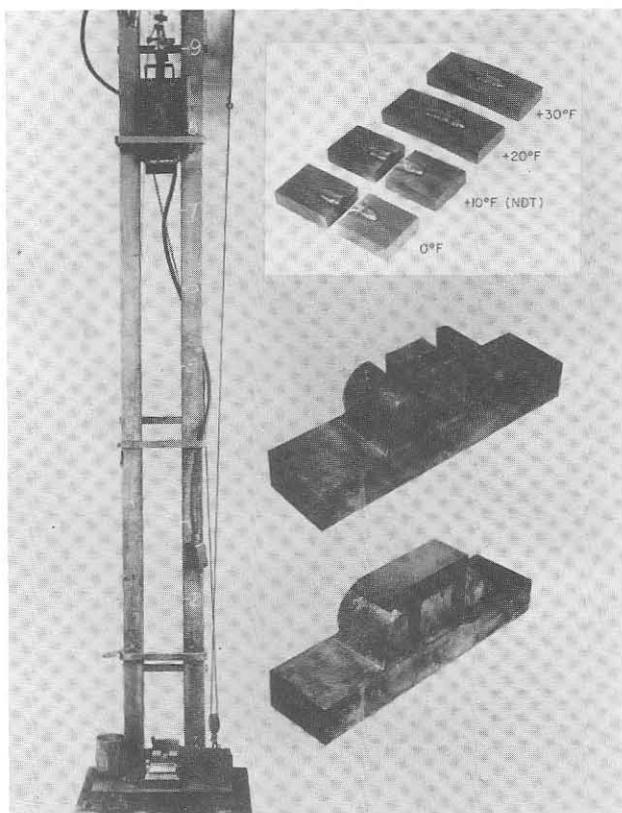
FIGURE 5 — Drop-Weight-Test (DWT) equipment and DWT series illustrating the sharp increase in dynamic fracture toughness above the NDT temperature.

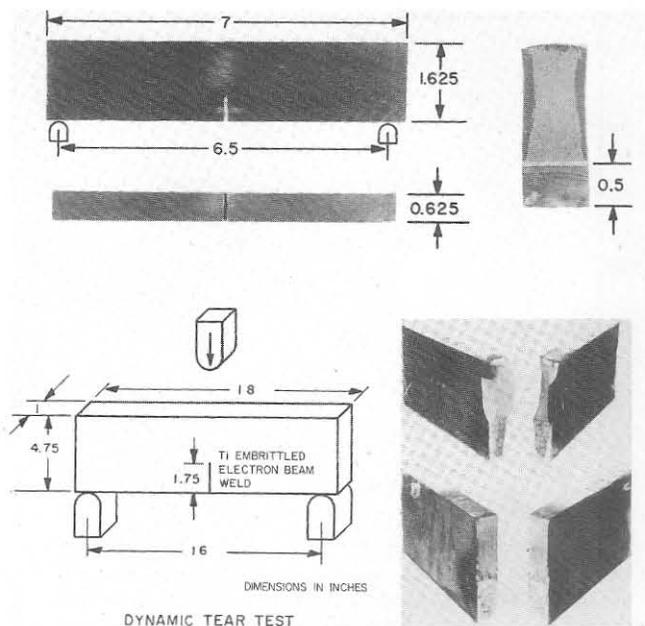
FIGURE 6 — Features of 5/8 inch and 1 inch DT test specimens. The 5/8 inch DT specimen (top) features a machine slit with a knife-edge-sharpened notch tip. The 1 inch DT specimen (bottom) features a brittle electron beam weld, which is also used for the 5/8 inch DT, as desired. The broken halves of the 1 inch DT specimens illustrate brittle and ductile type fractures.

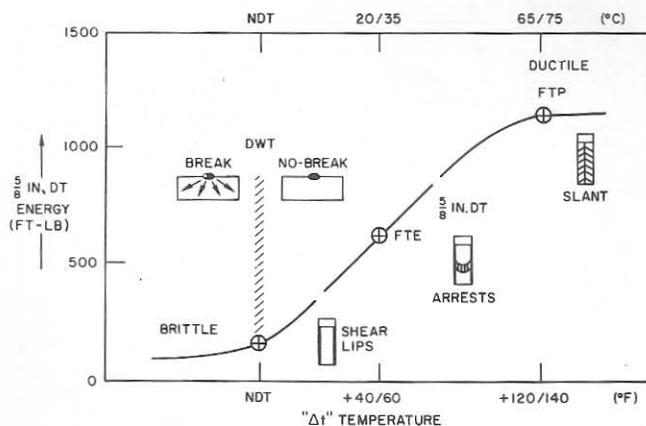
FIGURE 7 — The correspondence between results of the DWT-NDT test and the DT test. The fracture resistance level of steel at its NDT temperature is equivalent to a $K_{I_d}/\sigma_{ys} = 0.5$ ratio (9) which is the limit of the plane-strain measuring capability of a 5/8 inch DT specimen. The rise in fracture energy and change in fracture appearance of the specimens at the NDT temperature document the transition from plane strain (elastic) to high-ductility plane stress (plastic) fracture for a steel which develops high-shelf-level fracture toughness.

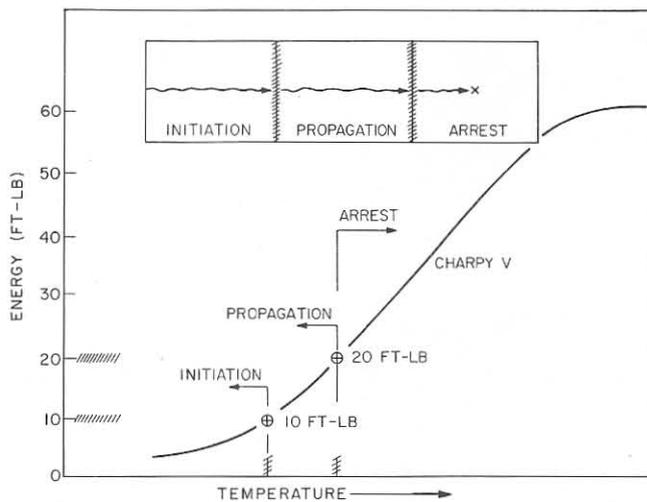
FIGURE 8 — Summary of C_V energy values of ship fracture initiation, propagation, and arrest plates at the failure temperature.

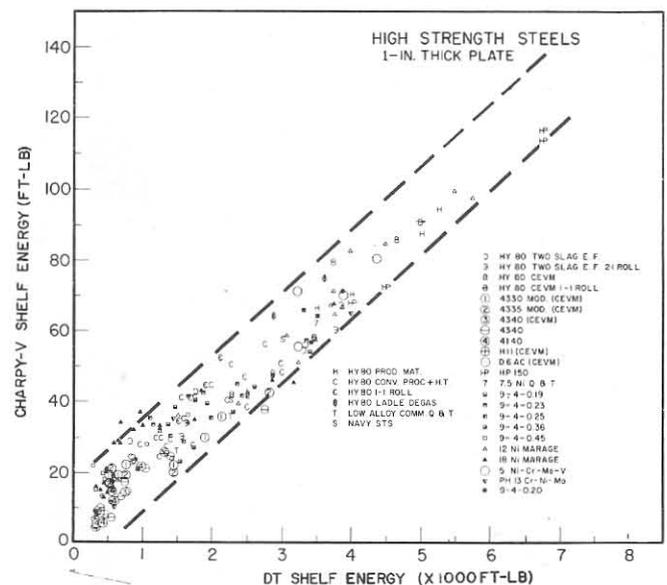
FIGURE 9 — Correlation of C_V shelf energy with DT shelf energy.

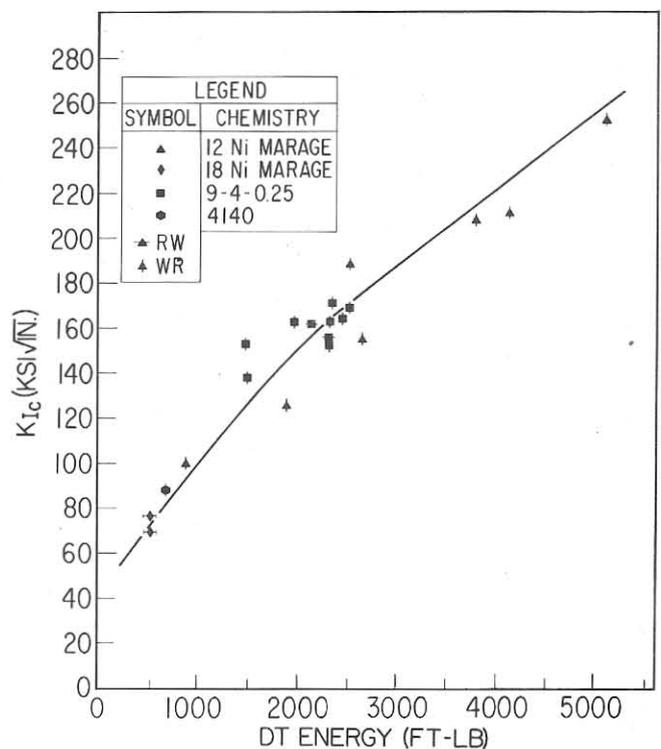
FIGURE 10 — Correlation of K_{Ic} and DT test values for steel.

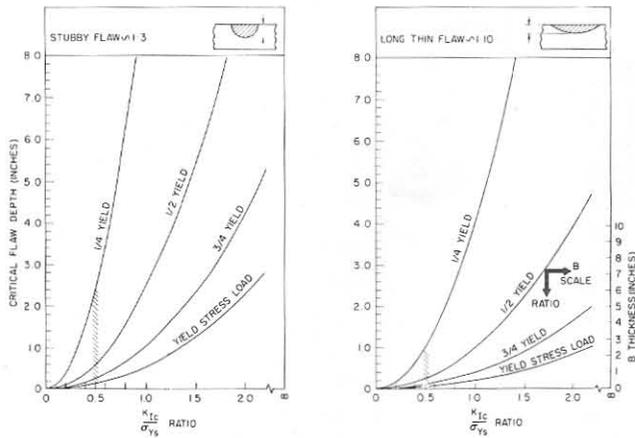
FIGURE 11 — Relationships between critical flaw size and stress as a function of K_{Ic}/σ_{ys} ratio. The relationships are calculated from a fracture-mechanics analysis for a surface flaw and plane-strain stress state. Section size requirement for a plane-strain fracture is indicated by the B scale in the right-hand plot.

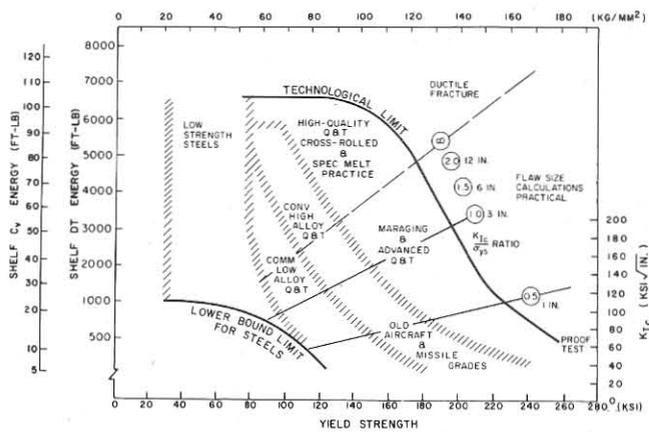
FIGURE 14 — Metallurgical zoning of the RAD which defines the strength transition for various generic alloy steel types (2).
