The Eight Forms of Corrosion⁽¹⁾

M. G. FONTANA*

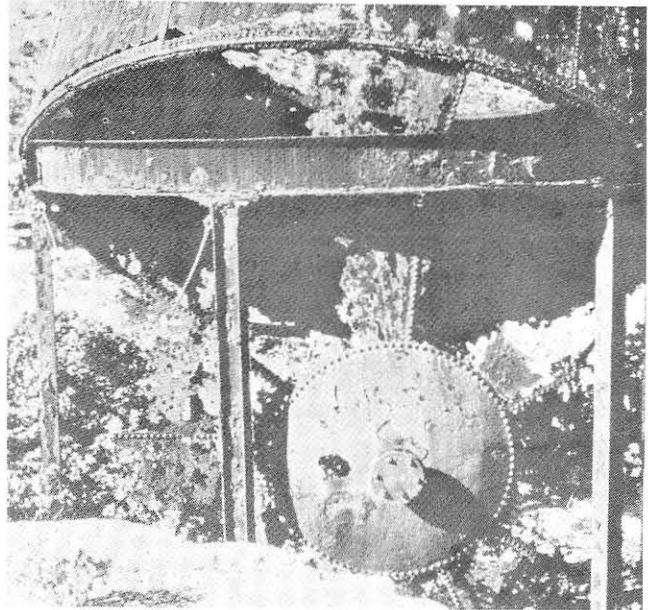
FIGURE 1 — Rusting of abandoned steel tank.

Uniform attack is the most common form of corrosion. It is normally characterized by a chemical or electrochemical reaction which proceeds uniformly over the entire exposed surface or over a large area. The metal becomes thinner and eventually fails. For example, a piece of steel or zinc immersed in dilute sulfuric acid will normally dissolve at a uniform rate over its entire surface. A sheet iron roof will show essentially the same degree of rusting over its entire outside surface. Figure 1 shows a steel tank in an abandoned gold-smelting plant. The circular section near the center of the photograph was thicker than the rest of the tank. This section is now supported by a *lace curtain* of tank bottom metal.

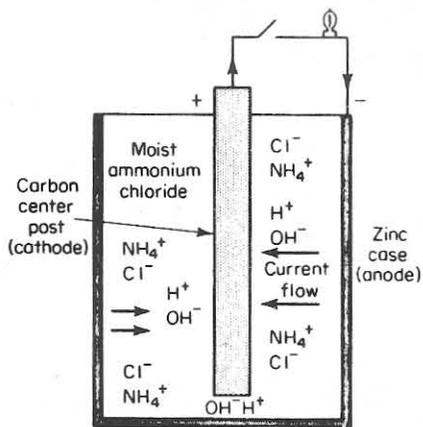
FIGURE 2 – Section of dry-cell battery.

The driving force for current and corrosion is the potential developed between the two metals. The so-called dry-cell battery depicted in Figure 2 is a good example of this point. The carbon electrode acts as a noble or corrosion-resistant metal (the cathode), and the zinc as the anode which corrodes. The moist paste between the electrodes is the conductive (and corrosive) environment

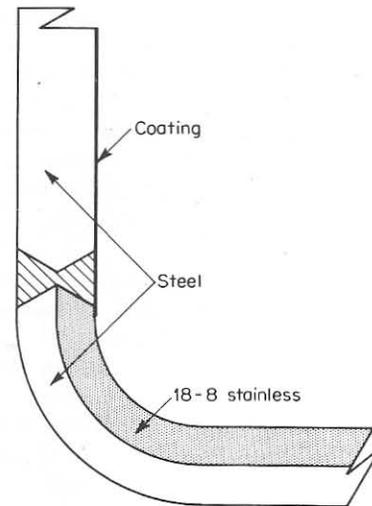
FIGURE 4 — Detail of welded steel and stainless clad tank construction.

started failing because of perforation of the side walls. Most of the holes were located within a 2 inch band above the weld shown in Figure 4. Some of the all-steel tanks had given essentially trouble-free life for periods as long as 10 to 20 years as far as side-wall corrosion was concerned.

The explanation for the above failure is as follows. In general, all paint coatings are permeable and may contain some defects. For example, this baked phenolic coating would fail in double-distilled water service. Failure of the new tanks resulted from the unfavorable area effect. A small anode developed on the mild steel side plates. This area was in good electrical contact with the large stainless steel bottom surface. The area ratio of cathode to anode was almost infinitely large, causing very high corrosion rates in the order of 1000 mpy.

4. Apply coatings with caution. Avoid situations similar to that described in connection with Figure 4. Keep the coatings in good repair, particularly the one on the anodic member.

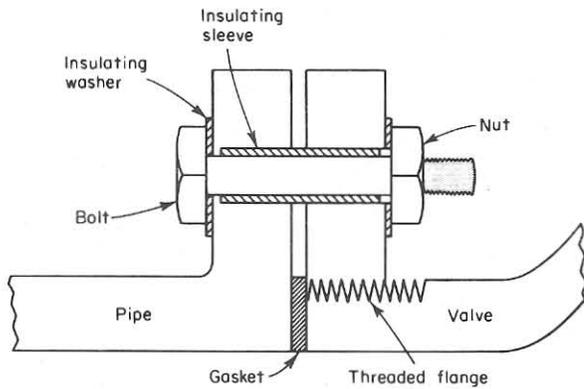
FIGURE 5 — Proper insulation of a flanged joint.

6. Avoid threaded joints for materials far apart in the series. As shown in Figure 5, much of the effective wall thickness of the metal is cut away during the threading operation. In addition, spilled liquid or condensed moisture can collect and remain in the thread grooves. Brazed joints are preferred, using a brazing alloy more noble than at least one of the metals to be joined. Welded joints using welds of the same alloy are even better.

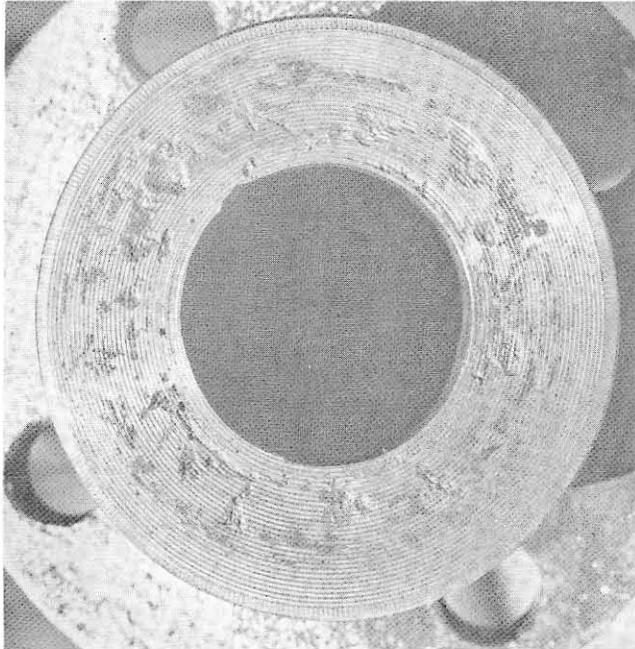
FIGURE 8 – Gasket (crevice) corrosion on a large stainless steel pipe flange (E. V. Kunkel).

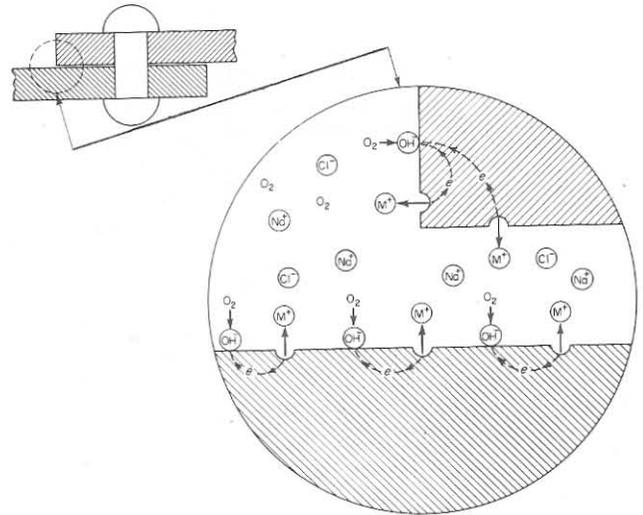
FIGURE 9 – Crevice corrosion, initial stage.

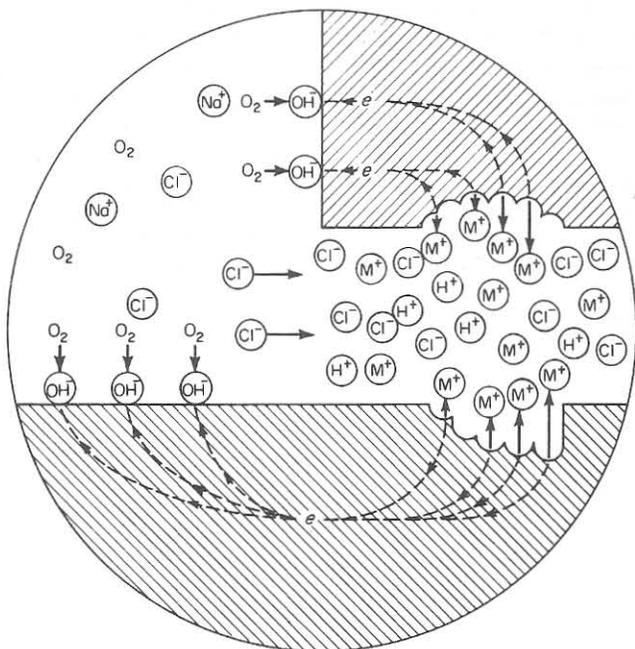
FIGURE 10 — Crevice corrosion, later stage.

Oxygen depletion has an important indirect influence, which becomes more pronounced with increasing exposure. After oxygen is depleted, no further oxygen reduction occurs, although the dissolution of metal M continues as shown in Figure 10. This tends to produce an excess of

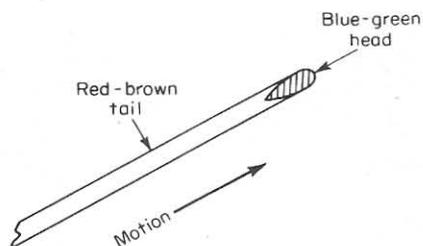
FIGURE 11 — Schematic diagram of a corrosion filament growing on an iron surface (magnified).

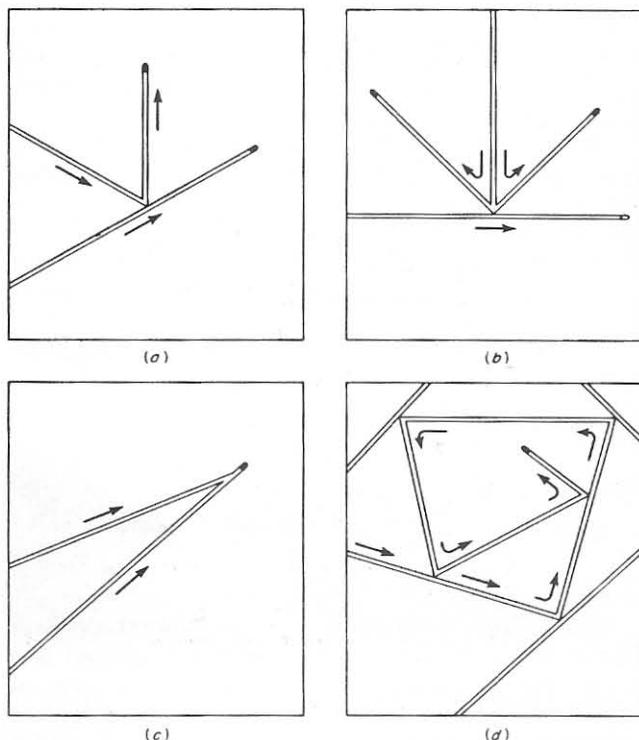
FIGURE 12 — Schematic diagrams illustrating the interaction between corrosion filaments. (a) Reflection of a corrosion filament, (b) splitting of a corrosion filament, (c) joining of corrosion filaments, and (d) "death trap".

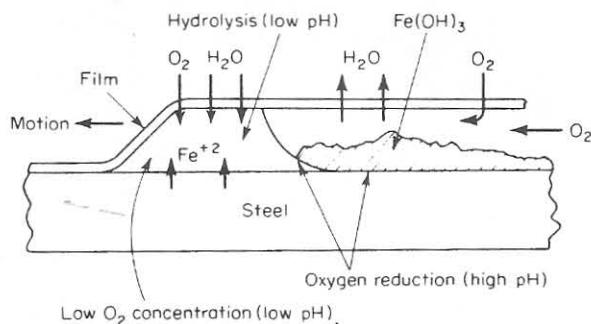
FIGURE 13 — Cross section of a corrosion filament on a steel surface.

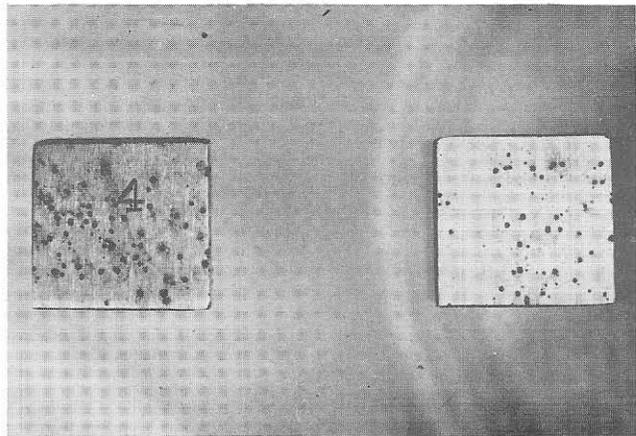
FIGURE 14 — Pitting of 18-8 stainless steel by acid-chloride solution.

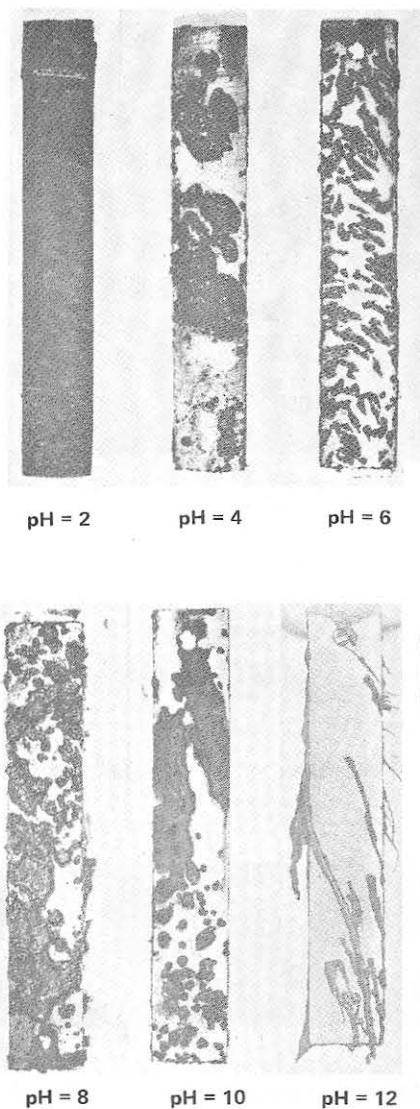
FIGURE 18 — Corrosion of steel after 24 hours in 5% NaCl and 500 lb/in.² oxygen pressure (Continental Oil Co.).

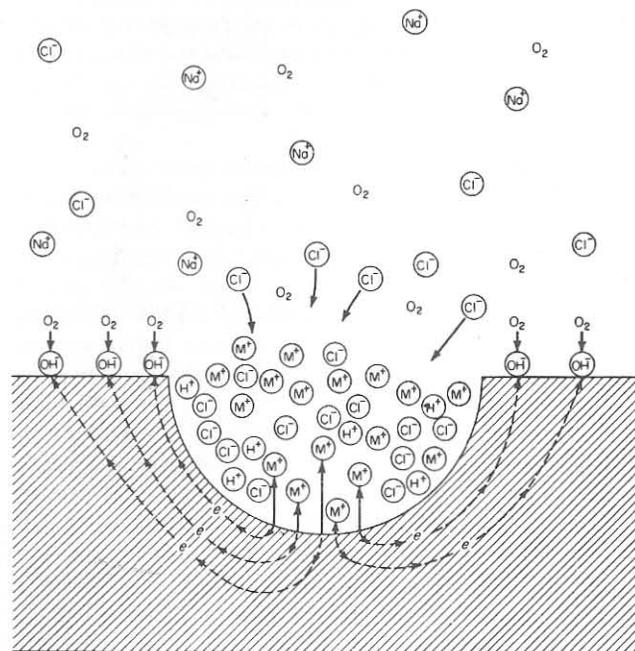
FIGURE 19 — Autocatalytic processes occurring in a corrosion pit.

Although Figure 19 indicates how a pit grows through self-stimulation, it does not immediately suggest how this process is initiated. Evans⁴ has indicated how it could lead to the start of pitting. Consider a piece of metal M devoid of holes or pits, immersed in aerated sodium chloride solution. If, for any reason the rate of metal dissolution is momentarily high at one particular point, chloride ions will migrate to this point. Since chloride stimulates metal dissolution, this change tends to produce conditions which are favorable to further rapid dissolution at this point. Locally, dissolution may be momentarily high because of a surface scratch, an emerging dislocation or other defect, or random variations in solution composition. It is apparent that during the initiation or early growth stages of a pit, conditions are rather unstable. The locally high concentration of chloride and hydrogen ions may be swept away by stray convection currents in the solution since a protective pit cavity does not exist. The authors have observed that new pits are indeed unstable, since many become inactive

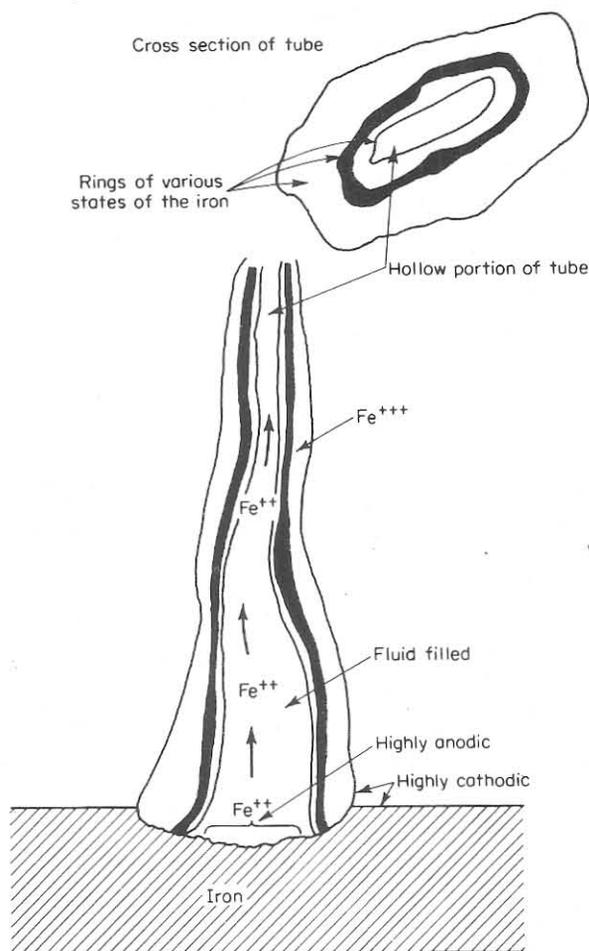
FIGURE 20 — Corrosion tube growth mechanism (Continental Oil Co.).

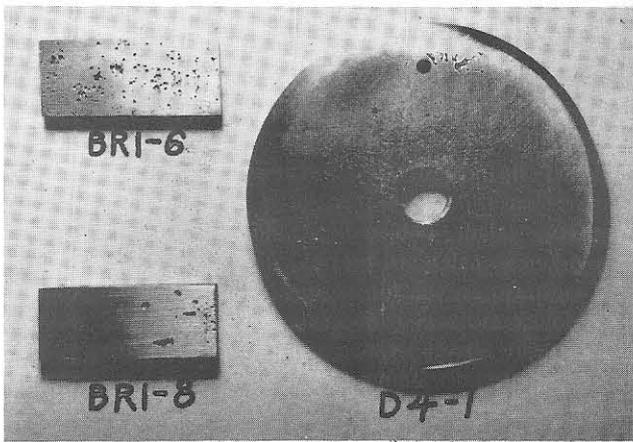
FIGURE 21 — Effect of velocity on pitting of stainless steel.

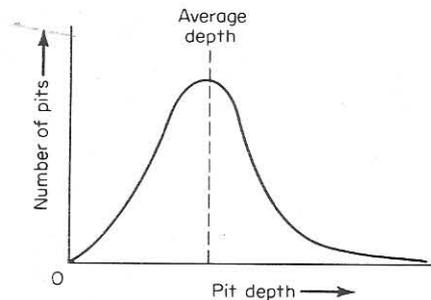
FIGURE 22 — Relationship between pit depth and the number of pits appearing on a corroded surface.

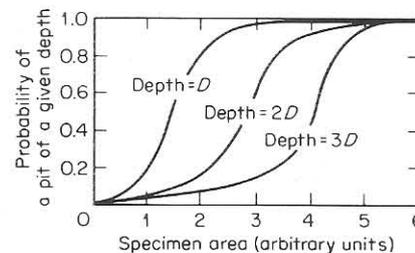
FIGURE 23 — Pit depth as a function of exposed area.

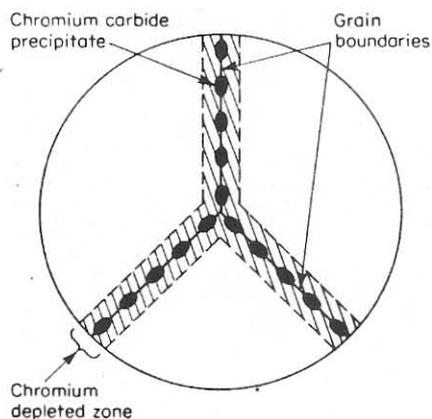
FIGURE 24 — Diagrammatic representation of a grain boundary in sensitized Type 304 stainless steel.

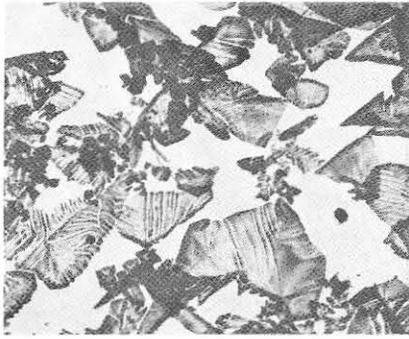
FIGURE 26 — Electron photomicrograph of carbides isolated from sensitized Type 304 stainless steel.

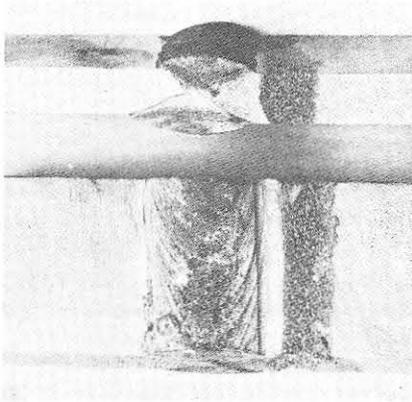
FIGURE 27 — Intergranular corrosion in weld decay zone. Right, Type 304, and left, stabilized with titanium.

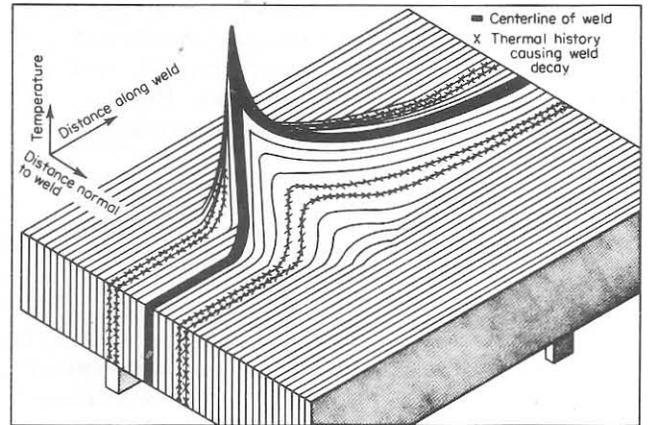
FIGURE 28 — Table cloth analogy of heat flow and temperatures during welding. Visualize a mountainlike block being moved beneath an elastic striped tablecloth. The rise and fall of each stripe represents the rise and fall of temperature in a welded plate (DuPont Co.).

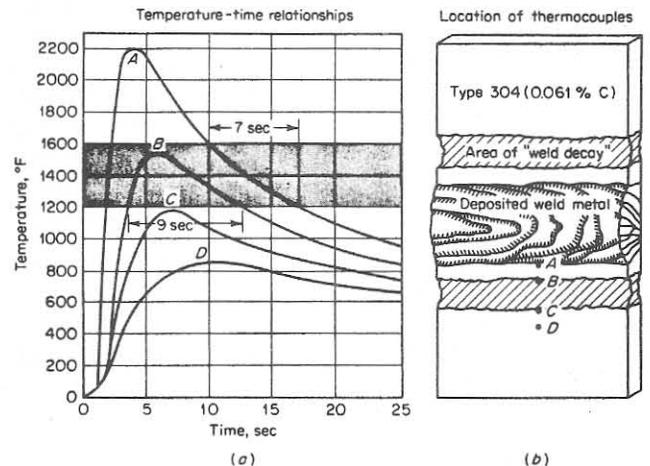
FIGURE 29 — Temperatures during electric-arc welding of Type 304 stainless steel (DuPont Co.).

Figure 29⁶ depicts in different form essentially the same picture. Thermocouples were placed at points A, B, C, and D, and temperatures and times recorded during welding. The metal at points B and C (and between these points) is

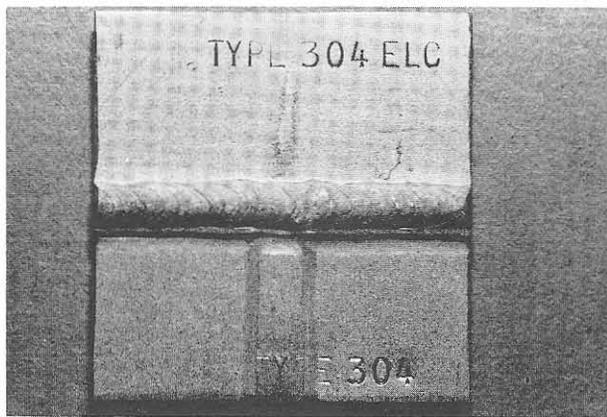
FIGURE 30 – Elimination of weld decay by Type 304L.

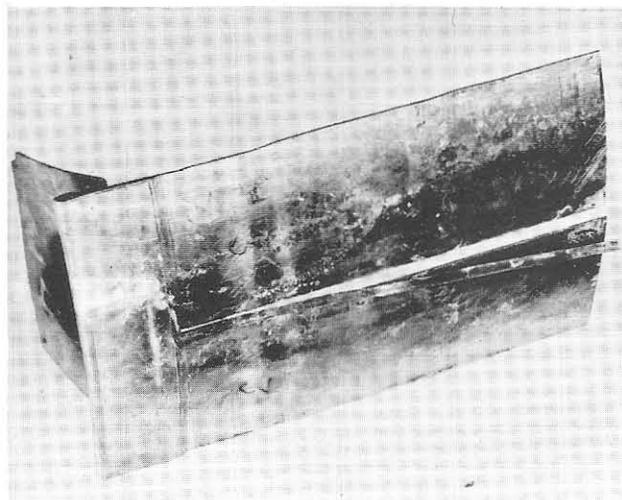
FIGURE 31 – Knife-line attack on Type 347 stainless steel.

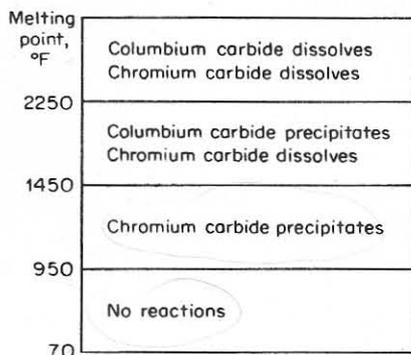
FIGURE 32 — Schematic chart showing solution and precipitation reactions in Types 304 and 347.

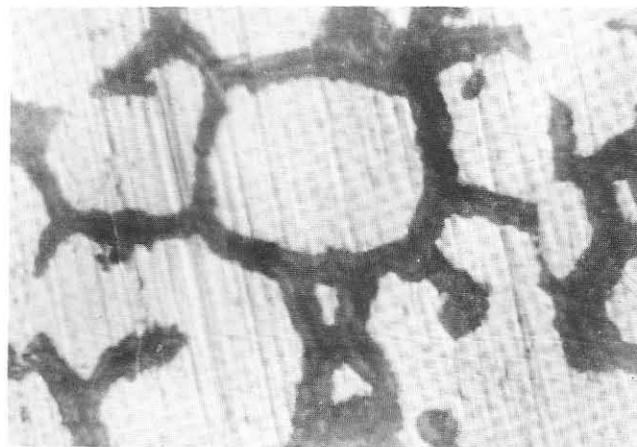
FIGURE 33 — Intergranular corrosion of ancient Greek bronze.

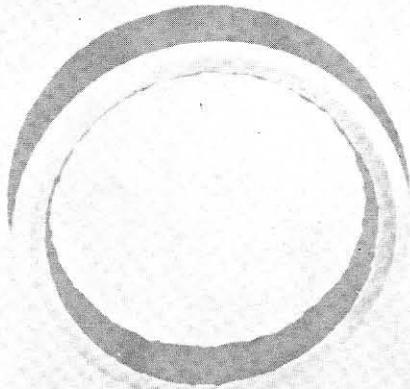
FIGURE 34 – Uniform dezincification of brass pipe.

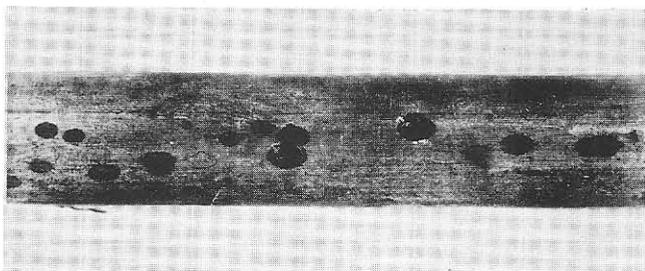
FIGURE 35 – Plug-type dezincification.

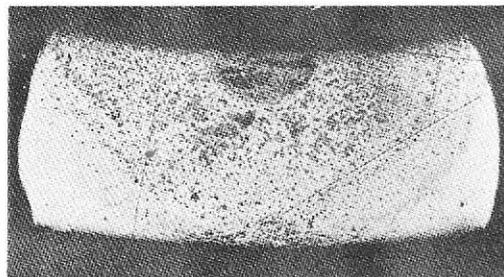
FIGURE 36 – Section of one of the plugs shown in Figure 35.

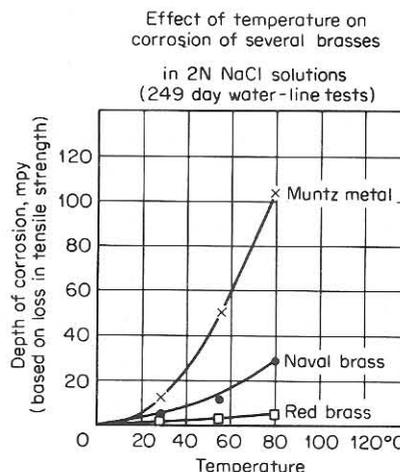
FIGURE 37 – Effect of temperature on corrosion of three brasses.

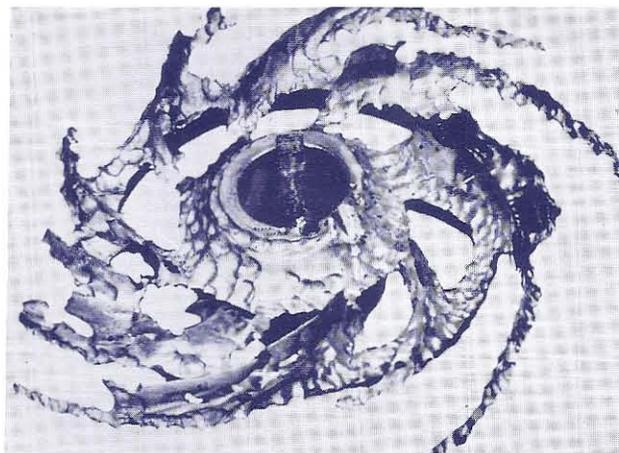
FIGURE 38 — Erosion corrosion of stainless alloy pump impeller.

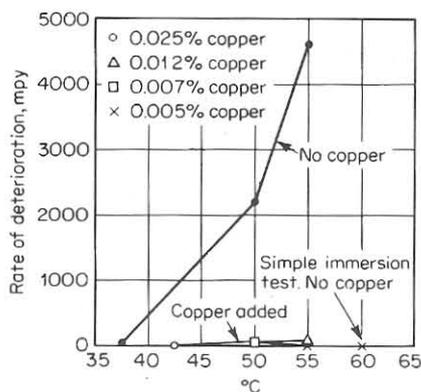
FIGURE 40 — Effect of temperature and copper-ion addition on erosion corrosion of Type 316 by sulfuric acid slurry (velocity, 39 ft/sec.).

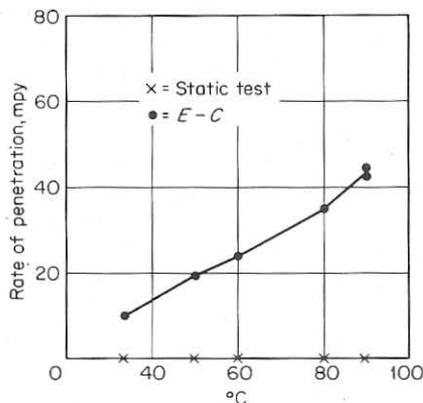
FIGURE 41 — Erosion corrosion of hard lead by 10% sulfuric acid (velocity 39 ft/sec.).

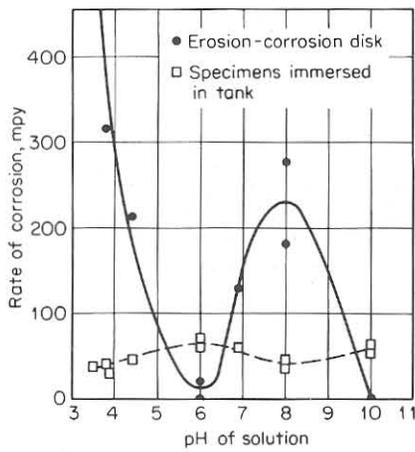
FIGURE 42 — Effect of pH of distilled water on erosion corrosion of carbon steel at 50 C (velocity 39 ft/sec).

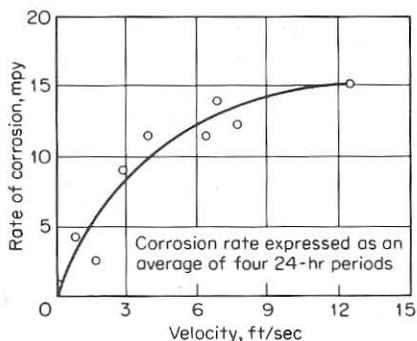
FIGURE 43 — Erosion corrosion of 3003 aluminum by white fuming nitric acid at 108 F.

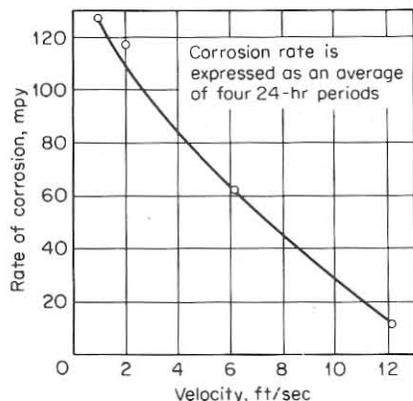
FIGURE 44 — Erosion corrosion of Type 347 stainless steel by white fuming nitric acid at 108 F.

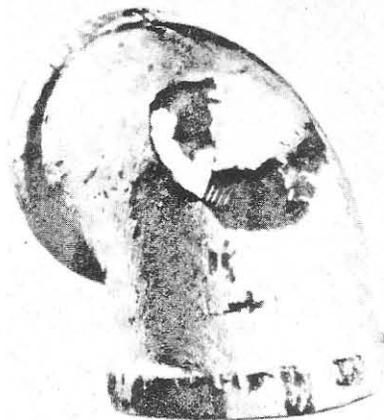
FIGURE 45 — Impingement failure of elbow in steam condensate line.

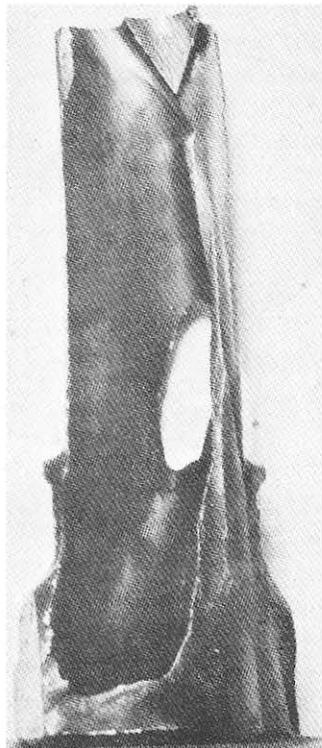
FIGURE 46 — Erosion corrosion of slide valve at 900 F in petroleum refinery.

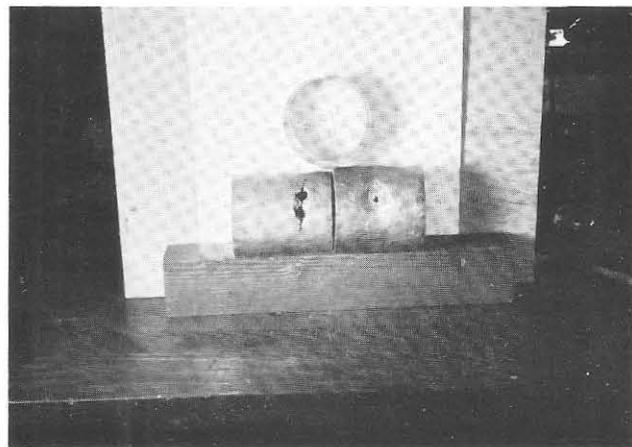
FIGURE 47 — Impingement by escaping steam from cracked tube (left).

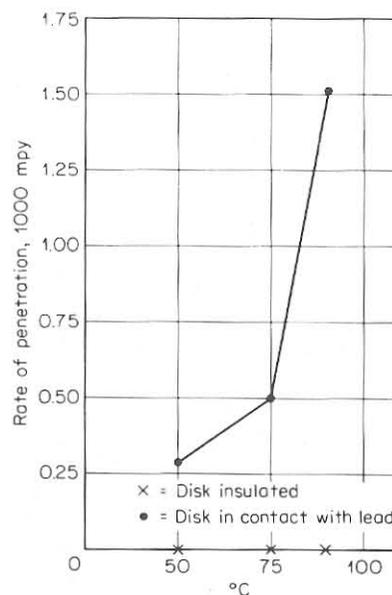
FIGURE 48 — Effect of contact with lead on erosion corrosion of Type 316 by 10% sulfuric acid (velocity 39 ft/sec.).

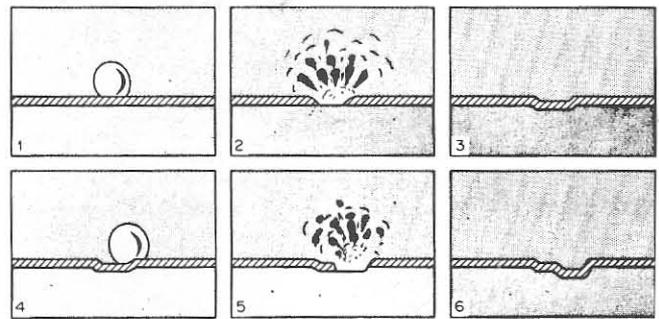
FIGURE 49 — Schematic representation of steps in cavitation (R. W. Henke).

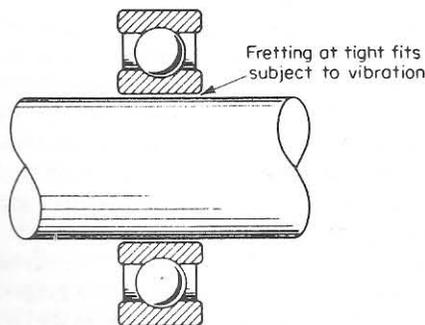
FIGURE 50 — Example of typical fretting corrosion location.

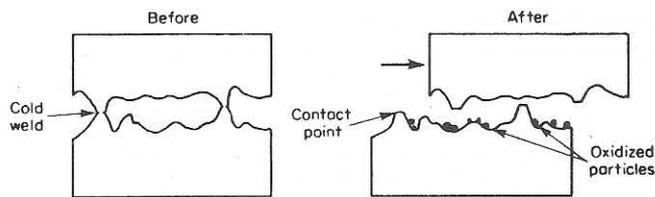
FIGURE 51 — Schematic illustration of the wear-oxidation theory of fretting corrosion.

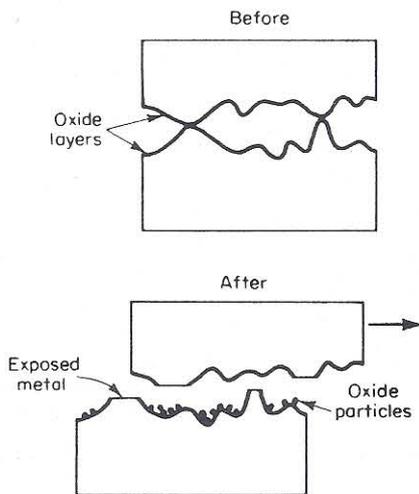
FIGURE 52 — Schematic illustration of the oxidation-wear theory of fretting corrosion.

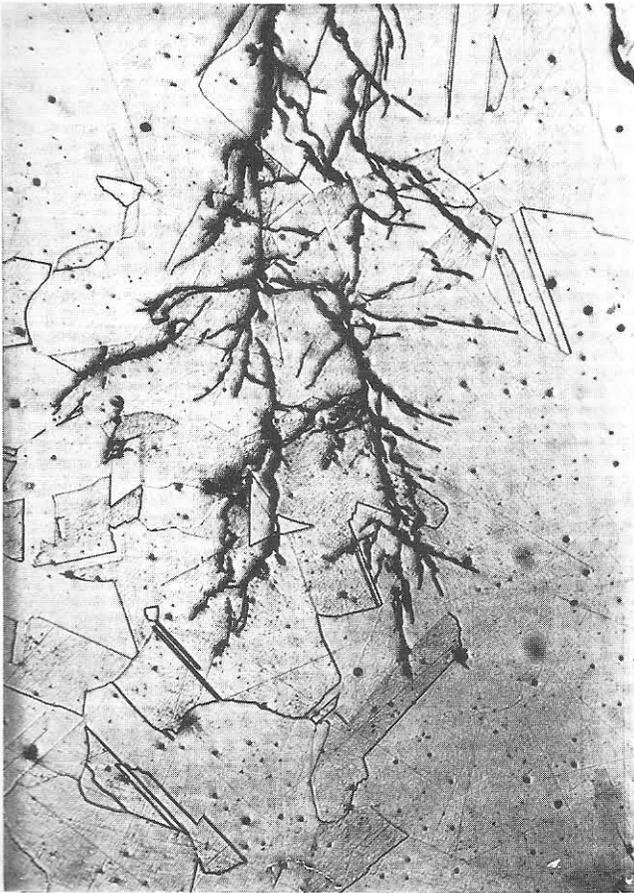
FIGURE 53 — Cross section of stress corrosion crack in stainless steel.

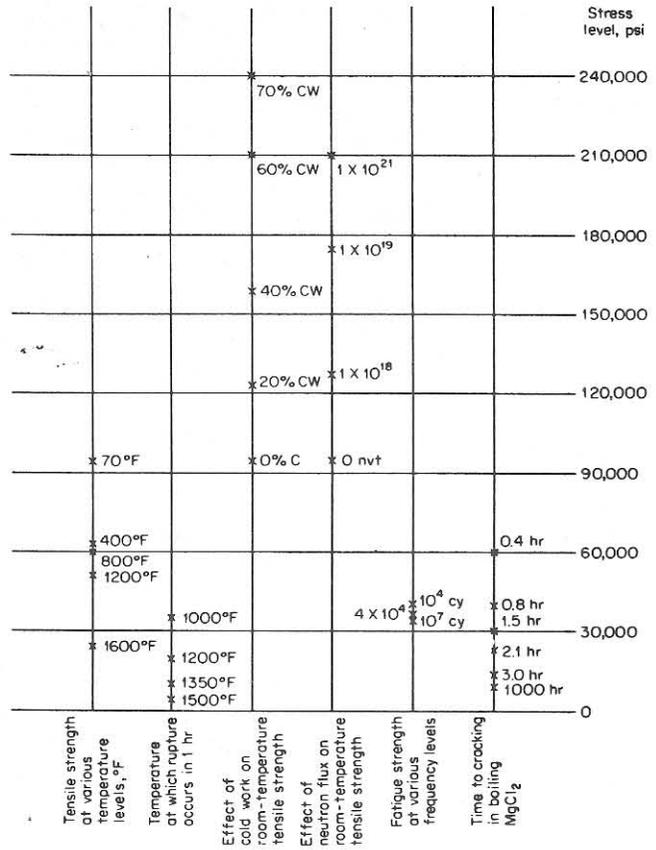
FIGURE 54 — Comparison of fracture stresses by various techniques compared with stress corrosion cracking. Material: Type 304 stainless (R. W. Staehle, Ohio State University).

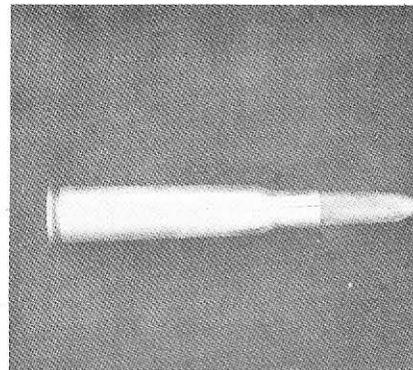
FIGURE 55 — Season cracking of German military ammunition.

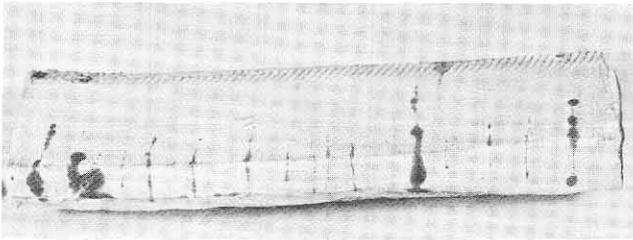
FIGURE 56 — Carbon steel plate from a caustic storage tank failed by caustic embrittlement (Imperial Oil, Limited, Ontario, Canada).

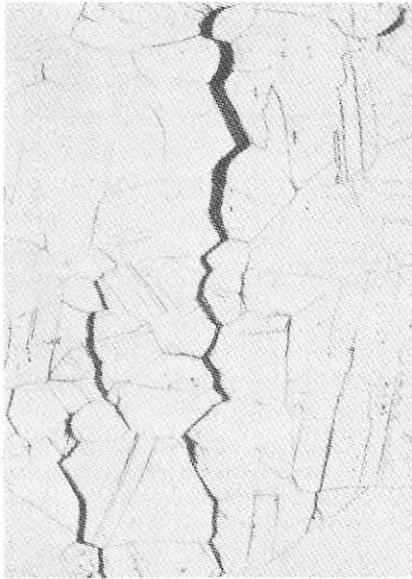
FIGURE 57 — Intergranular stress corrosion cracking of brass (E. N. Pugh).

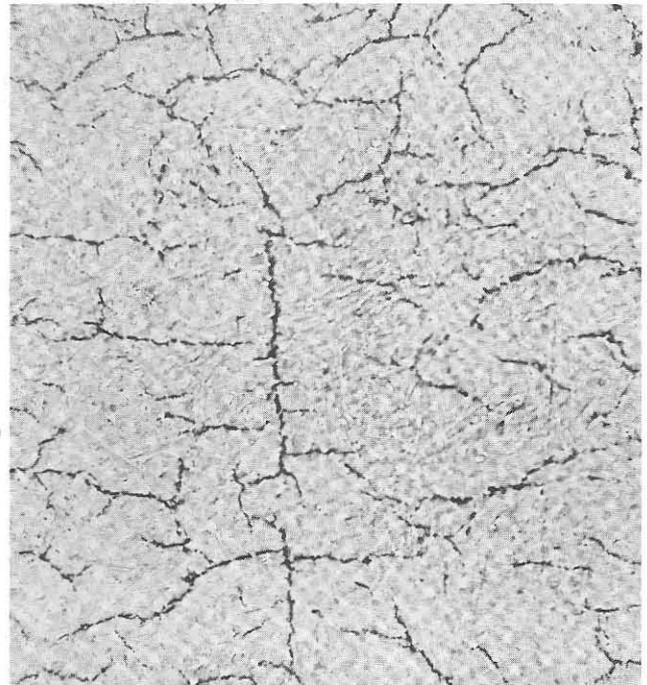
FIGURE 58 — Stress corrosion cracking of the head of a 6Al-4V-Ti alloy tank exposed to anhydrous N_2O_4 .

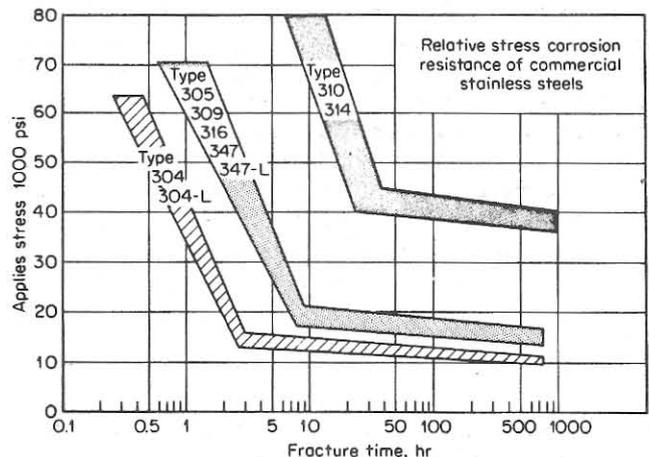
FIGURE 59 — Composite curves illustrating the relative stress corrosion cracking resistance for commercial stainless steels in boiling 42% magnesium chloride.

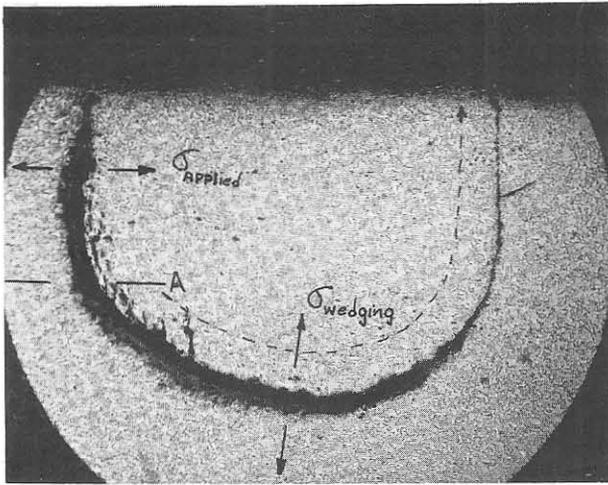
FIGURE 60 — The wedging action of corrosion products. This crack in stainless steel has proceeded in its circular path under the influence of stresses produced only by corrosion products.

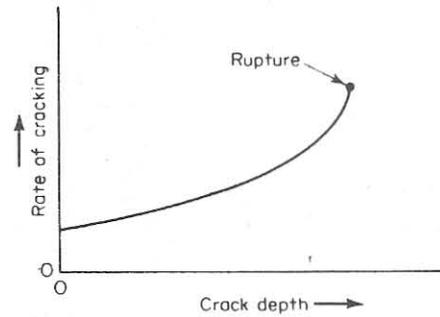
FIGURE 61 — Rate of stress corrosion crack propagation as a function of crack depth during tensile loading.

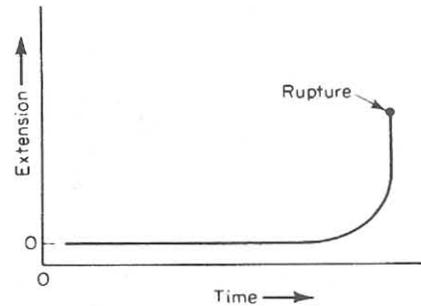
FIGURE 62 — Specimen extension as a function of time during constant-load stress corrosion cracking test.

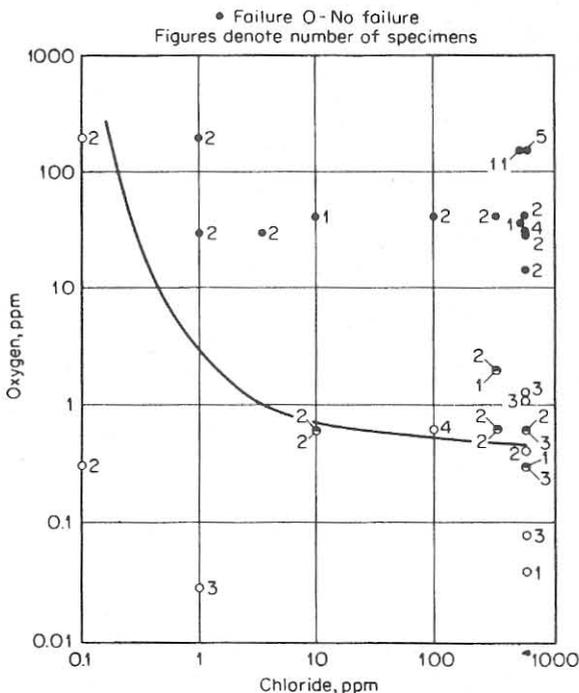
FIGURE 63 — Proposed relationship between chloride and oxygen content of alkaline phosphate-treated boiler water, and susceptible to stress corrosion cracking of austenitic stainless steel exposed to the steam phase with intermittent wetting.

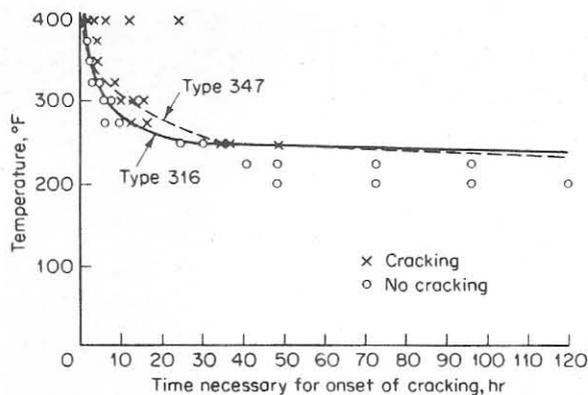
FIGURE 64 — Effect of temperature on time for crack initiation in Types 316 and 347 stainless steels in water containing 875 ppm NaCl (W. W. Kirk, F. H. Beck, and M. G. Fontana. Stress Corrosion Cracking of Austenitic Stainless Steels in High Temperature Chloride Waters, in T. Rhodin (ed.), Physical Metallurgy of Stress Corrosion Fracture, Interscience Publishers, Inc., New York (1959).

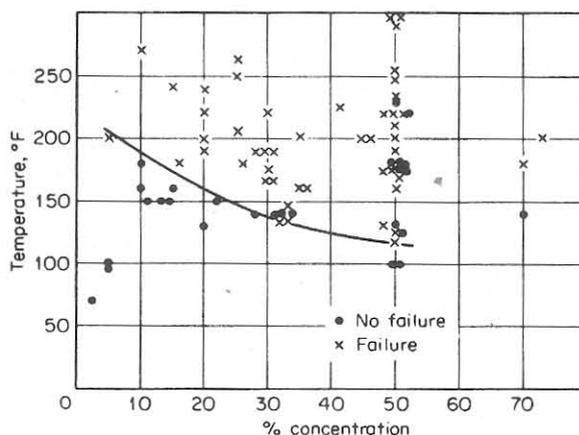
FIGURE 65 — Effects of temperature and concentration on the cracking of as-welded carbon steel in sodium hydroxide based on service experience.

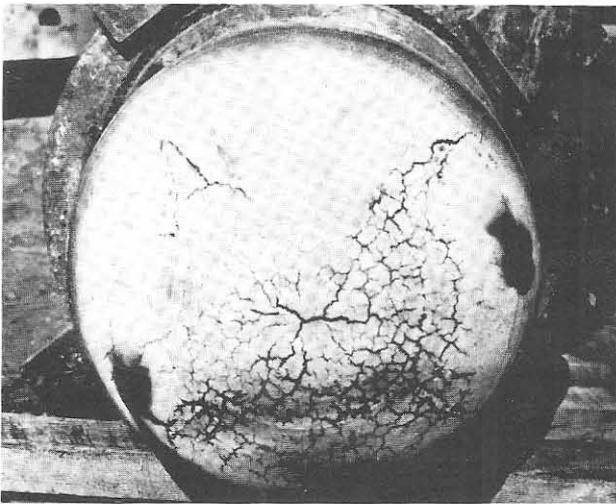
FIGURE 66 — Stress corrosion of Type 304 autoclave (Mallinckrodt Chemical Works).

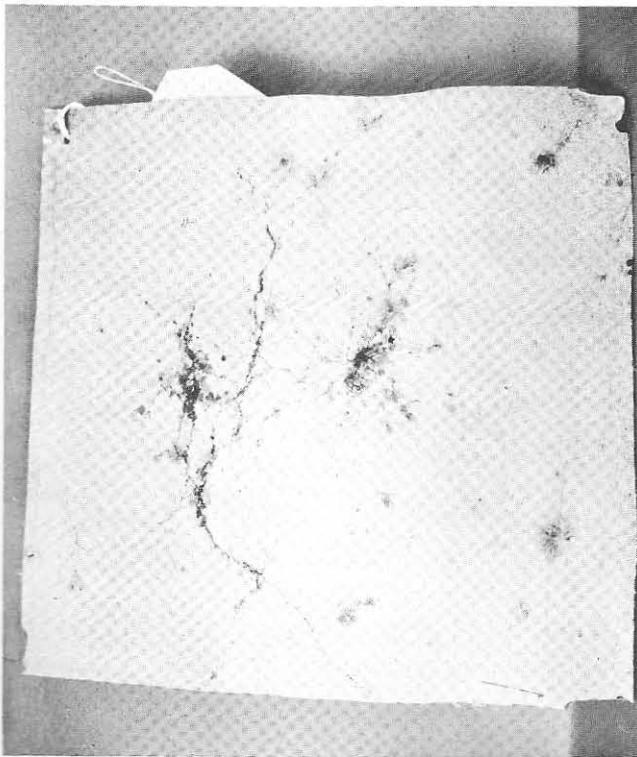
FIGURE 67 — External stress corrosion of Type 304 vessel.

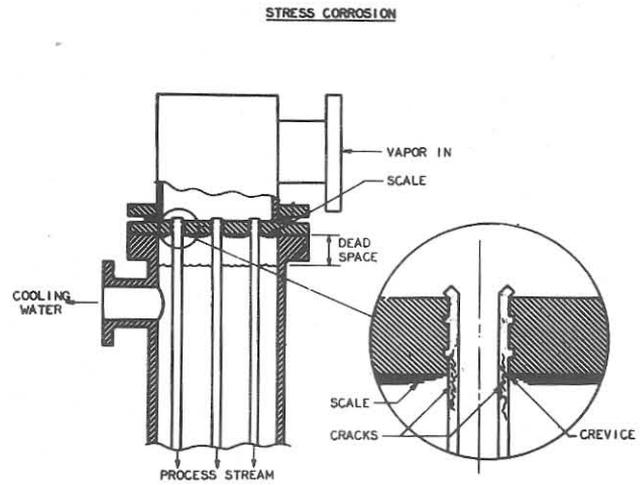
FIGURE 68 — Cracking of Type 316 tubes in dead space area (J. A. Collins).

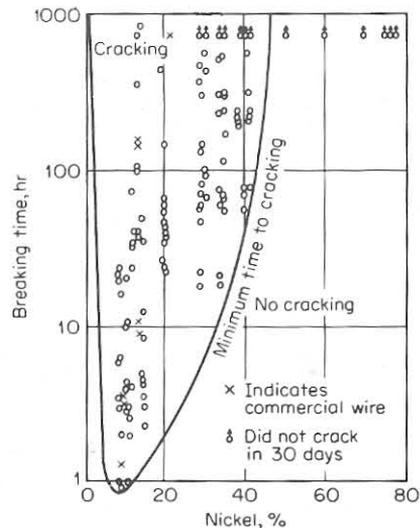
FIGURE 69 — Stress corrosion cracking of iron-chromium-nickel wires in boiling 42% magnesium chloride (H. R. Copson, Effect of Composition Cracking of Some Alloys Containing Nickel, in T. Rhodin (ed.), Physical Metallurgy of Stress Corrosion Fracture, Interscience Publishers, Inc., New York (1959).

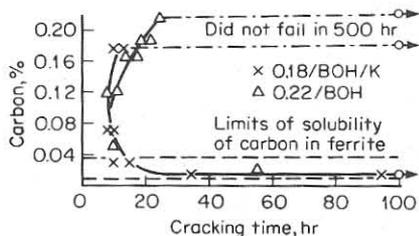
FIGURE 70 — Effect of carbon content on the cracking time of mild steel exposed to boiling calcium ammonium nitrate (R. N. Parkins).

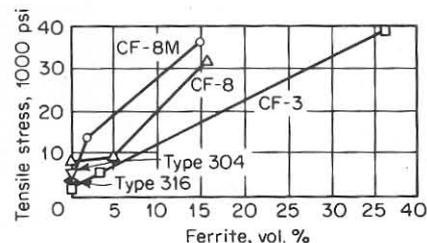
FIGURE 71 — Effect of ferrite on stress required to induce stress corrosion cracking in several cast stainless alloys. Type 304 and 316 with zero ferrite also plotted. Specimens exposed 8 hours in condensate from 875 ppm chloride water at 400 F. (M. G. Fontana, F. H. Beck, J. W. Flowers, *Metal Progr.*, Vol. 86, p. 99 (1961) December.

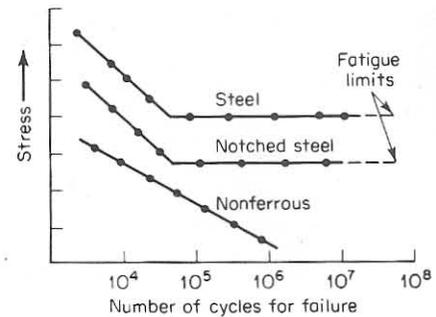
FIGURE 73 – Schematic illustration of the fatigue behavior of ferrous and nonferrous alloys.

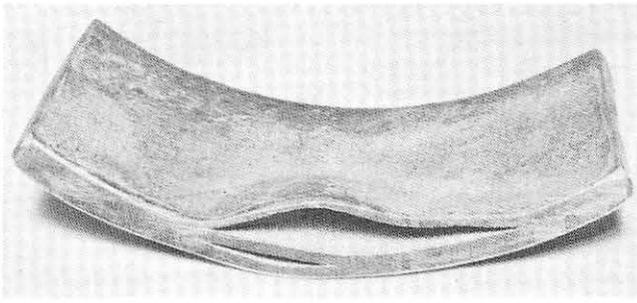
FIGURE 74 — Cross section of a carbon steel plate removed from a petroleum process stream showing a large hydrogen blister. Exposure time: 2 years (Imperial Oil Limited, Ontario, Canada).

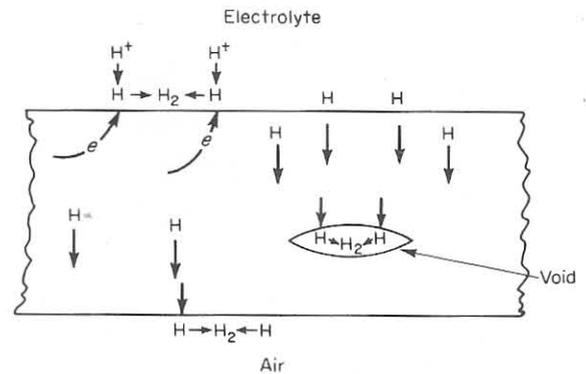
FIGURE 75 — Schematic illustration showing the mechanism of hydrogen blistering.

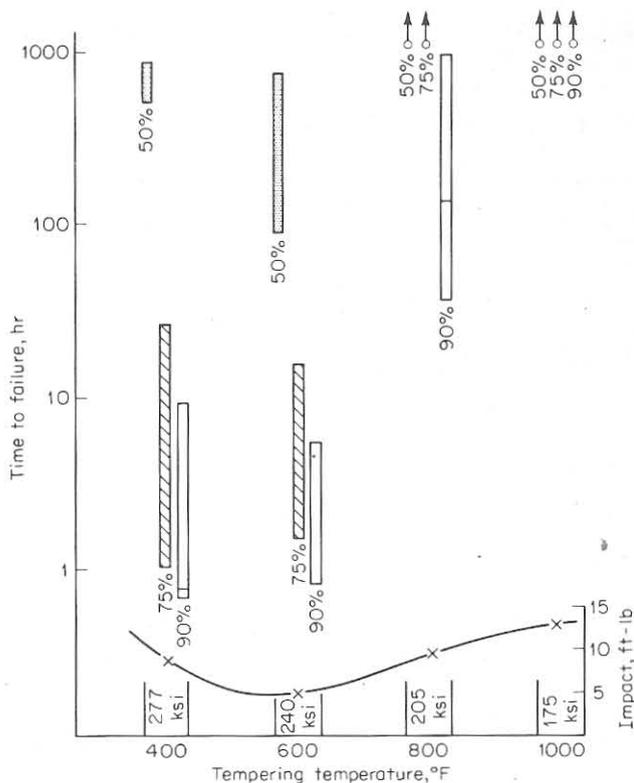
FIGURE 76 — Time to failure vs tempering temperature for 4340 steel at stress levels of 50, 75, and 90% yield stress. Specimens exposed to wetting and drying 3.5% NaCl solution at room temperature.

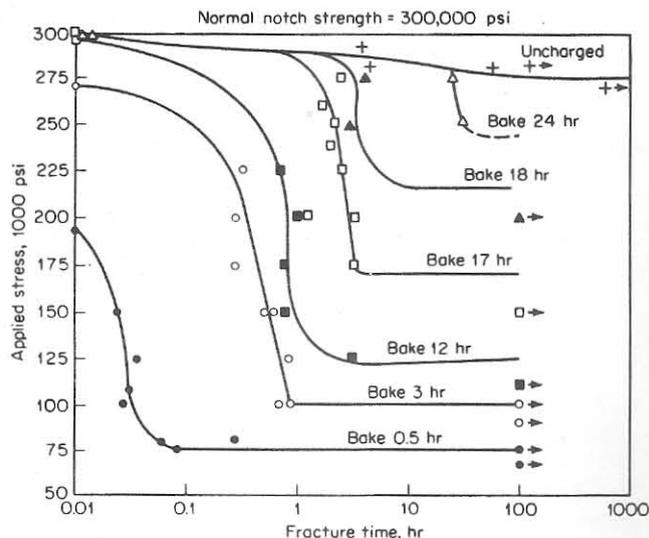
FIGURE 77 — Static fatigue curves for various hydrogen concentrations obtained by baking 4340 steel different times at 300 F.

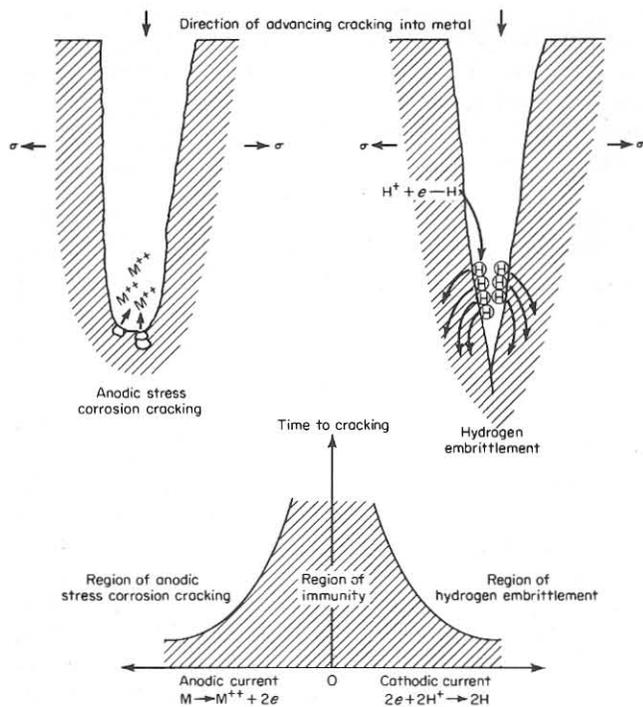
FIGURE 78 — Schematic differentiation of anodic stress corrosion cracking and cathodically sensitive hydrogen embrittlement (R. W. Staehle).
