MINISTRY OF TRANSPORT AND CIVIL AVIATION

# CIVIL AIRCRAFT ACCIDENT

Report of the Court of Inquiry  
into the Accidents to  
Comet G—ALYP on 10th January, 1954  
and Comet G—ALYY on  
8th April, 1954

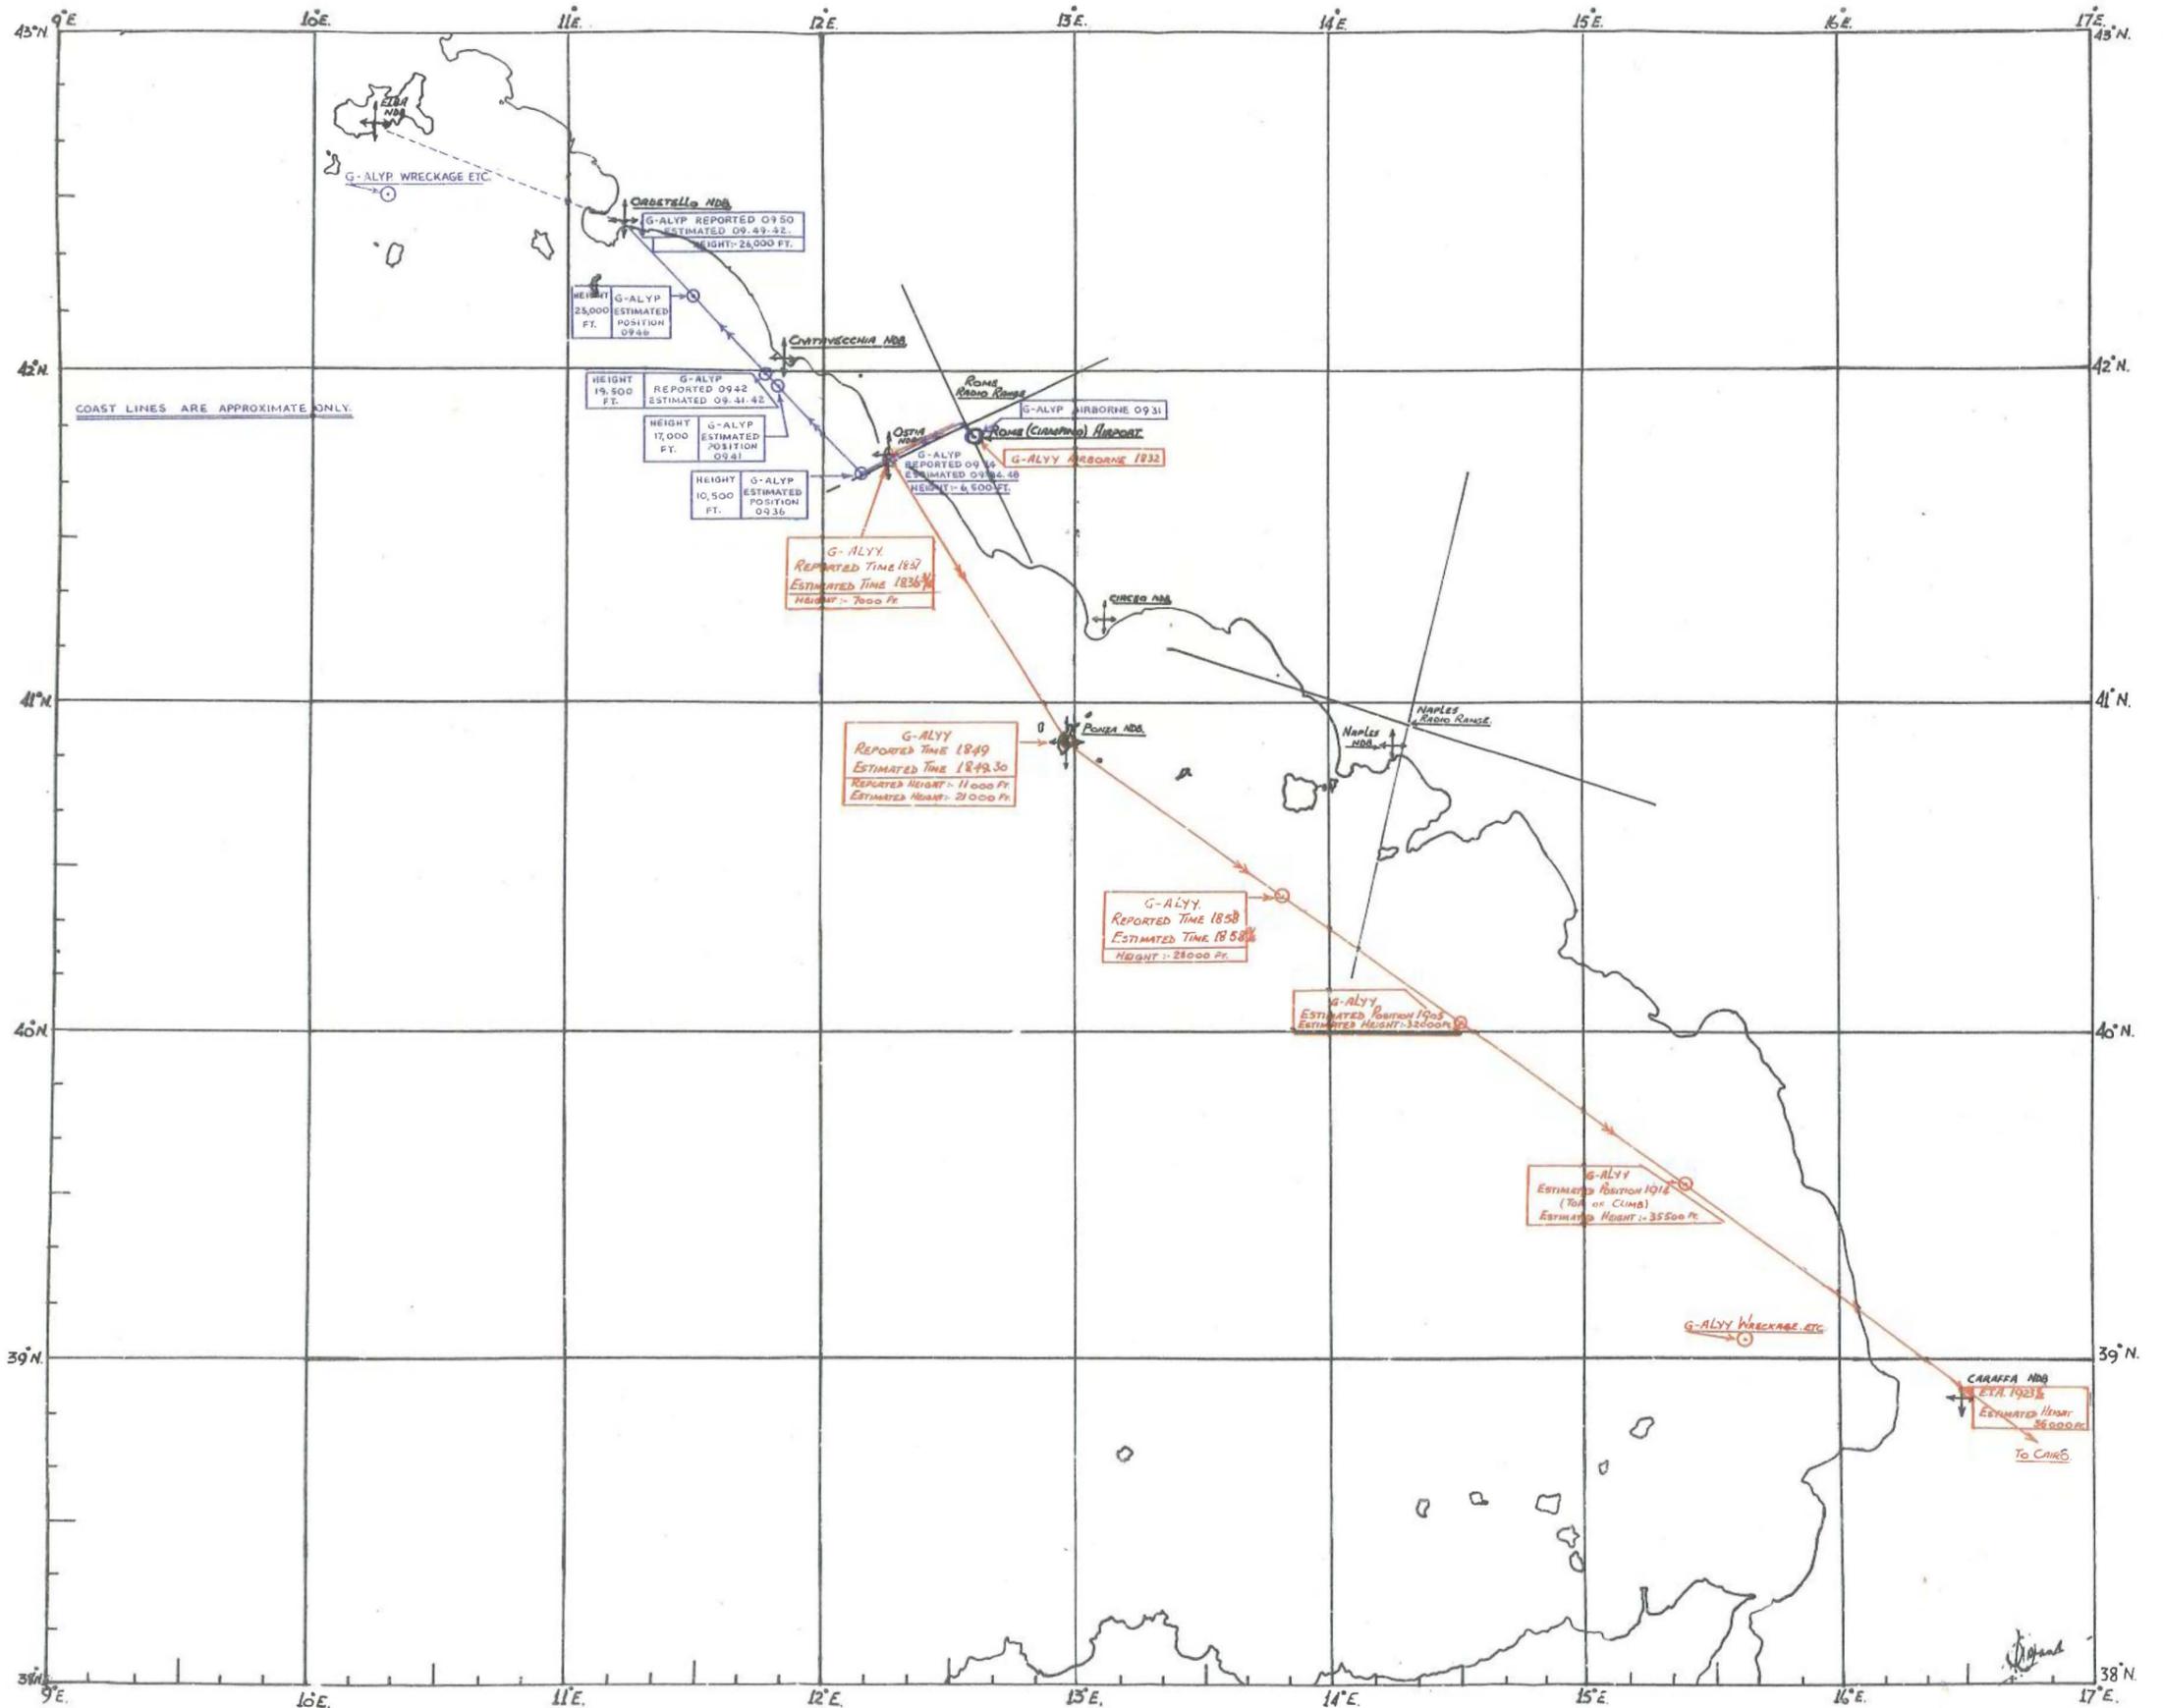
FIG. 1.

28. The chart, which is Figure 1 of this Report, was prepared from all the information available and produced by a Navigating Officer from B.O.A.C. The estimated flight track of the aircraft and the position in which bodies and wreckage were found can be seen on the chart and the witness gave it as his opinion that at 0951 hours the aircraft was probably approaching a height of 27,000 feet.

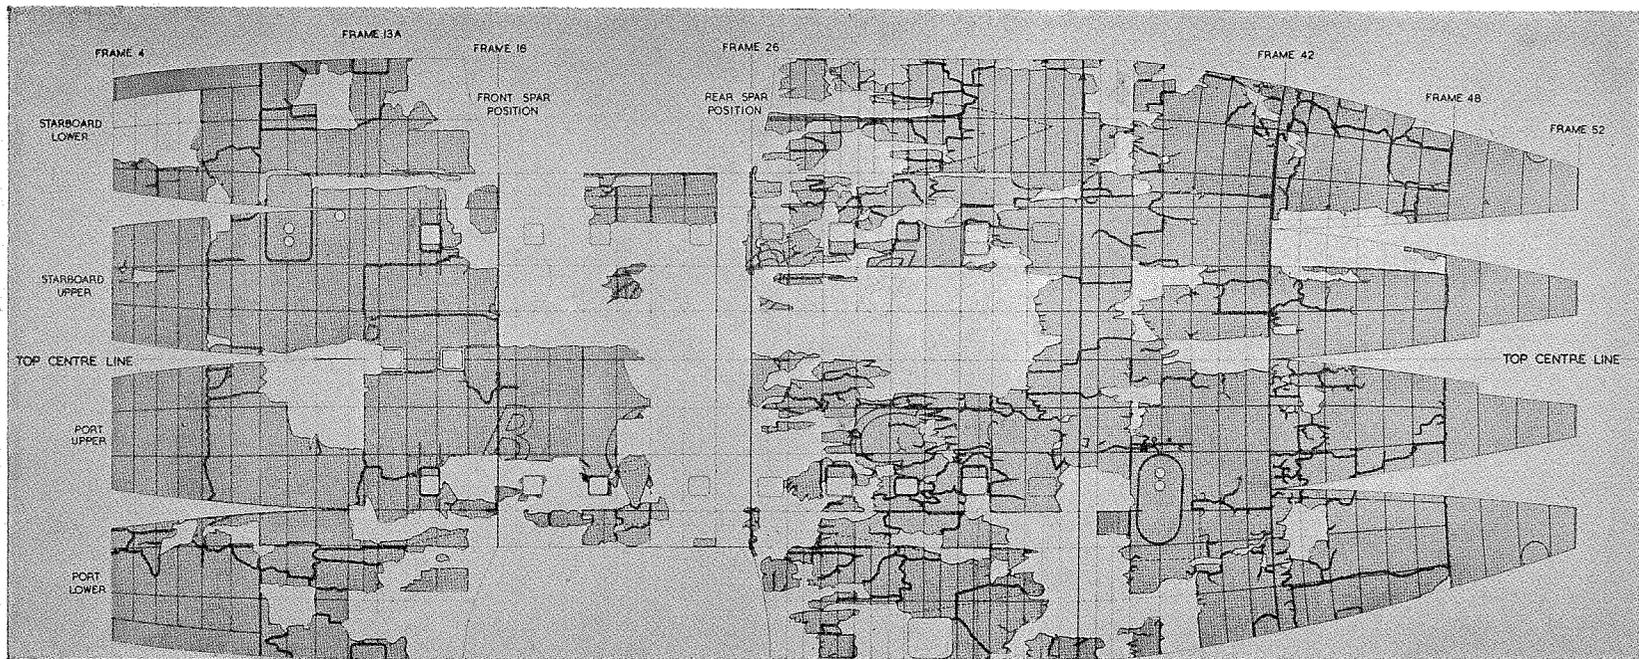
FIG. 3. DEVELOPMENT DRAWING OF FUSELAGE SHOWING AMOUNT OF WRECKAGE RECOVERED—G-ALYP.

50. The search was prosecuted at depths varying between 70 fathoms and 100 fathoms. It is noteworthy that this was the first occasion on which television equipment had been used for this purpose. The first date on which anything was located on the bottom by television was the 12th February, 1954. I need not recount in detail the history of the search. Suffice it to say that by the 23rd March, 1954, only the floating wreckage, the pressure dome, and parts of the rear fuselage and the engines and wing centre section had been recovered and that thereafter the search continued until by the end of August, 1954, about 70 per cent. of the empty weight of the aircraft, made up of about 70 per cent. of the structure, 80 per cent. of the power plant and 50 per cent. of the equipment, had been recovered. I have included as Appendix V a table, which was put in evidence, showing the dates of recovery of the main portions of the wreckage and the dates on which they reached Farnborough. Diagrams\* (Figures 2 and 3) give a striking impression of the amount of material which was ultimately recovered, though they

relate only to the external structure. Figure 4 is a photograph showing the reconstruction of the fuselage and tail unit from the wreckage and Figure 5 is a photograph showing the reconstruction of the front fuselage.

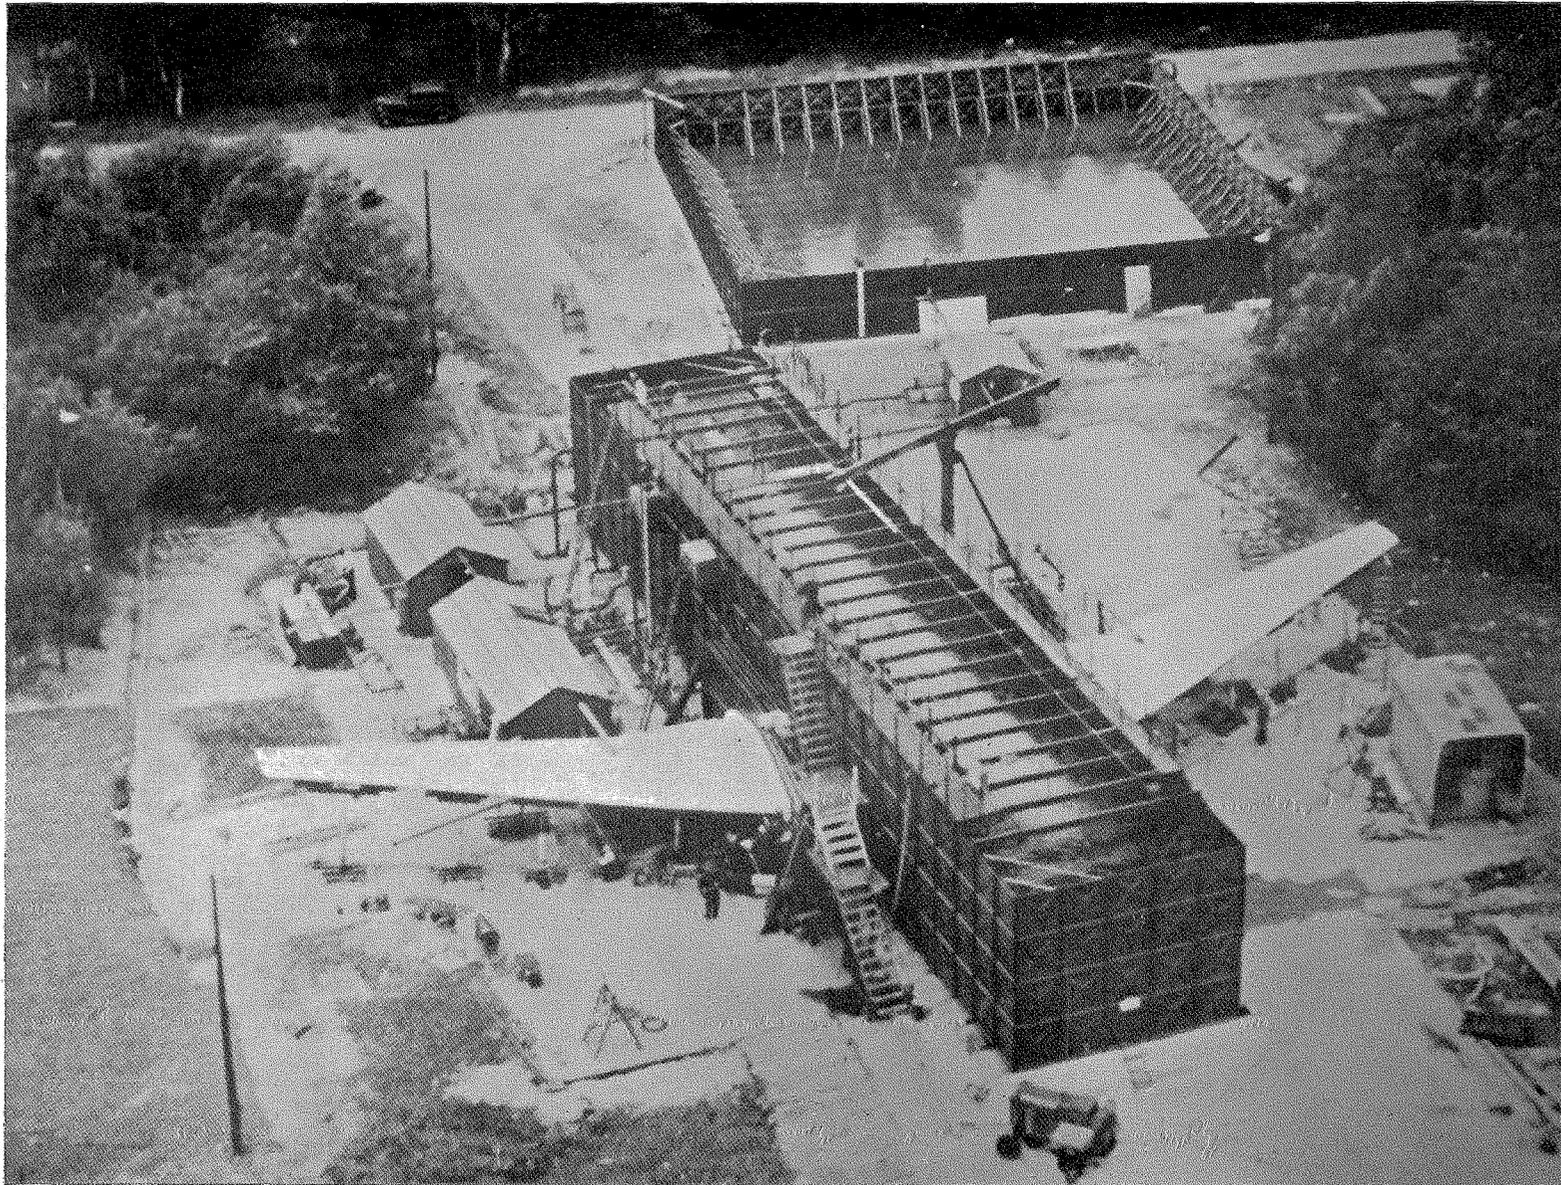
FIG. 6. AERIAL VIEW OF COMET G-ALYU IN TESTING TANK.

63. By a remarkable effort, to which de Havillands and the firms who built the tank (see Figure 6) contributed to the full and by the use of all the resources of R.A.E., repeated loading tests began early in June on aircraft G-ALYU (Yoke Uncle). The object of the tests was to simulate the conditions of a series of pressurised flights. To this end the cabin and wings were repeatedly subjected to a cycle of loading as far as possible equivalent to that to which they would be subjected in the period between take-off and landing. In addition to one application of cabin pressure, fluctuating loads were applied to the wings in bending to reproduce the effect of such gusts as might be expected in normal conditions, although the contribution of gust loads to the stresses in the cabin structure, compared with that made by the internal pressure, was in general small. Moreover, the programme of tests included, at intervals of approximately 1,000 "flights" a proving test in which the pressure was raised to  $1\frac{1}{3}$  P (11 lb./sq. in.). It must be understood that there are other sources of fluctuating load and, therefore, of fatigue to which no precise value can be attached. No attempt was made to represent these in the test. Examples are vibration due to irregular airflow, vibration due to the engines and the jet efflux and fluctuating loads occurring during take-off and landing.

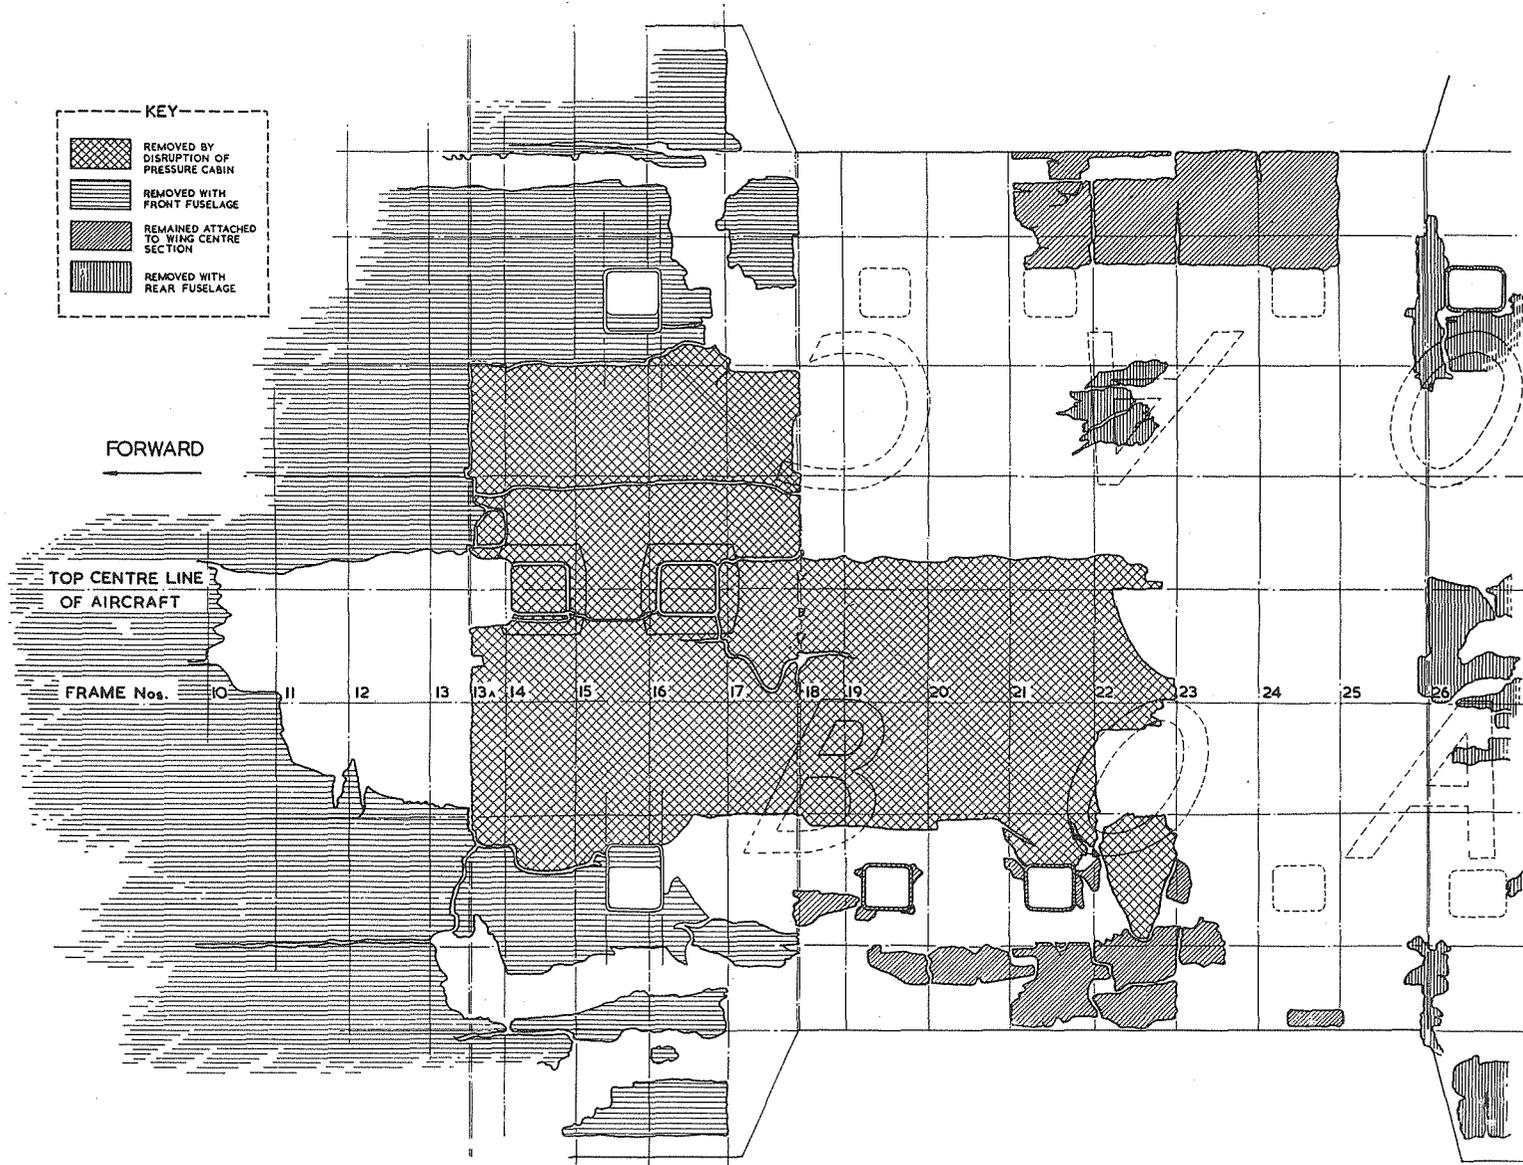
FIG. 18. DEVELOPMENT DRAWING OF WRECKAGE AROUND ADF AERIAL WINDOWS—G-ALYP.

76. A development drawing of the wreckage recovered from the part of the cabin over the wing spar is shown in Figure 18. Apart from the area on top of the cabin around the A.D.F. windows, which is shown cross-hatched, the
