Fig. 1. Survey of the various aspects of fatigue of structures [11].

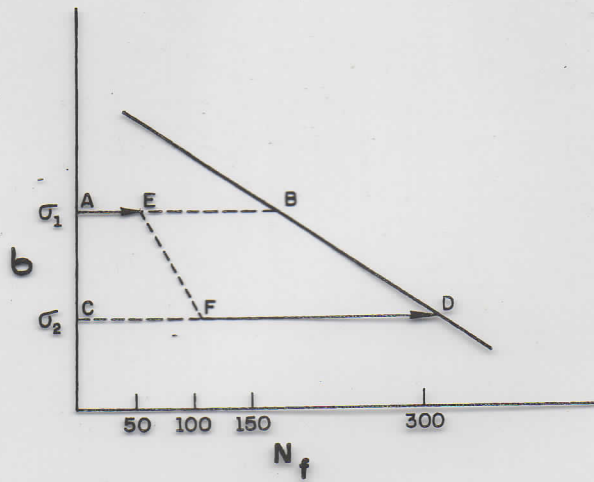
Figure 14.9 Damage accumulation, in a high-to-low loading sequence. (Adapted with permission from B. I. Sandor, *Fundamentals of Cyclic Stress and Strain* (Madison, WI: University of Wisconsin Press, 1972))

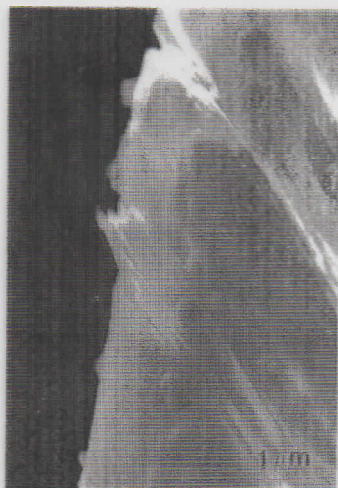
Figure 14.13 SEM of extrusions and intrusions in a copper sheet. (Courtesy of M. Judelwicz and B. Ilchner)

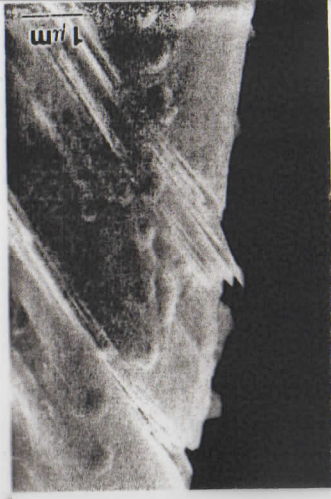
Figure 14.13 SEM of extrusions and intrusions in a copper sheet. (Courtesy of M. Judelwicz and B. Ilischer)

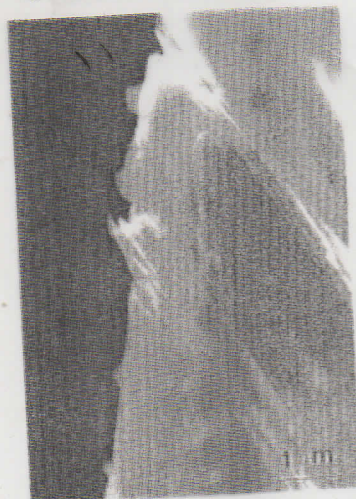
Figure 14.13 SEM of extrusions and intrusions in a copper sheet. (Courtesy of M. Judelwicz and B. Ilchner)

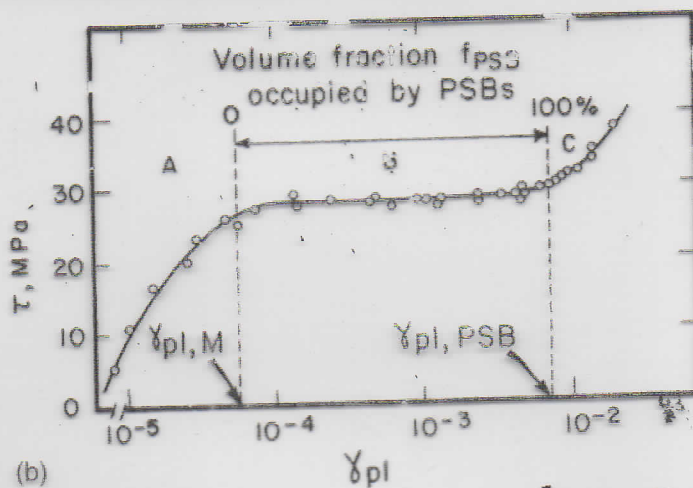
Figure 14.10 (a) Persistent slip bands in vein structure. Polycrystalline copper fatigued at a total strain amplitude of 6.4×10^{-4} for 3×10^5 cycles. Fatiguing carried out in reverse bending at room temperature and at a frequency of 17 Hz. The thin foil was taken $73 \mu\text{m}$ below the surface. (Courtesy of J. R. Weertman and H. Shirai) (b) Cyclic stress-strain curve for a single crystal of copper oriented for single slip (After H. Mughrabi, *Mater. Sci. & Eng.*, 33 (1978) 207)

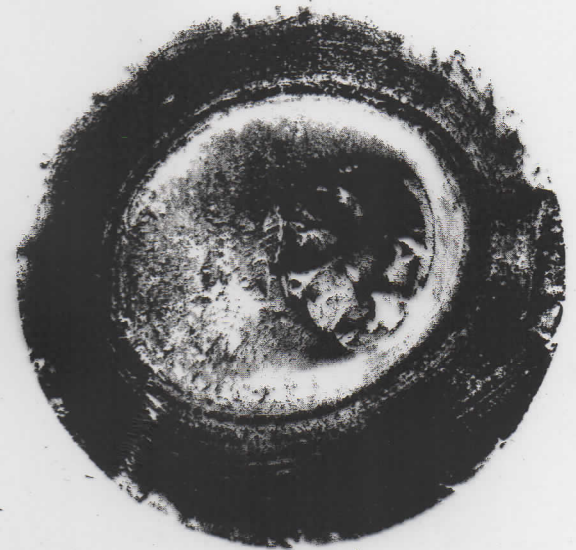
Fig. 17-10 "Ratchet marks" around edges of fatigue failures indicate that fracture began at several points. (Courtesy of D. J. Wulpi, International Harvester Company.)

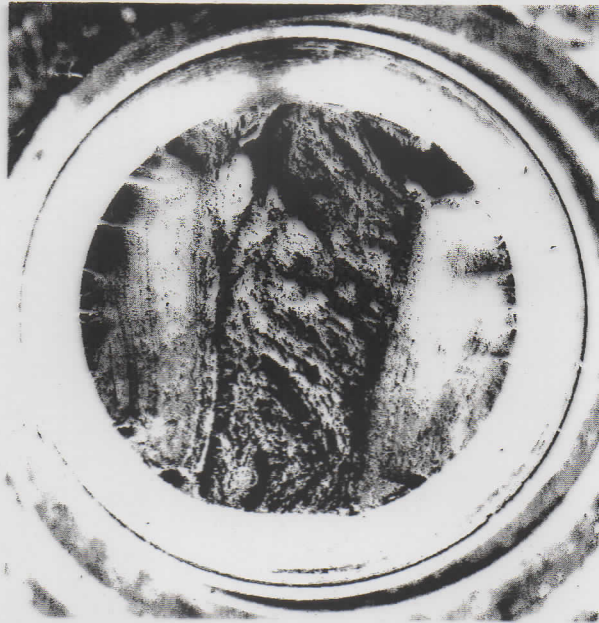
Fig. 17-29 This 1050 shaft, 1.94 in. in diameter, broke in reversed bending fatigue. A sharp fillet concentrated the bending stresses, causing a crack to develop on opposite sides with final fracture in the middle. (Courtesy of D. J. Wulpi, International Harvester Company.)

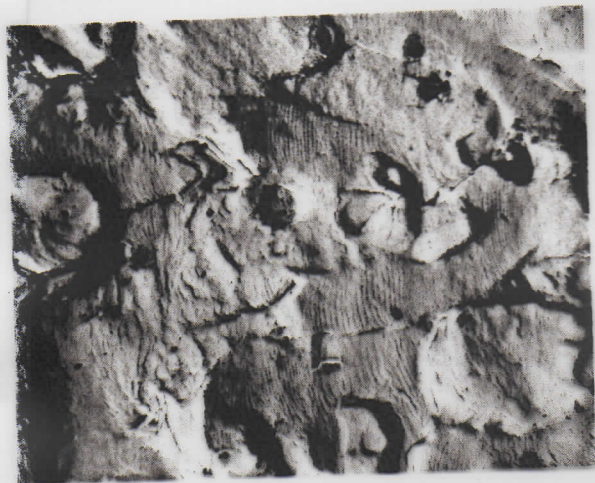
Fig. 15. Microfractograph of a fatigue rupture surface of duralumin (alternate bending, ± 7 kg/mm², rupture in 0.27×10^6 cycles).
