Photocatalytic Performance of White Cement Mortars Exposed in Urban Atmosphere

By Sérgio Roberto Andrade Dantas, Fúlvio Vittorino & Kai Loh

Polytechnic School of São Paulo University

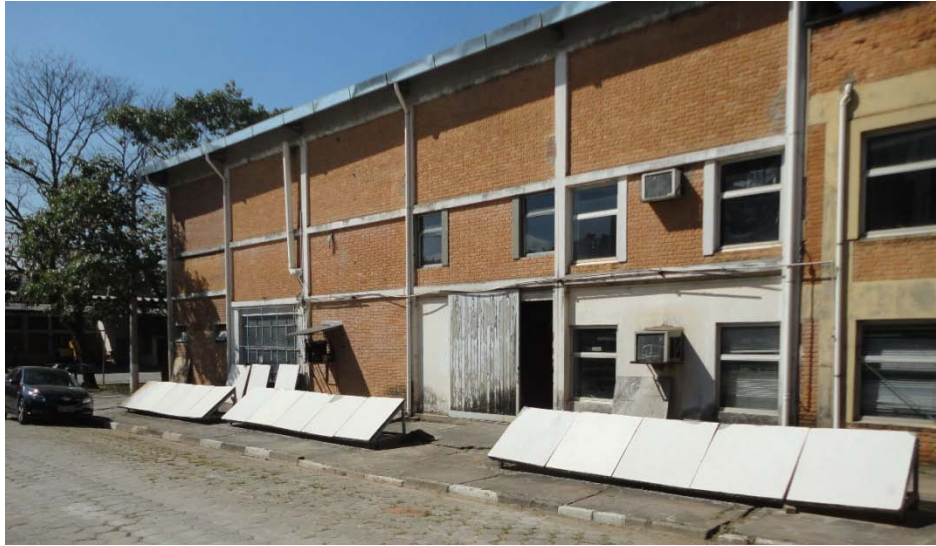
Fig.1: Exposure of specimens

The tests were carried out on specimens with dimensions of 1.2m × 1.2m under exposure to an urban environment for 41 months in the city of São Paulo (Latitude: 23° 33' 15" S; Longitude: 46° 44' 1" W) in the northwest direction, to maximize exposure to sunlight, as shown in Fig.1. A slope of 33° used concerning to the ground, to obtain, (i) a higher solar radiation index; and

(ii) to prevent the stagnation of rainwater on the specimen surfaces, thus limiting the proliferation of microorganisms.

The mortars were applied by a mason, with a maximum thickness of 1 cm and with the absolute minimum roughness to obtain a high reflectance. The substrate was finished with cement paste to achieve regularisation, the homogenization of water absorption, enhanced adhesion, and to prevent an increase in the consumption of the mortars.

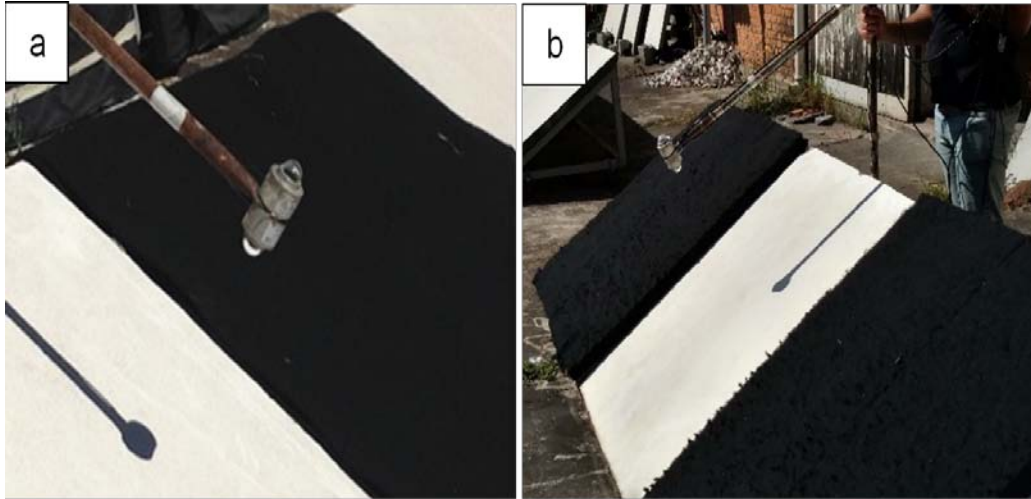
Fig. 3: (a) Pyranometers and (b) data collection

The reflectance values were determined in accordance with the methods given in the ASTM and ASHRAE standards [28,29]. All measurements were carried out from 11h00 to 13h00 because of the highest incidence of global solar radiation on the specimens surfaces. The measurements were carried using two pyranometers, with measuring ranges of 305–2800 nm and maximum measuring ranges of up to 2000 W/m², with an output signal of 0–50 mV and sensitivity of 10–35µV/W/m². A data acquisition system was employed using a datalogger with a 6.5-digit display and

conversion rate (maximum) of 10 measurements per second, with an RS232 output. An acquisition rate of 1 measurement per second and acquisition time of 20 s are employed, by a previous study by Dantas, Vittorino, and Loh [12]. Fig.3 presents the measurement procedure.

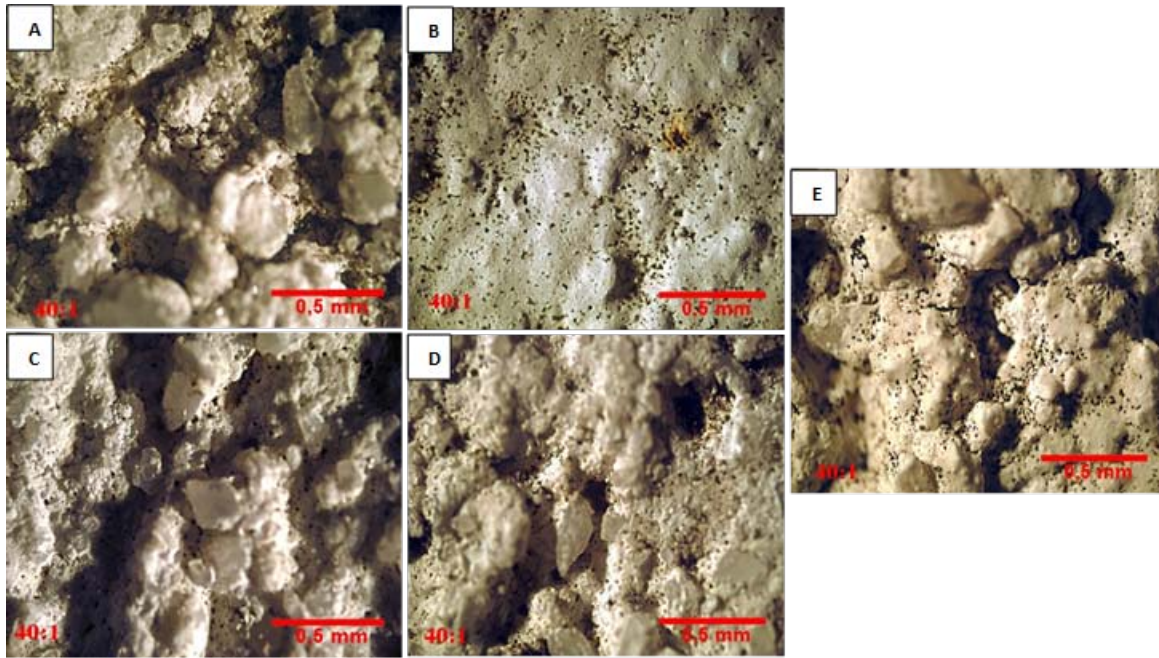
Fig. 4: The surface roughness of specimens

specimens exhibited a lower roughness than those of the other specimens in the early stages of the exposure time period. Also, a lower rugosity can prevent impregnation and to ease the removal of dirt by rainfall, resulting in an increased reflectance under exposure to solar and luminous radiation. However, this is not observed after 24 months of exposure, when the acrylic film exhibited degradation, allowing for increased accumulation of dirt on the surfaces of type-B specimens. Fig.4 presents the surfaces of the mortars.

Visual inspection using an optical microscope revealed an increase in the roughness of the specimens surfaces. The images revealed that the type-B

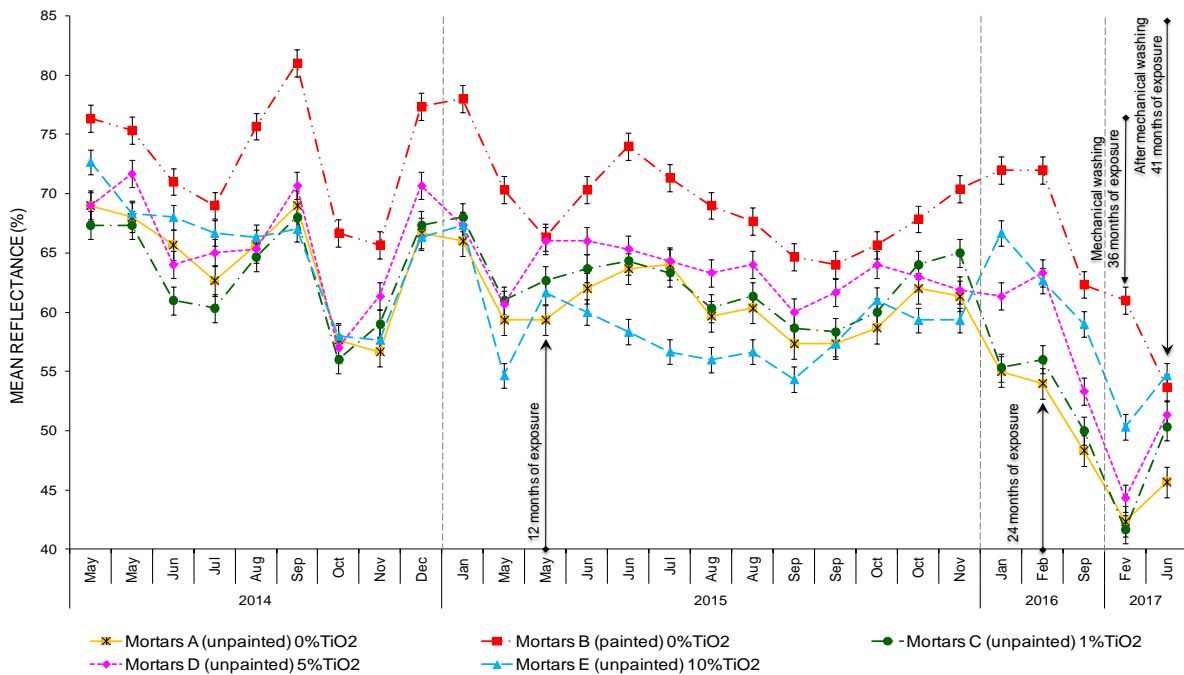
Fig. 5: Mean reflectance of mortars after 41 months of exposure to an urban environment

Fig.5 presents the mean (average of three values of each sample) reflectance of the specimens over the 41 months of exposure to the urban environment. Figs.6 and 7 present the total global solar radiation incident on the horizontal surfaces and the total monthly rainfall in São Paulo city, respectively.

During the first 12 months of exposure, type-B specimens exhibited a noticeable high reflectance, given that the acrylic paint did not exhibit degradation. Moreover, no marked differences are observed among the reflectance results of the other mortars groups, which could be considered to have equal values. For type-A mortar, a decrease in the reflectance was expected as a result of the natural aging process, which results from the accumulation of dirt. For types C, D, and E, their initial reflectance values were expected to remain stable for a longer time period. Also, the small

After 12 months, type-E mortars exhibited a decrease in the reflectance under exposure to solar radiation when compared with the other mortars. This difference remained significant until the 16th month of exposure. However, with longer exposure time, an important difference in the behavior of the mortars was

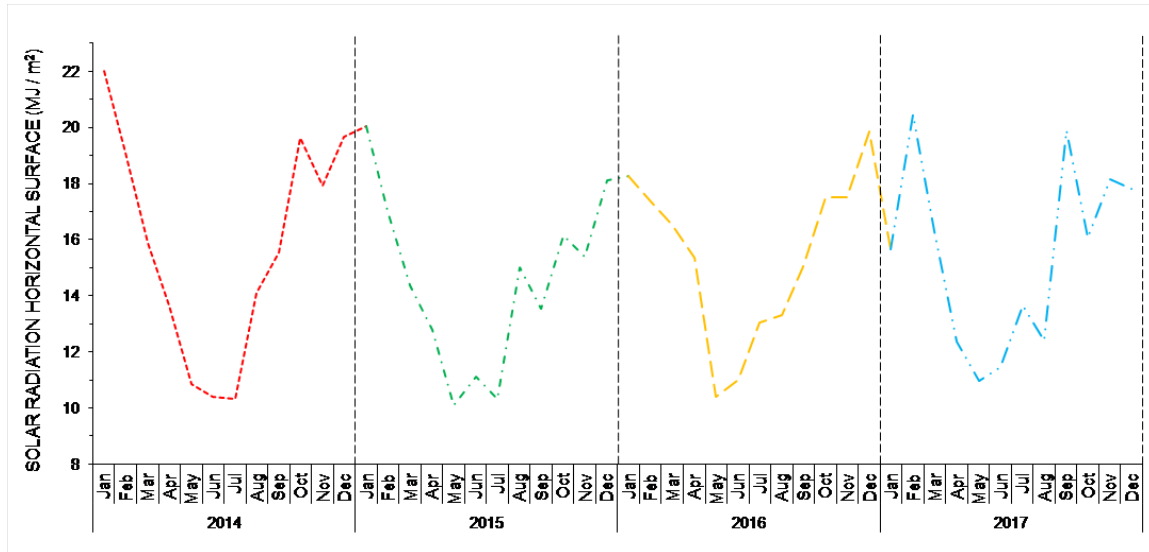
Fig. 6: Solar radiation on horizontal surfaces in São Paulo city

observed. The increase in reflectance from September (2015) to October (2015) was directly related to the high rainfall that occurred during this period (Fig.7) and the increase in solar radiation (Fig.6) associated to the beginning of the spring season. This two factors contributed to the cleaning of the specimens surface and the increase in the photocatalytic activity during this period.

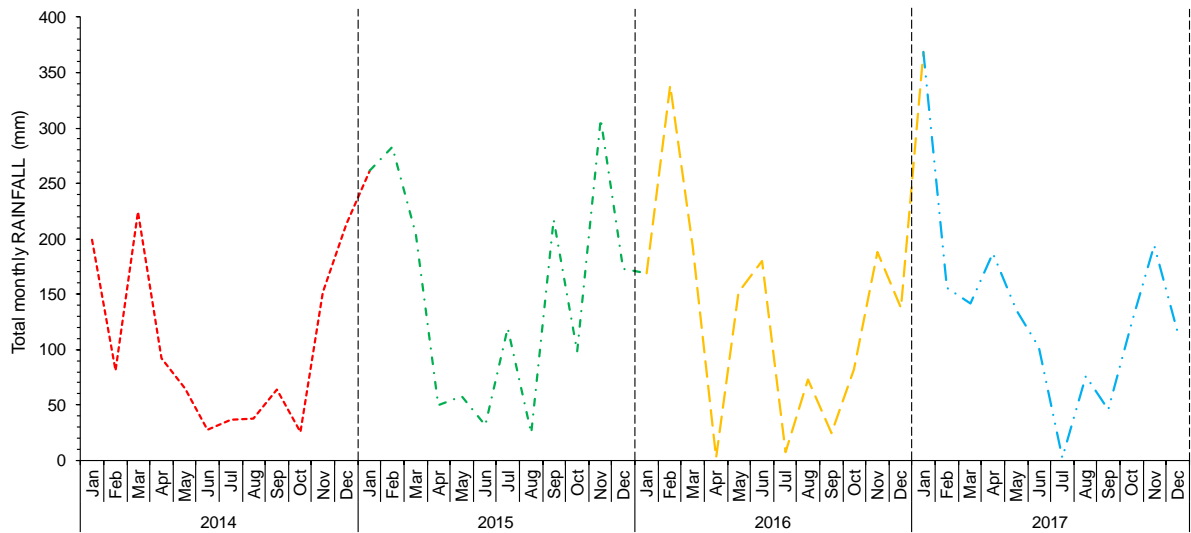
Fig. 7: São Paulo city monthly rainfall

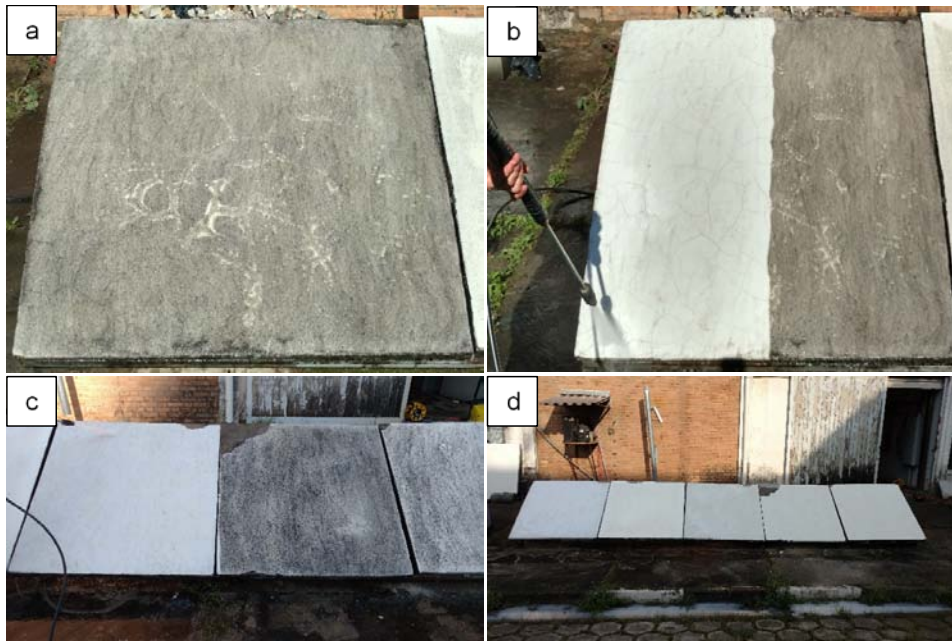
Fig.8: (a) Before washing; (b) during washing; (c) difference between specimens; and (d) after washing

In the third year (2017), a significant decrease was observed in the values of reflectance under exposure to solar radiation in all the specimens. Over the three years of exposure, apart from type-B samples, all the mortars exhibited a higher impregnation by dirt, which limited the photocatalytic activity. After that, the samples were cleaned using a washing machine, to reproduce the process commonly employed for cleaning building facades. Fig.8 presents some examples before and after the washing.

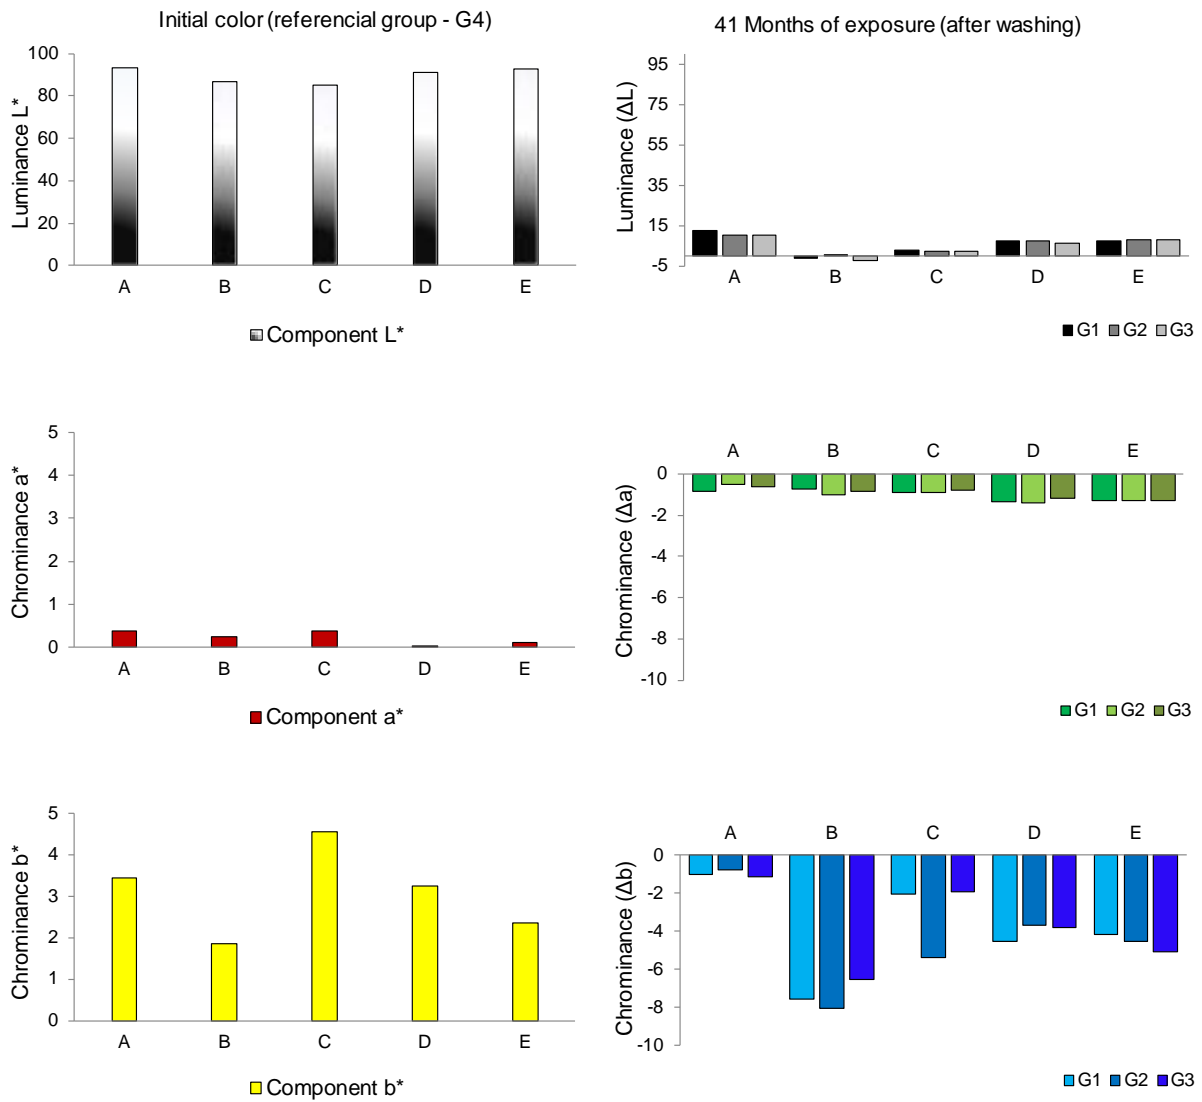
Fig. 9: Changes in color of mortars by CIE L*a*b*

For evaluation of the white color, the CIE L*a*b* components (ΔL^* / Δa^* / Δb^*) to be individually considered for a better perception of the changes in the shades of the mortars. The components were calculated using simple arithmetic differences, and Fig.9 presents the initial values and the differences between the colors at the beginning of exposure and after 41 months of exposure, following the washing of the specimens.

Thus, concerning to the difference of color (measured according to CIE L*a*b* scale), differences in the chromatic components of the mortars were observed upon evaluation after 41 months of exposure, following the washing, as shown in Fig.9.

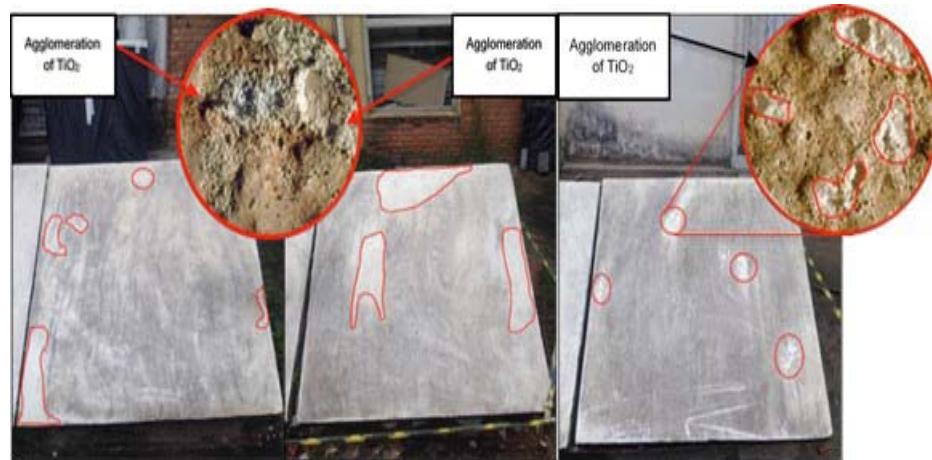
Fig.10: n-TiO₂ agglomerates of E-type mortars

ineffectiveness of the photocatalytic activity can connect to: (i) the increased accumulation of dirt on the specimens surfaces; (ii) increases in the surface roughness of the mortars, and (iii) the impact of n-TiO₂ non-dispersion that resulted in the formation of agglomerates, as shown in Fig.10.

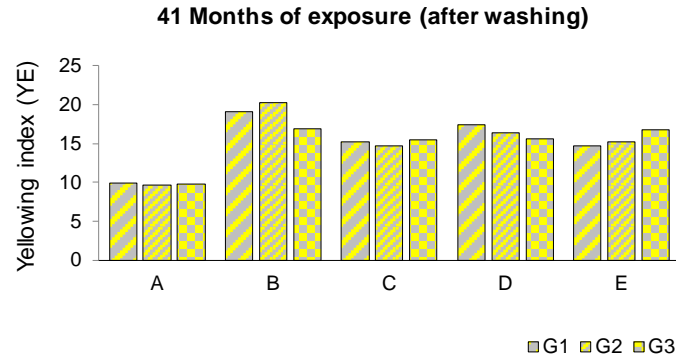
Fig.11: Yellowing index (YE) by CIE L*a*b*

The yellowing index (YE) determined by the spectrophotometer (see Fig.11) was higher for type-B specimens than it was for the other. The yellowing of the specimens was also observable using the naked eye when compared with other white-color surfaces. This change was due to the degradation of the acrylic film of the paint over the long-term exposure.

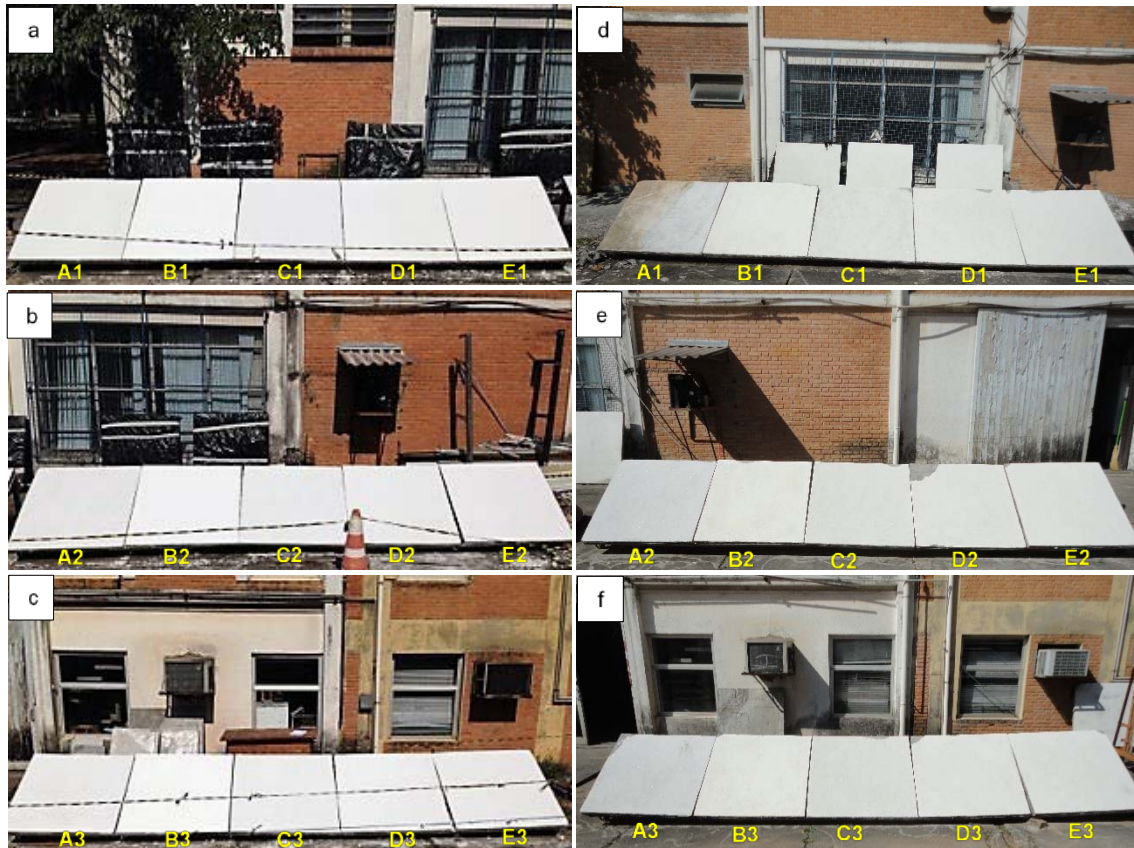
Fig.12: Color perception of specimens: (a,b, and c) 1st month and (d,e, and f) 41st month

After washing all the specimens exhibited white color surfaces, in the observation by the naked eye. However, in comparison with the colors in the beginning, different shades were observed for the specimens. Considering that the perception of color change is intrinsically subjective and dependent on the personal judgment of each observer, the perception of the white color is exclusively dependent on the type of lighting in which the surfaces are evaluated, in addition to the intensity of the light. The specimens exposed into an urban environment, which implies that there were variations in the visual perception of the observer concerning the time of day, degree of occurrence, and amount of rainfall during the surface evaluation. However, the spectrophotometer indicates the same color, independent of the weather conditions. Fig.12 presents the differences in the color perceptions of the mortars at the beginning ($t = 1^{\text{st}}$ month) and end ($t = 41^{\text{st}}$ month) of the exposure time period.

- The chromatic components (Δa and Δb), which contributed significantly to the results obtained using the spectrophotometer, as the loss of the initial white color.
- The light reflected by the surface of the specimens, which results in a phenomenon referred to as metamerism. Because of the limitations of the spectrophotometer, this phenomenon was not detected using the equipment.
